# **BAYARD CANYON SUPPLEMENTAL INTERIM REMOVAL ACTION COMPLETION REPORT**

Hanover Whitewater Creek Investigation Unit  
Vanadium, New Mexico

July 2022

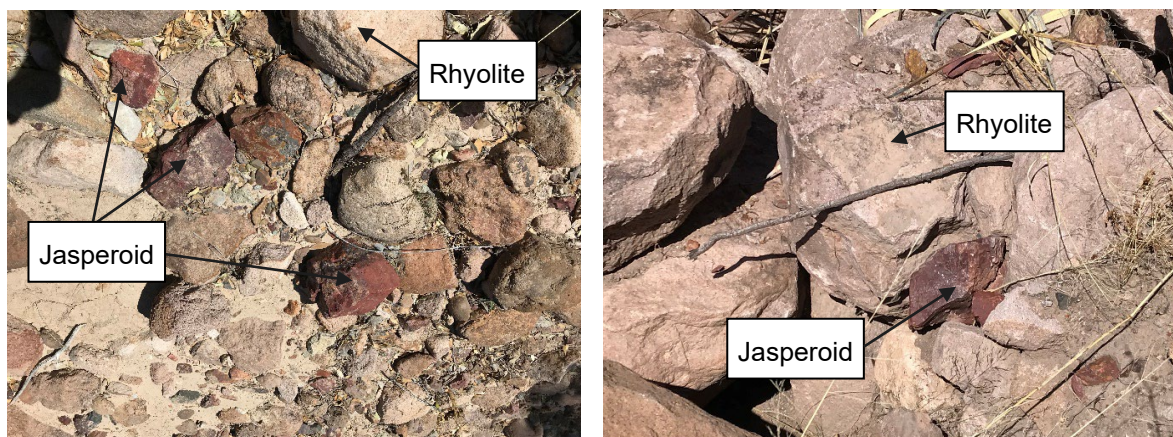
- A hematite red color characteristic of the jasperoid vein that contrasted with surrounding, tannish-colored soils and rocks from erosion of the site from surrounding rhyolite formations as noted in **Exhibit 4** below.

**Exhibit 4 – Photographs illustrating visual difference in jasperoid and rhyolite characteristics.**

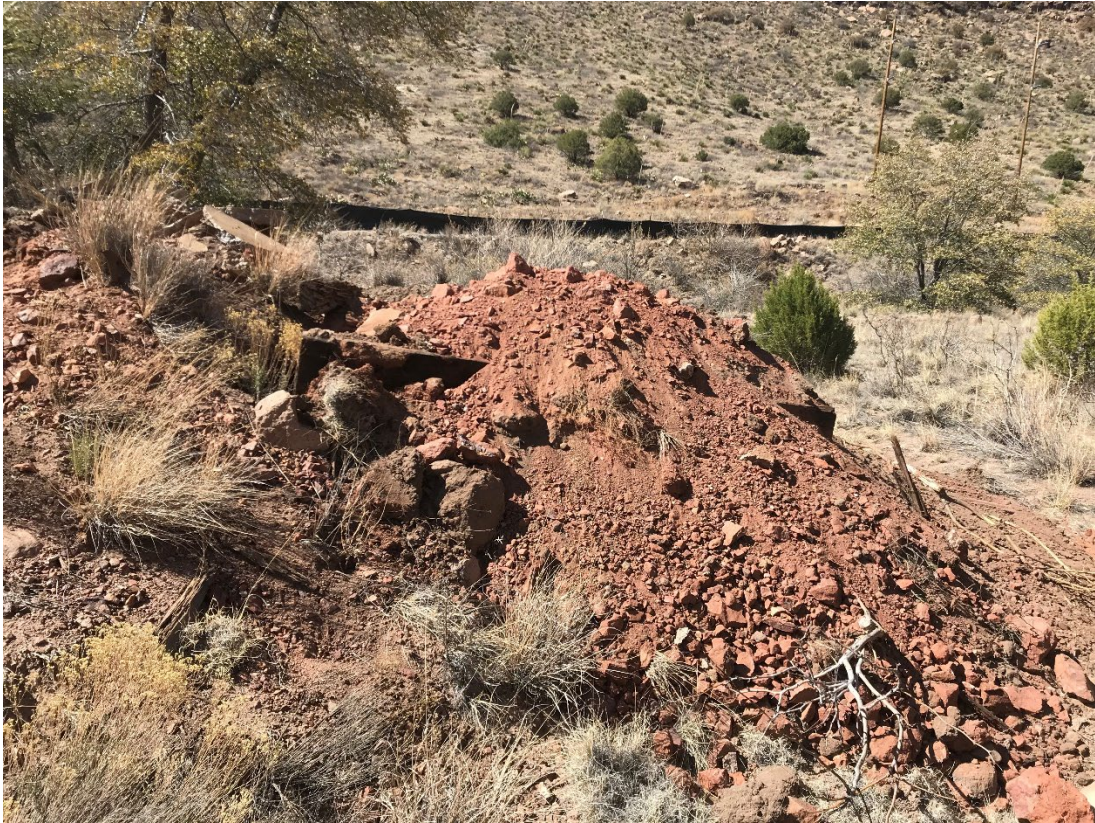
- Shaft 2 – An area approximately 14,666 ft<sup>2</sup> in size and an average depth of 0.5 feet (approximately 272 yd<sup>3</sup>) was removed in the vicinity of this shaft. See **Exhibit 6a** of site prior to stockpile removal. An outcropping of jasperoid vein was noted following removal of debris and stockpile. See **Exhibit 6b** of jasperoid vein outcrop following removal and prior to soil cover placement.

**Exhibit 6a – Photograph showing jasperoid stockpile material at Shaft 2.**

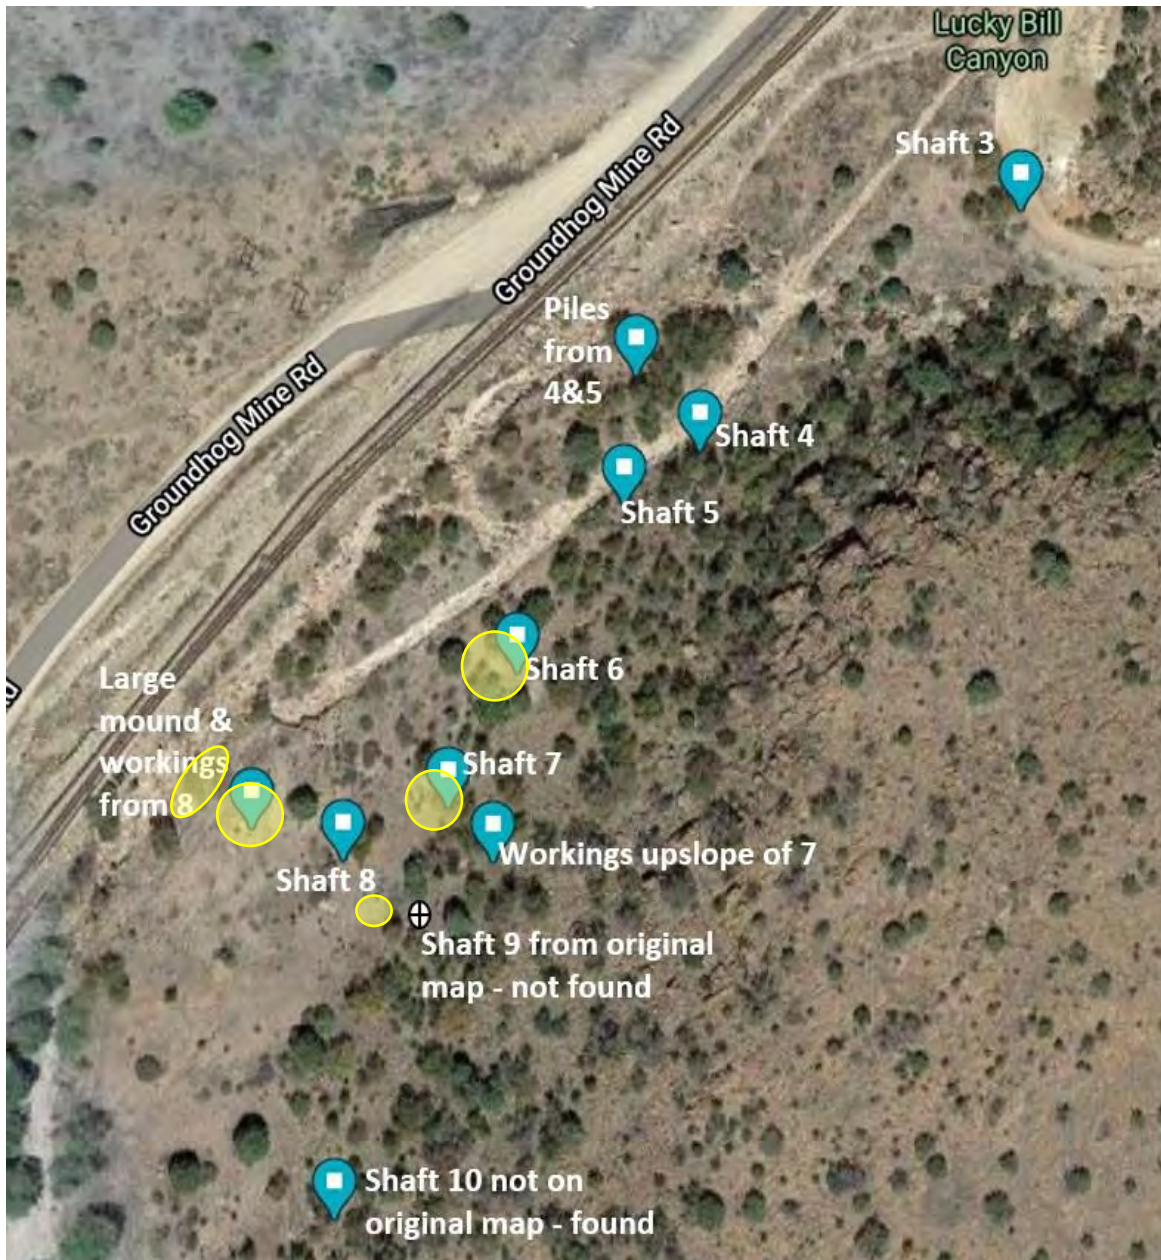
- Scraped east bank of creek at 3 small areas identified by NMED previous day. Upon removing outer edge, found area with reddish material along bank was larger than predicted. Cleaned bank so Pam can inspect Monday. See Figure 1 (oval) and Photo 1.
- Finished removing the large mound in its entirety after determining most of it contained target material. Removed underlying material to depth of 2 feet BGS. Figure 1.
- Removed rusty drum and reddish material from small area SE of Shaft 8. Figure 1.
- Finished removing target material from Shaft 7 area. Figure 1.
- Began removing material from Shaft 6 area. Figure 1 and Photo 2.
- Used water truck for dust suppression on haul road and on stockpiles.

Figure 1: Central portion of site. Shared Services excavated 3 small areas identified by NMED along creek bank (oval) plus additional material encountered beneath bank surface. Finished removing material around Shaft 7, and a small reddish area SE of Shaft 8. Removed entire mound and area beneath it. Started removing material at Shaft 6.

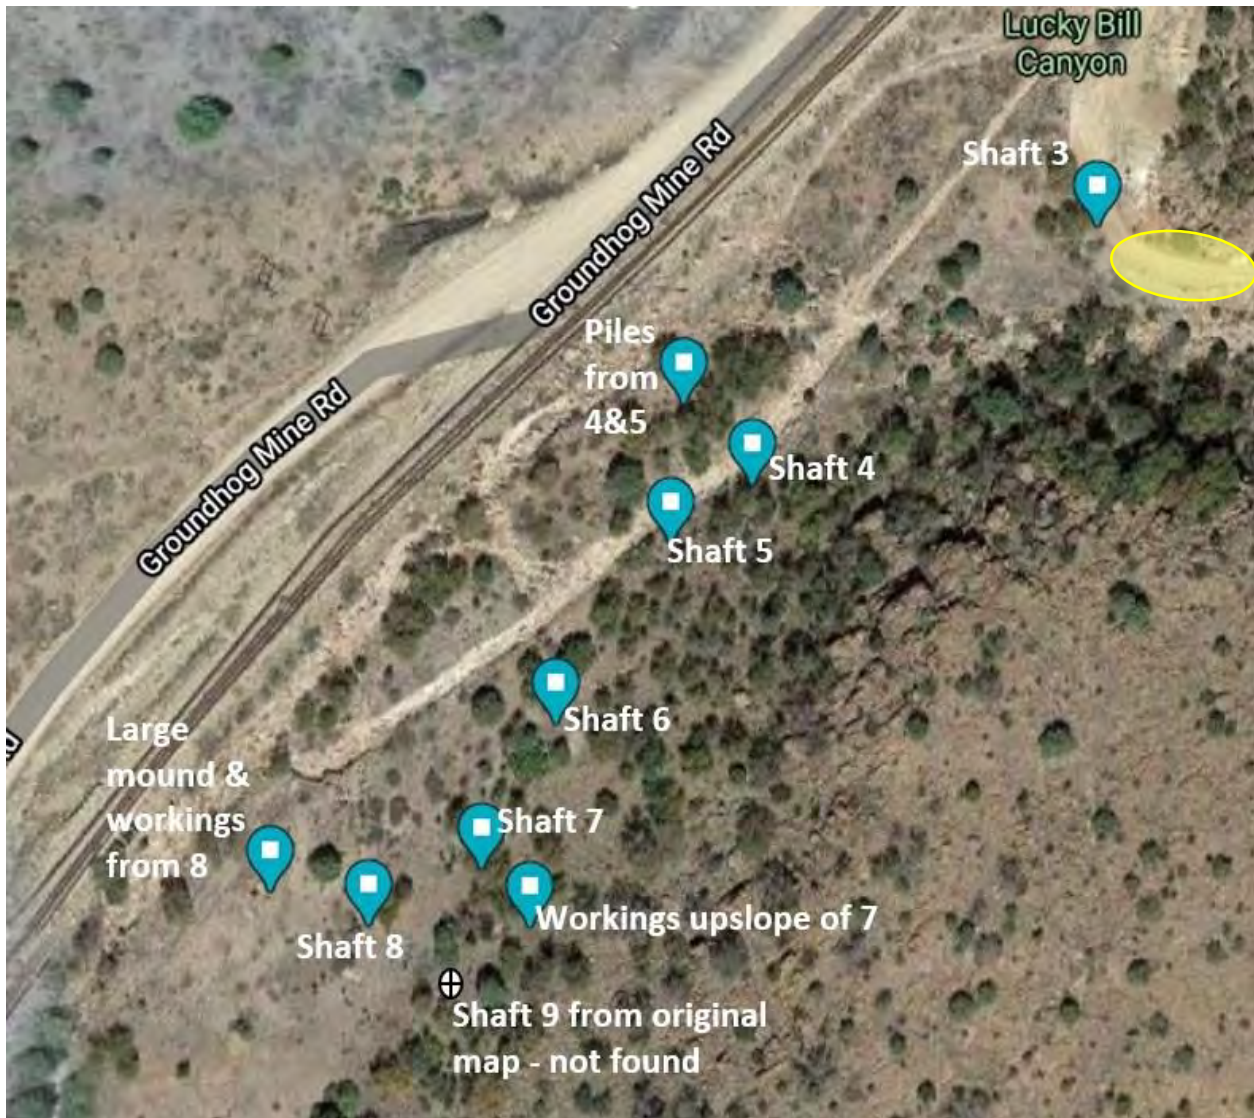
**Figure 1: Central Area.** Today, Shared Services worked full day adjacent to Shaft 3 at confluence with Lucky Bill Canyon – removing red, yellow, and gray soil to depths of 10', down to bedrock.

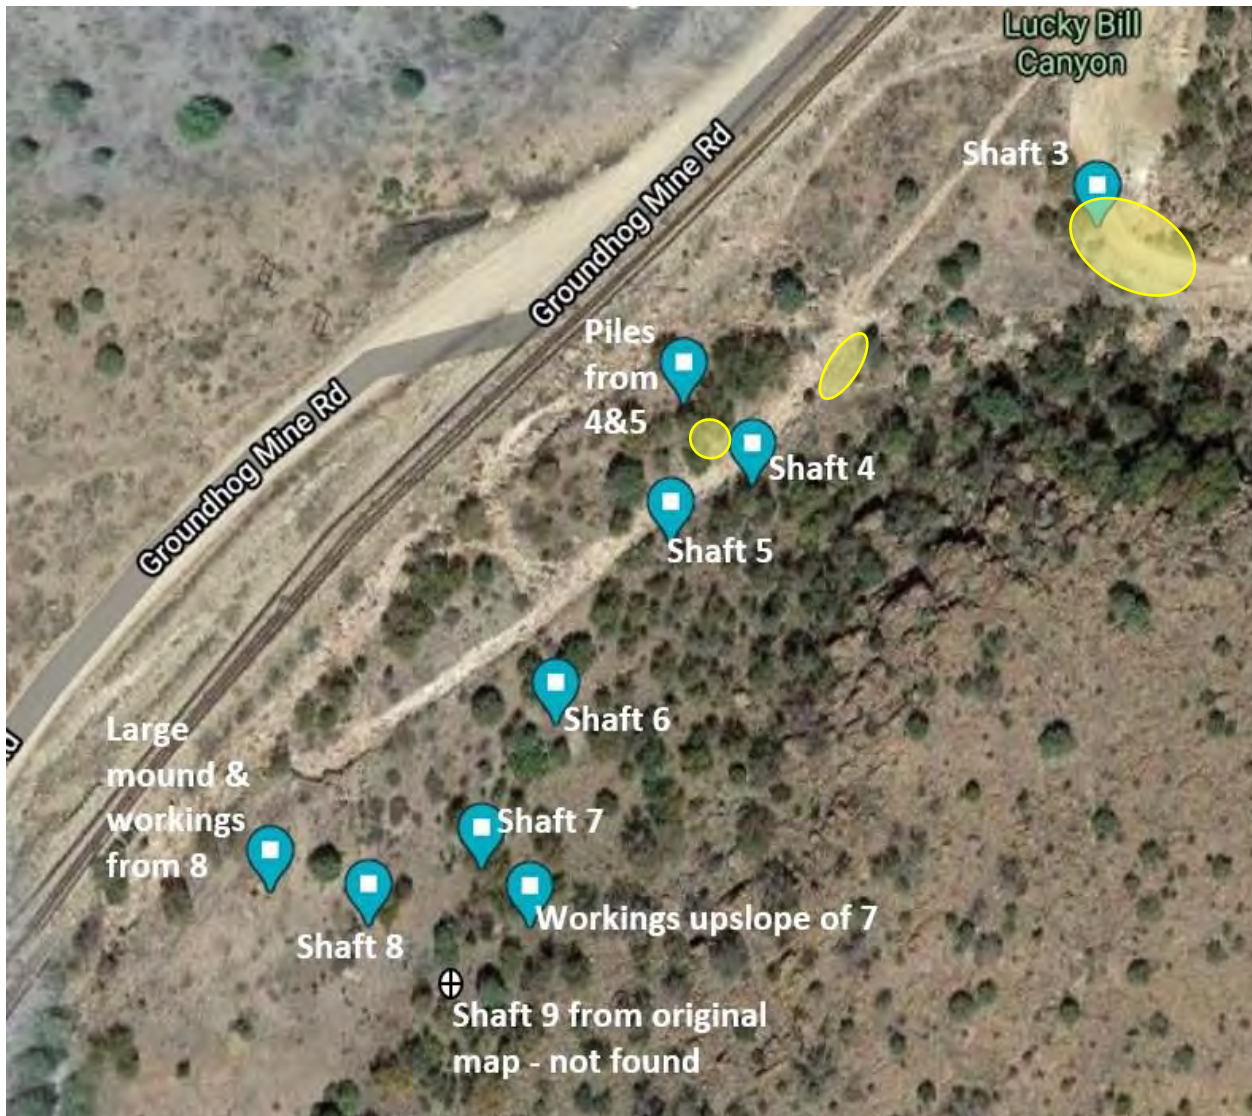
**Figure 1: Central Area.** Today, Shared Services:

- Worked a second full day adjacent to Shaft 3 at confluence with Lucky Bill Canyon – removing red, yellow, and gray soil to depths of 10', down to bedrock. Large yellow circle above.
- Removed small piles where reddish material was previously observed and flagged. Two smaller circles above.
- Built containment berm for new stockpile of removal soil near original stockpile adjacent to Groundhog. Began hauling to new stockpile. Not on map.
- Used recently-repaired water truck for dust control on haul roads and stockpiles.
- Used D8 dozer to continue pushing borrow material into pile near south end of site. Not on map.

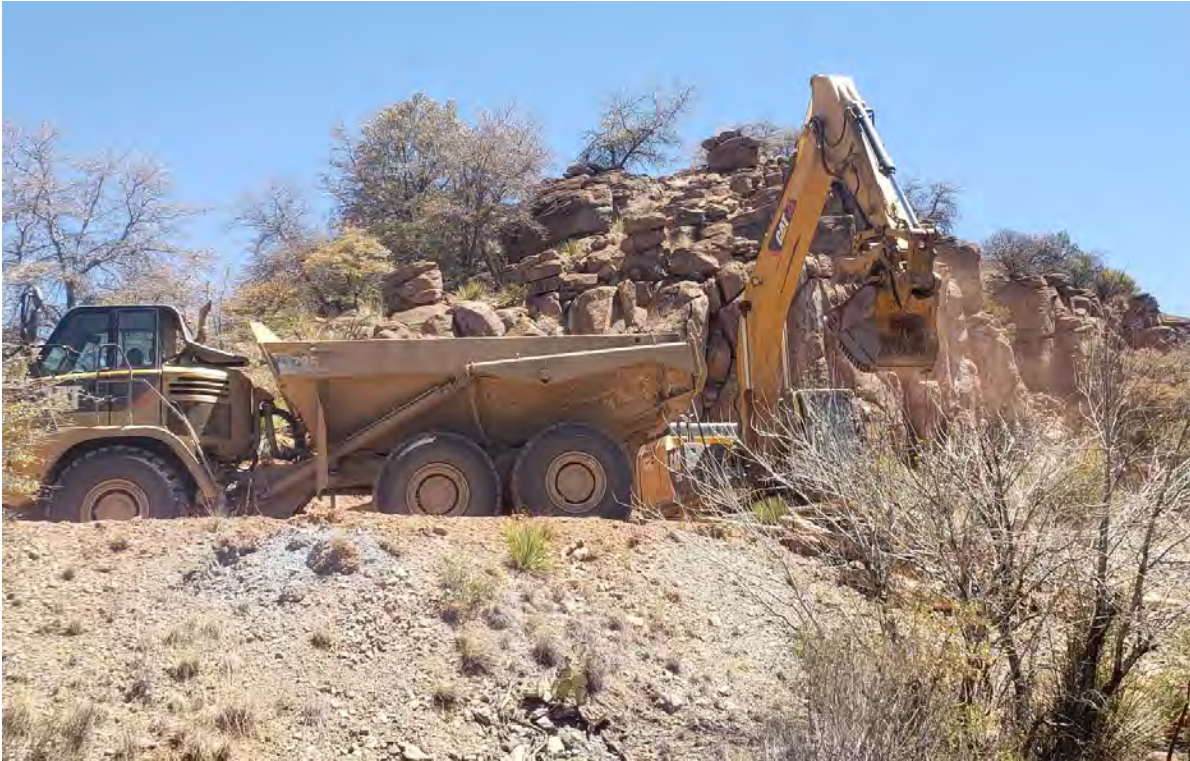
**Photo 1:** Shared Services continued removing material from the road near Shaft 3 at the confluence with Lucky Bill Canyon.

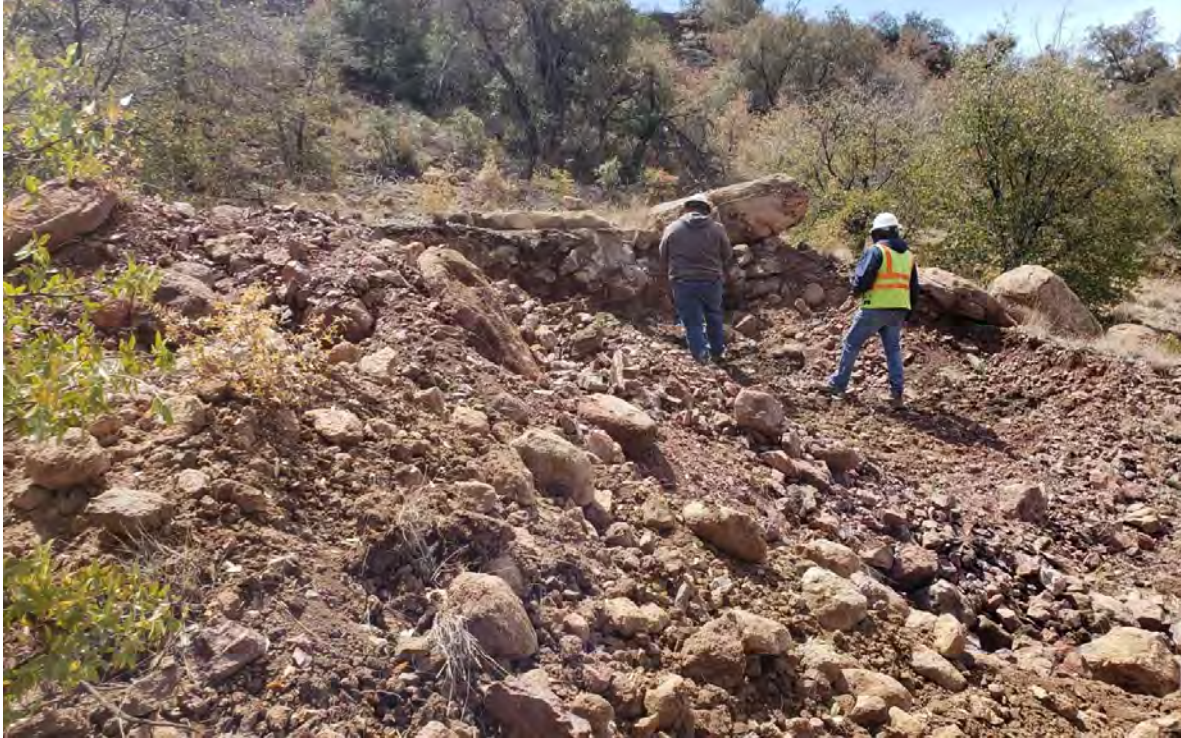
**Photo 1:** David Mercer (NMED) and Travis Wilmes (Shared Services) inspected concrete foundation at Shaft 2 where partial removal was completed previous day.

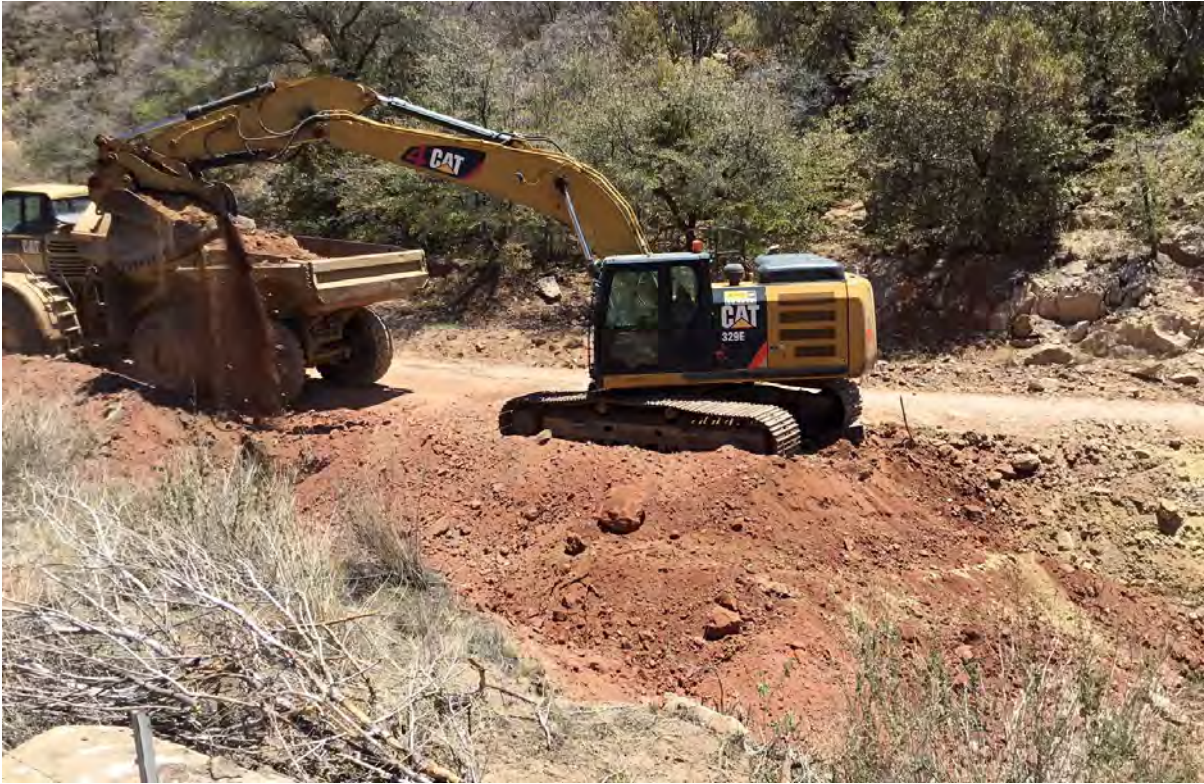
**Photo 1:** Shared Services removed red material at Shaft 1 along access road.

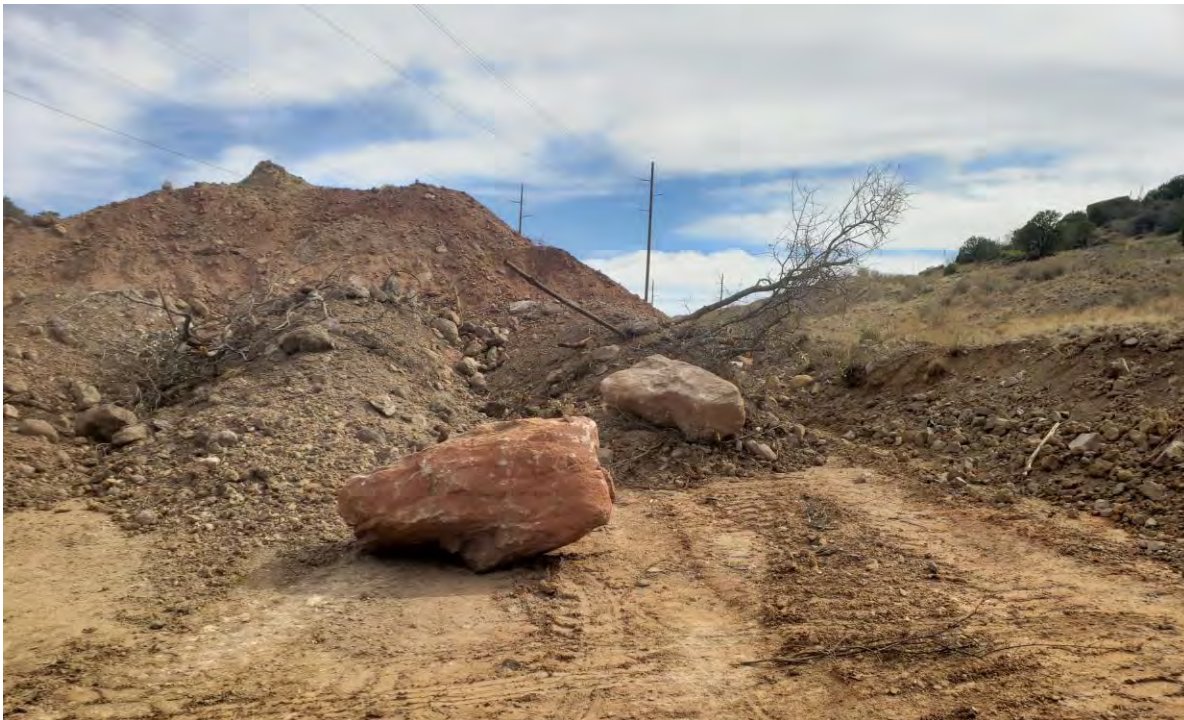
**Photo 4:** Crew hauled red-stained boulders to stockpile from central removal area.

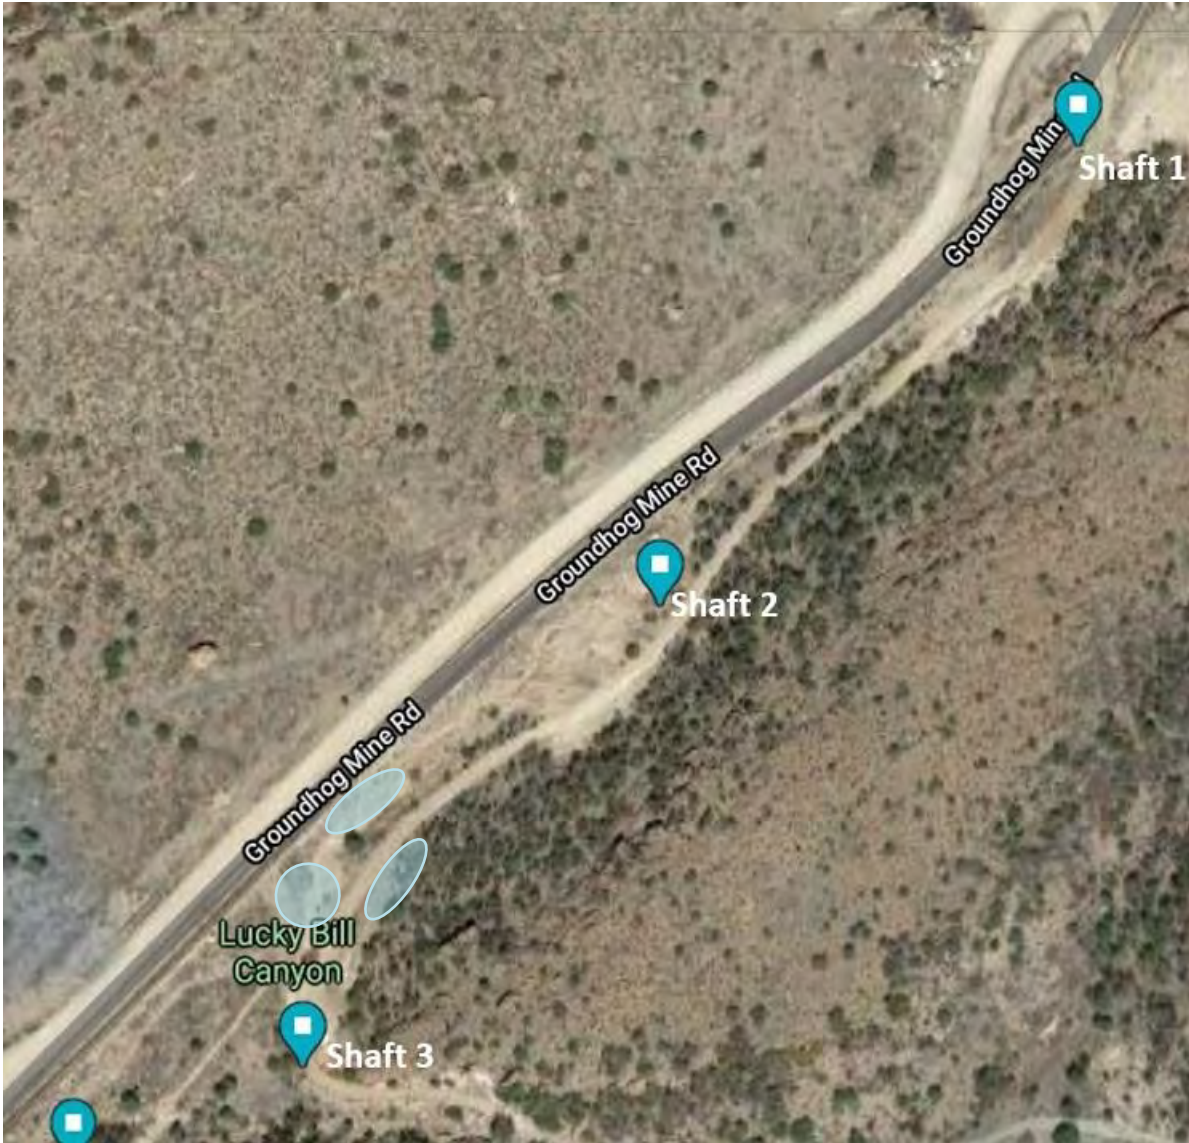
**Figure 2: Northern Area Backfill Map:**

- Shared Services finished filling deep area that formed during soil excavation (bottom circle), and other nearby areas (ovals).

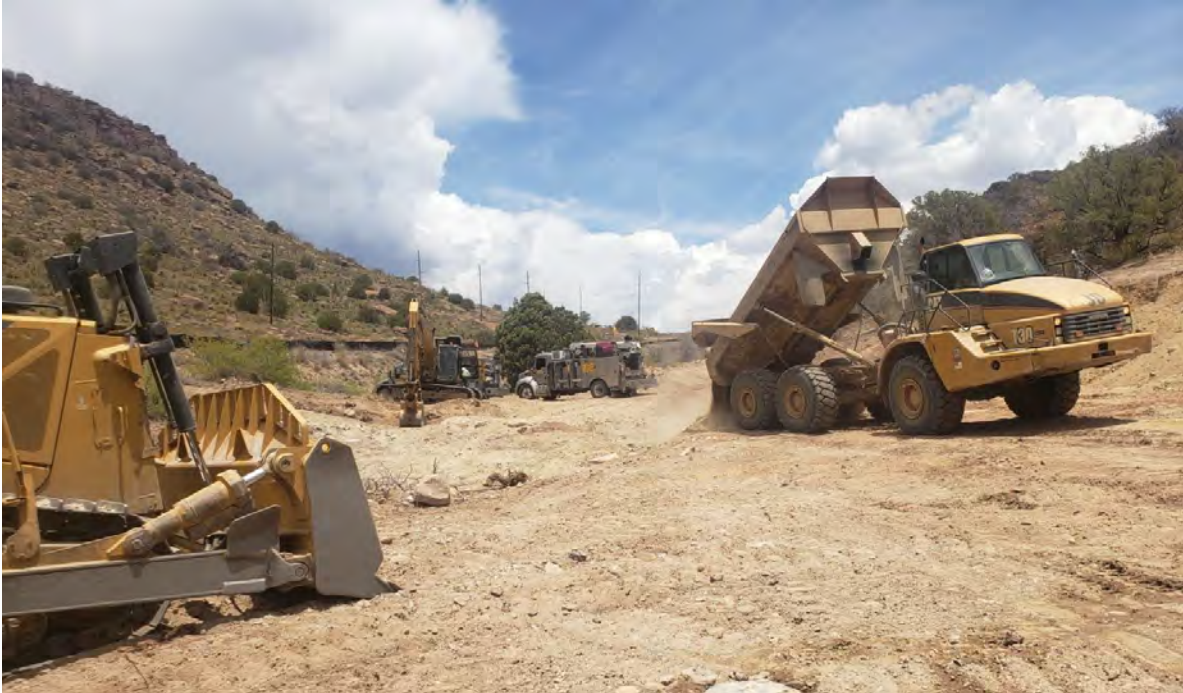
**Photo 1:** Shared Services finished filling large excavation above Lucky Bill confluence. Mechanics were onsite repairing a/c in excavator.

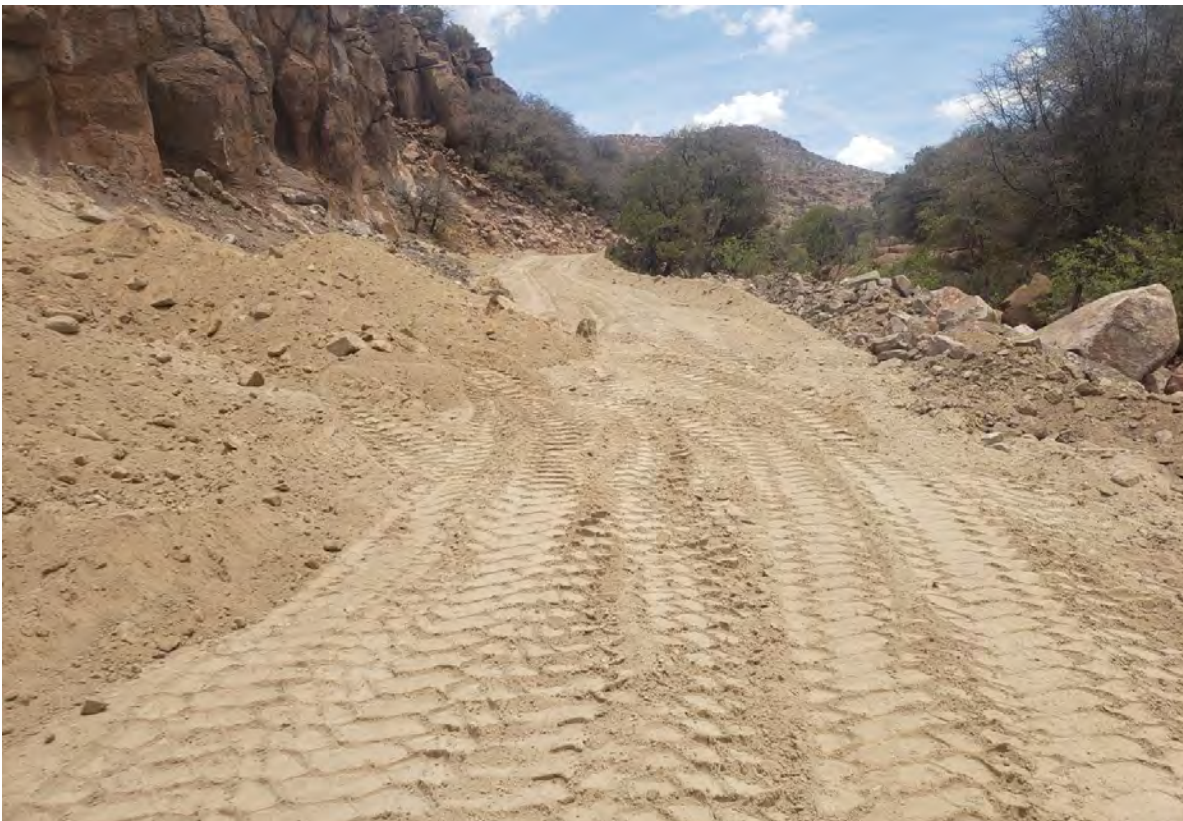
**Photo 2:** Crew added mounds of material (left) along former workings going into Lucky Bill.
