Re: Golf Course Interim Remedial Action Report
Smelter Tailing Soils Investigation Unit- Chino AOC

**Vegetation Monitoring Report for
“Golf Course” Interim Remedial
Action, Smelter/Tailing Soils
Investigation Unit**

**Vegetation Monitoring Report
for "Golf Course" – Interim
Remedial Action,
Smelter/Tailing Soils
Investigative Unit**

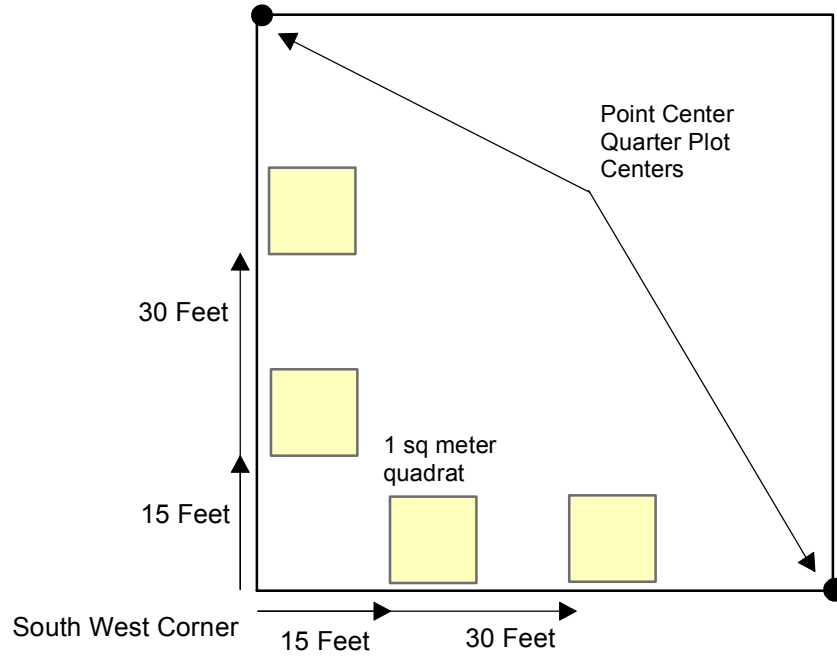
**ARCADIS** | **FIGURE 3**

On October 9, 2013, a transect/quadrate system was established for use as the framework to collect percent cover and density data. The Golf Course site was divided into a grid of 100-foot by 100-foot blocks as illustrated on Figure 2. Random-grid coordinates were used to select three blocks in areas east of the railroad tracks and two blocks west of the railroad tracks. Coordinates for the southwestern corner of each selected block are included in Table 2. Two 50-foot transects originated in the southwestern corner, with bearings to the north and east. A 3.3-foot by 3.3-foot quadrat (or 1-meter square) was placed at the 15- and 30-foot locations along each 50-foot transect (vegetation plot shown on Figure 3).

TYPICAL TRANSECT LAYOUT

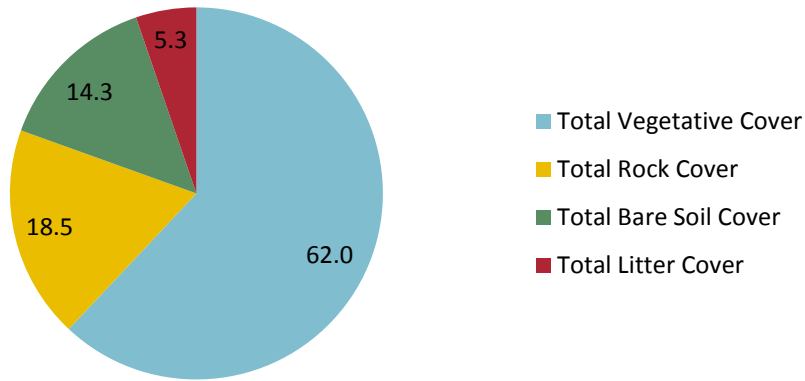
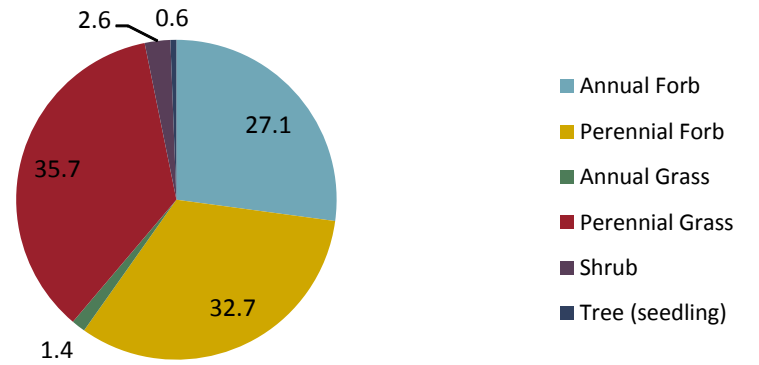
MEAN CANOPY COVER GRAPHS

Estimates of average total canopy cover of rock fragments, bare soil, and surface litter across the 20 quadrats were 19, 14, and 5 percent, respectively (Table 5 and Figure 4). Average basal cover estimates for vegetation, rock fragments, bare soil, and surface litter were 34, 32, 25, and 10 percent, respectively (Table 5 and Figure 5).

Estimates of proportional vegetative canopy cover across the 20 quadrats in order of dominance by life form were 36 percent perennial grasses, 33 percent perennial forbs, 27 percent annual forbs, 3 percent shrubs, 1 percent annual grasses, and 1 percent tree seedlings (Figure 4). Proportional basal cover by life form were 53 percent perennial grasses, 21 percent annual forbs, 19 percent perennial forbs, 5 percent shrubs, 2 percent annual grasses, and 1 percent tree seedlings (Figure 5). As expected with vegetative succession, annual species have declined since Year 1 when an average of 53 percent of vegetative cover was annuals compared to 29 percent in Year 5.

Mean Canopy Cover Components

Proportional Canopy Cover Contributed by Plant Classes

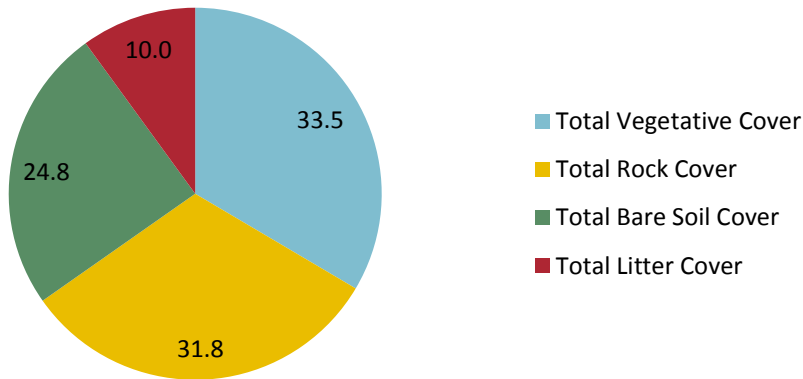
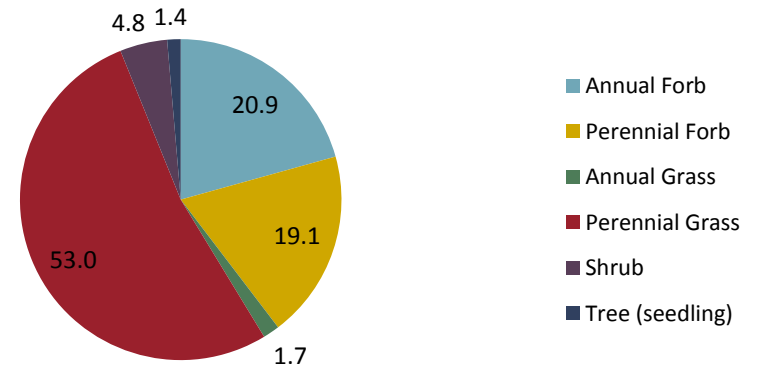
MEAN BASAL COVER GRAPHS

Mean Basal Cover Components

Proportional Basal Cover Contributed by Plant Classes

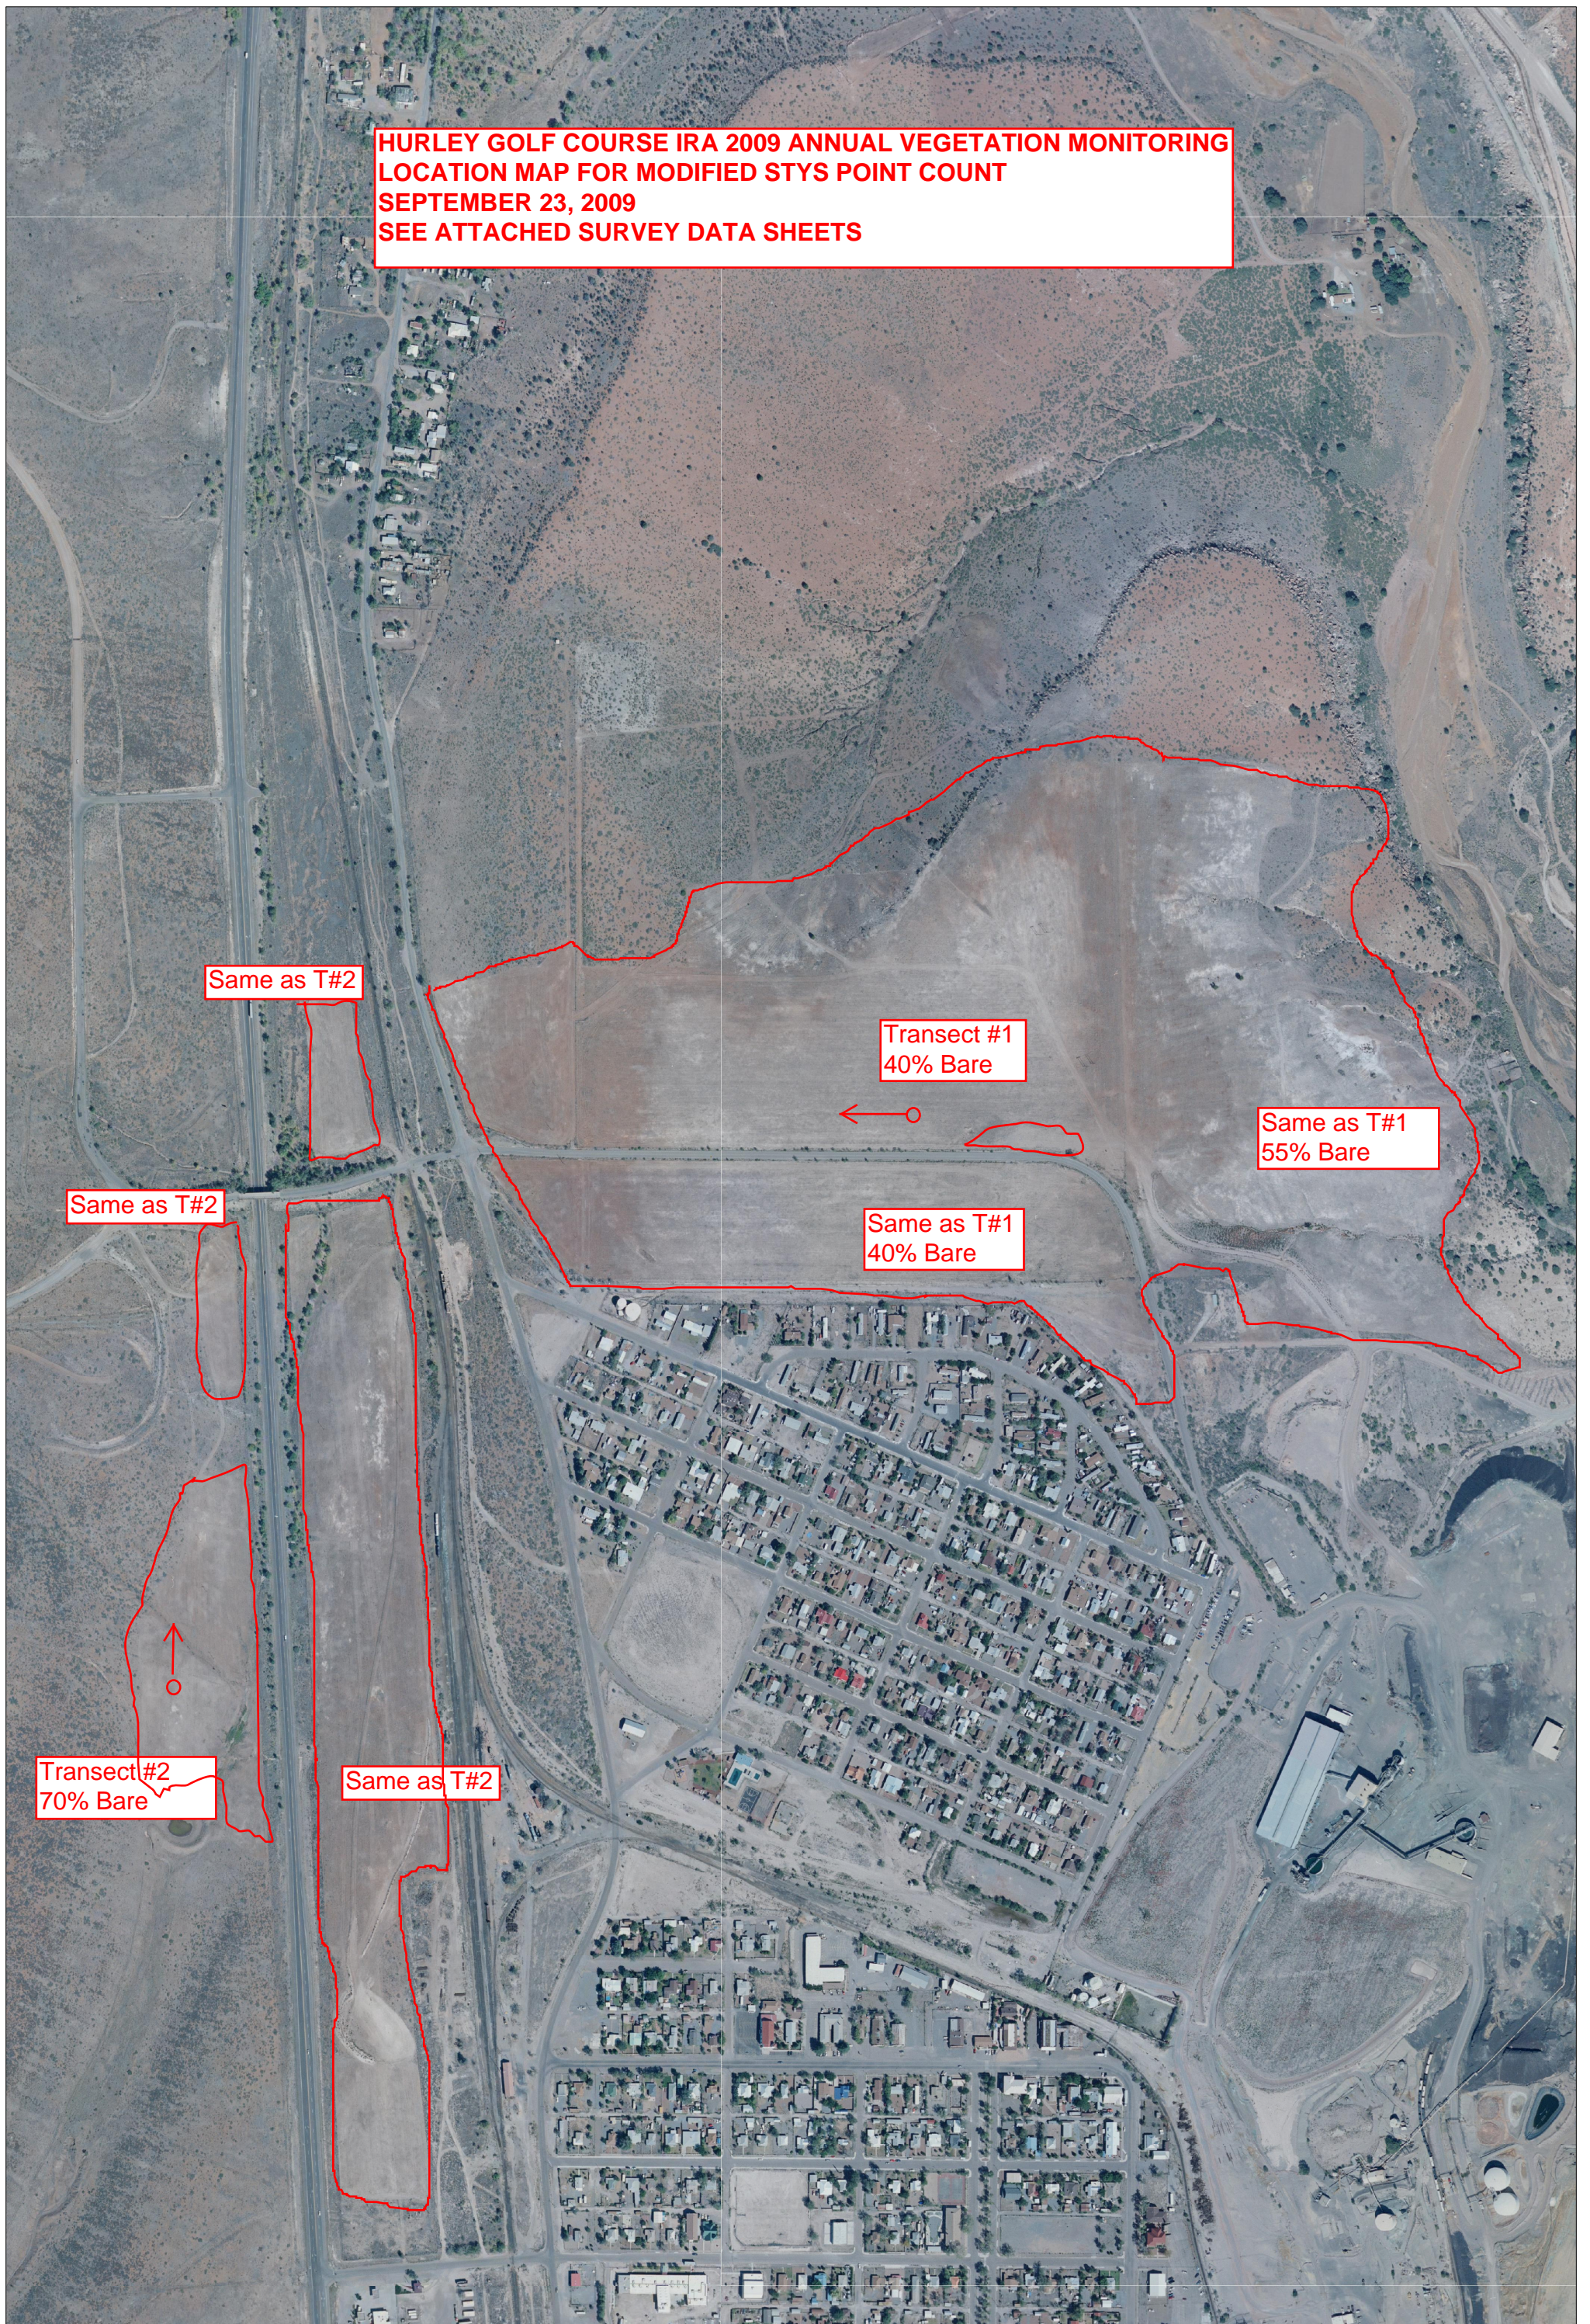
Two transects were established in September 2009 (i.e., a year after seeding) to evaluate vegetative cover using the point intercept methodology: Transect 1 in the northern portion of the Golf Course site and east of the rail road tracks; and Transect 2 in the west area and west of the railroad tracks¹. A map of the transect locations and associated data is included in Appendix A. At consistent intervals along each transect, the presence of bare ground, litter, annual vegetation, or perennial vegetation was recorded to estimate percent cover for each of these variables. Along Transect 1, 40 percent of the ground was bare, 12 percent was litter, and 48 percent was vegetation. Of the vegetated cover, 59 percent of the cover was composed of annual species and the rest of perennial species. Similarly, two other locations within the north area qualitatively assessed bare ground cover to be approximately 40 to 55 percent. Along Transect 2, 70 percent

of the ground was bare, 2 percent was litter, and 28 percent was vegetated. Of the vegetated cover, 46 percent of the cover was composed of annual species and the rest of perennial species. Similarly, three other locations in the west area qualitatively assessed appeared also to be approximately 70 percent bare ground.

Transect #2
70% Bare

Same as T#2

Survey: Modified Stys Point Count
by Jerry Donaldson & Pam Pinson

DATE: September 23, 2009 - 9:30 am

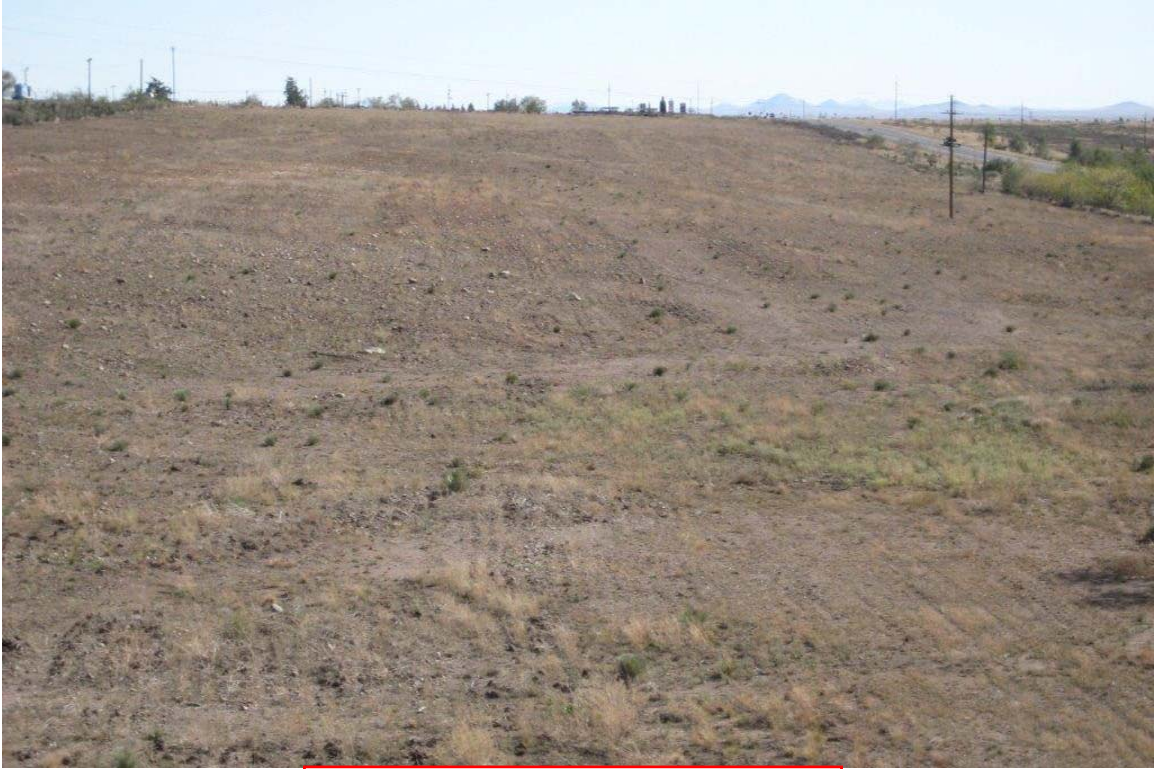
SOUTH PARCEL LOOKING SOUTH

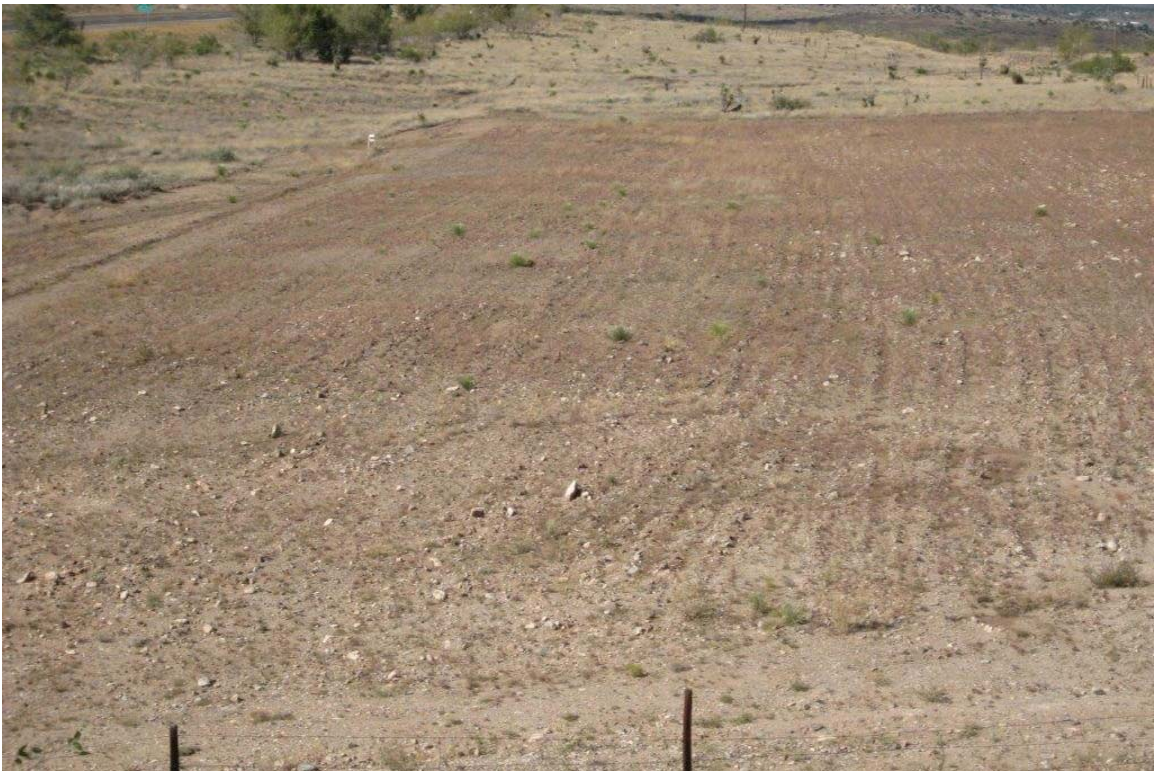
NORTH PARCEL LOOKING NORTH

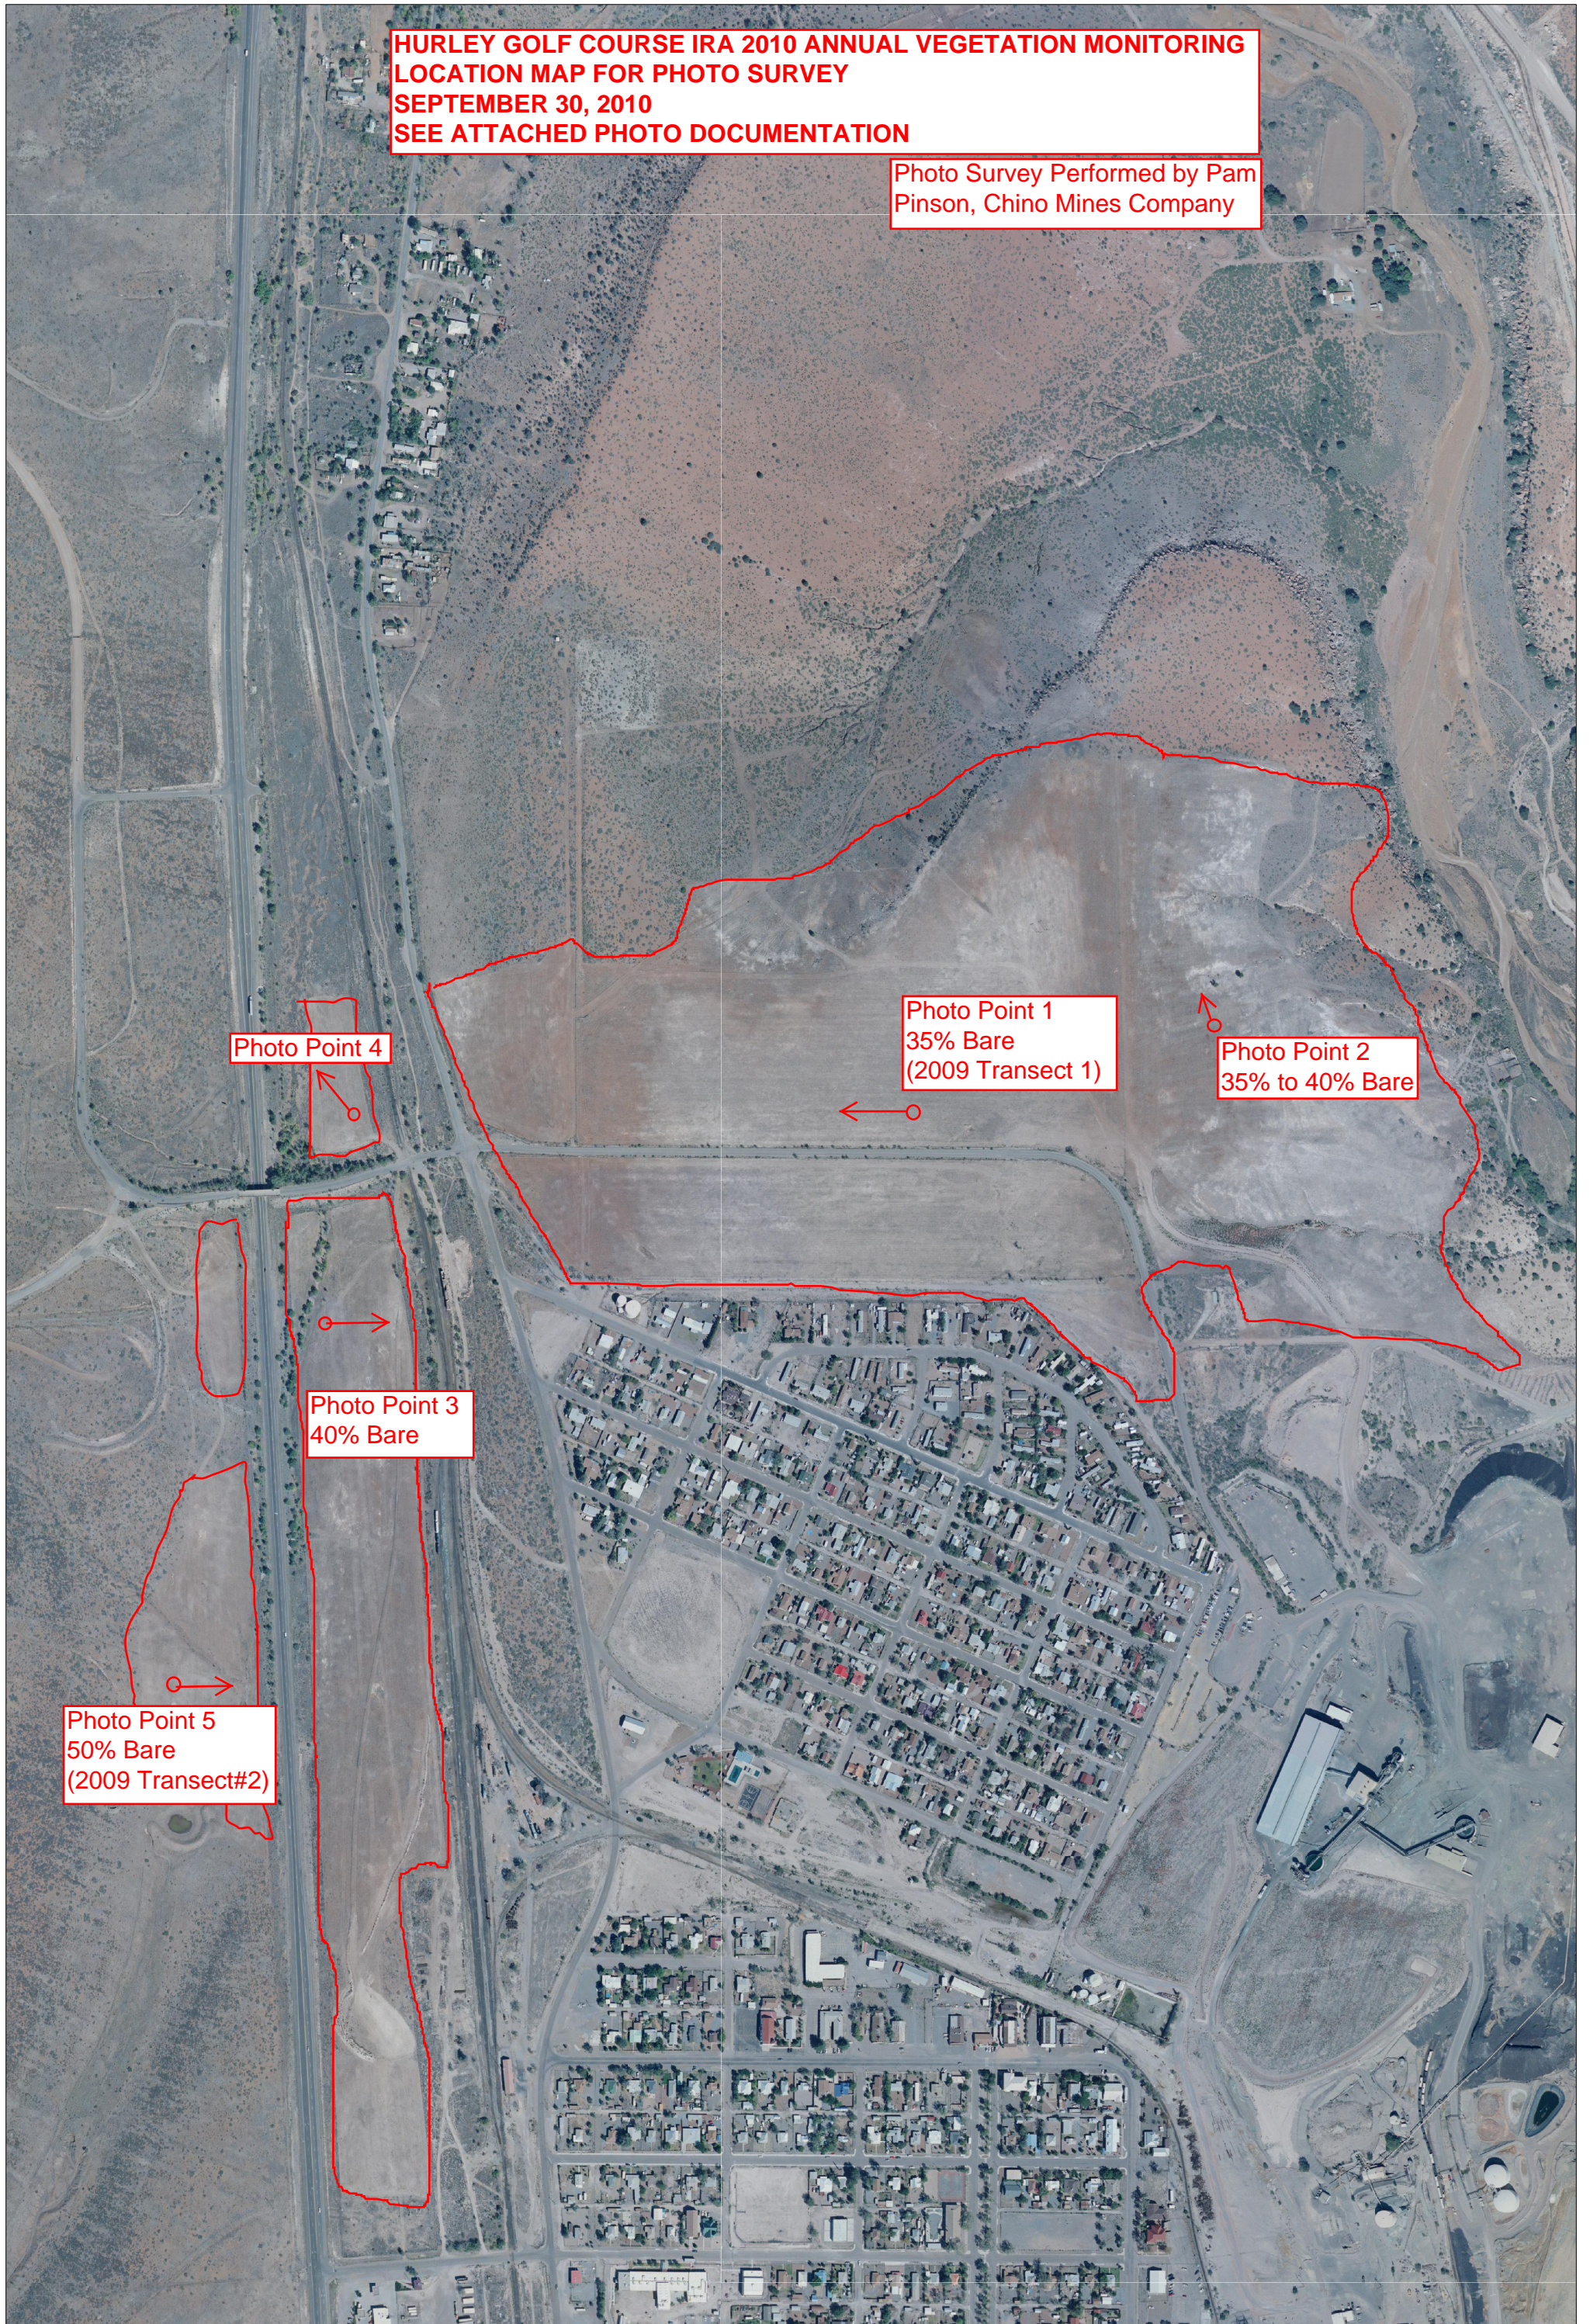
Transects 1 and 2 were again surveyed in September 2010 using the point intercept methodology. Transect 1 had 66 percent vegetative cover with only 30 percent bare ground and 4 percent litter. Similarly, one other location in the north area was qualitatively estimated to have approximately 35 to 40 percent bare ground. Transect 2 was qualitatively surveyed with an estimate of about 50 percent bare ground. One additional location in the west area demonstrated similar conditions with an assessment of approximately 40 percent bare ground.

Photo Point 3
40% Bare

Photo Point 5
50% Bare
(2009 Transect#2)

DATE: September 30, 2014 1:30 pm

Bare Ground (BG)	Litter (plant material)	Perennial and Annual Vegetation	Perennial Vegetation	Species
<input checked="" type="checkbox"/> <input checked="" type="checkbox"/>	••	<input checked="" type="checkbox"/> <input checked="" type="checkbox"/> <input checked="" type="checkbox"/>		Side Darts Russian Thistle Snakeweed
<input checked="" type="checkbox"/>		<input checked="" type="checkbox"/> <input checked="" type="checkbox"/> <input checked="" type="checkbox"/>		Blue John Mossy vine Vine Ragweed
		L		White Mallow Winterfat low green perennial? OTHERS - see photos
30% bare	4% Litter	66% Vegetation
