Re: Revised Razorback Ridge Area Supplemental Completion Report
Interim Remedial Action, Smelter Tailing Soils Investigation Unit - Chino AOC

**Response to New Mexico Environment Department Comments
on the Supplemental Completion Report - Razorback Ridge Area
Interim Remedial Action, Smelter/Tailing Soils Investigation Unit (STSIU)**

RAZORBACK RIDGE AREA

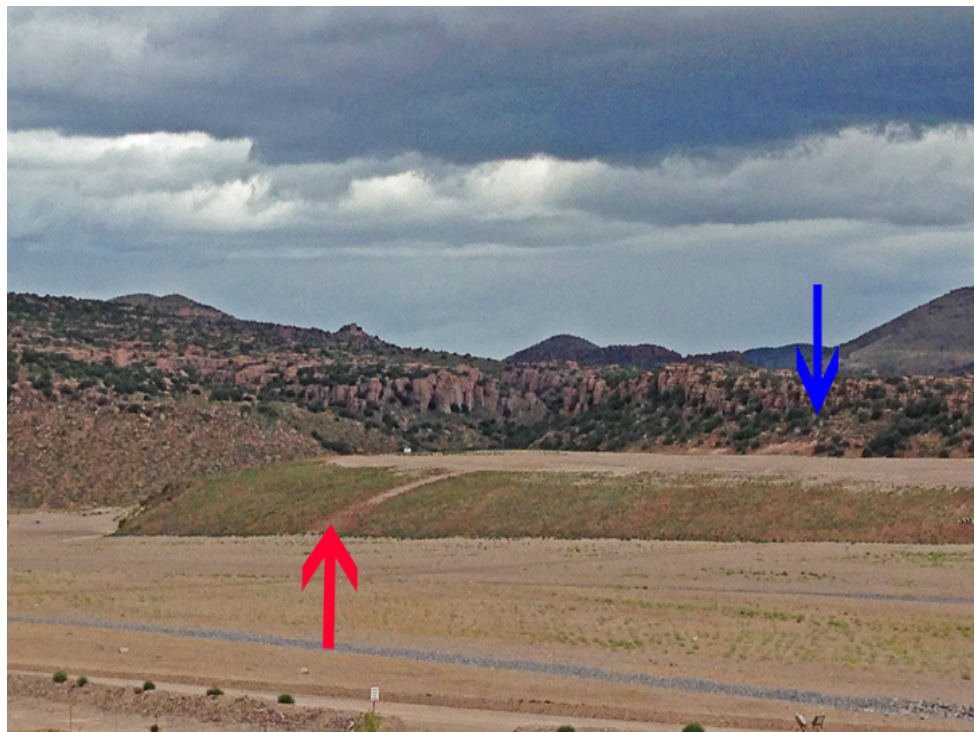
PHOTO 1

Facing east – north end of Razorback Ridge (red) with East Removal Borrow Area in background (blue).

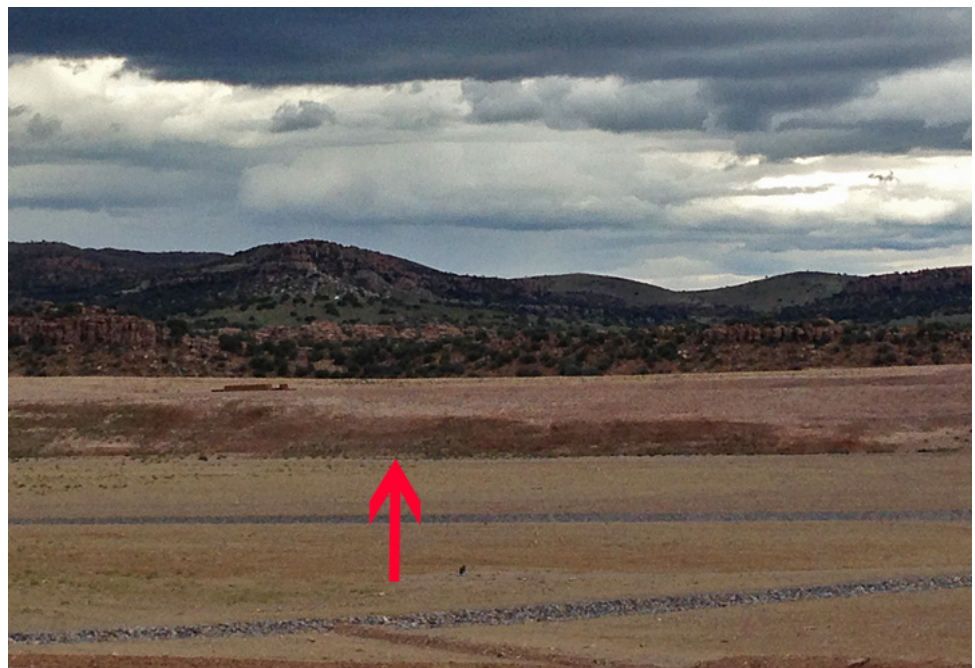
PHOTO 2

Facing east – center of Razorback Ridge (red) with East Removal Borrow Area in background.

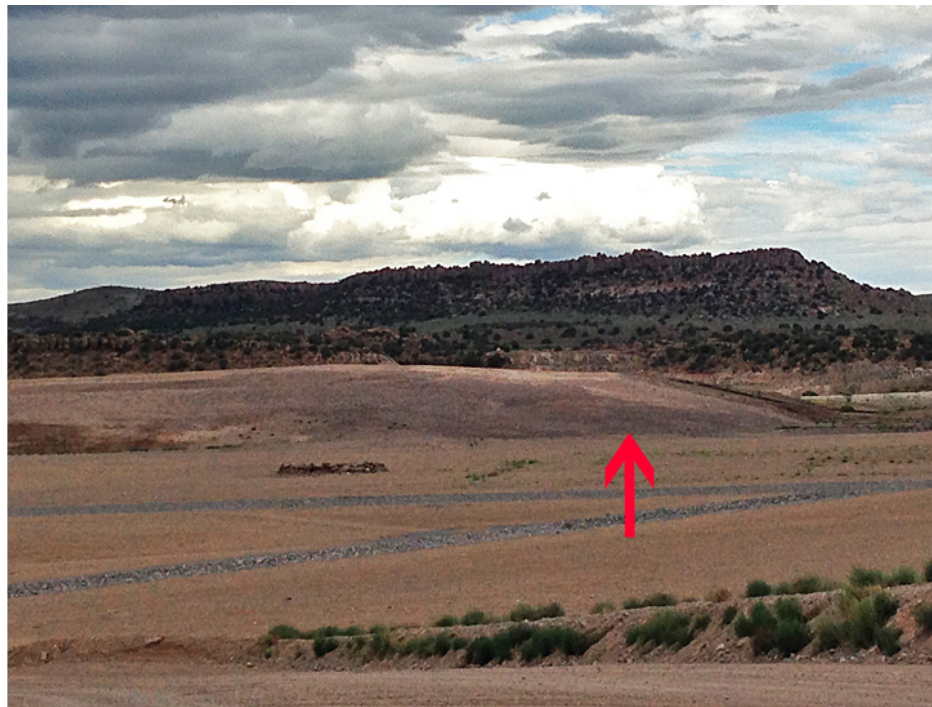
PHOTO 3

Facing east – south end of Razorback Ridge (red) with East Removal Borrow Area in background.

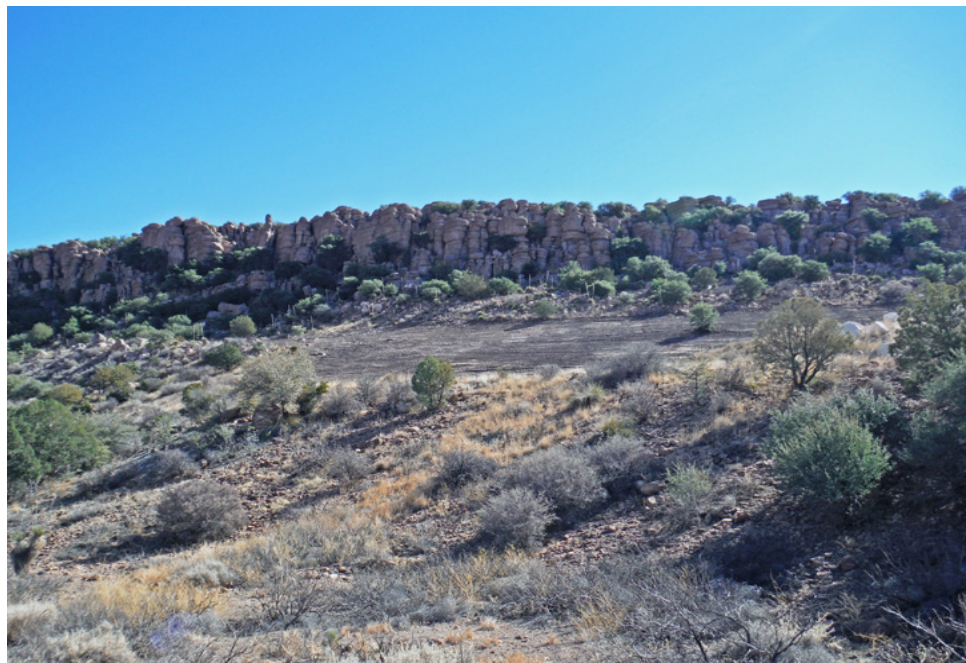
PHOTO 4

Facing east – northern end of East Removal Borrow Area (center).

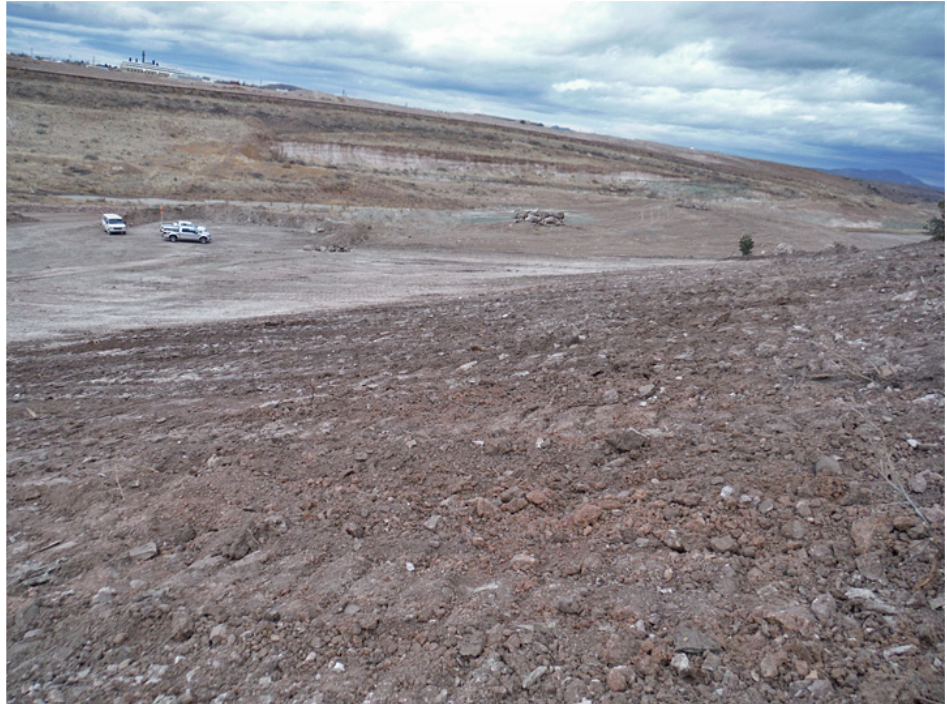
PHOTO 7

Facing northwest –
East Removal
Borrow Area and toe
in foreground.
Razorback Ridge on
horizon.

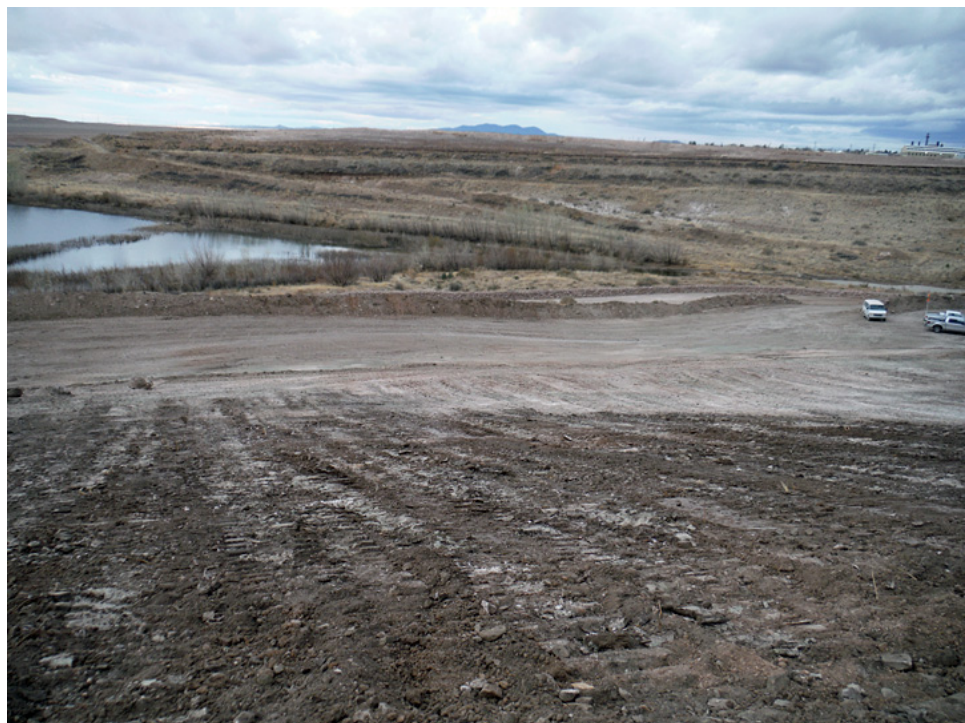
PHOTO 8

Facing southwest –
East Removal
Borrow Area, toe,
and road in
foreground with
James Canyon
Reservoir and
Razorback Ridge in
background.

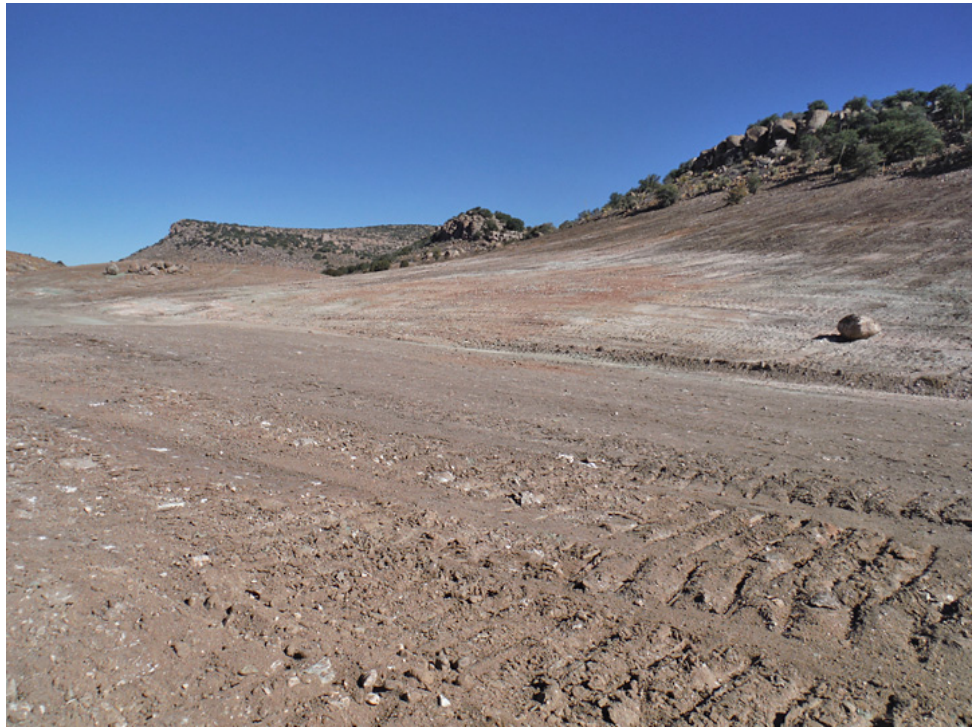
PHOTO 9

Facing north – East Removal Borrow Area, toe, and road.

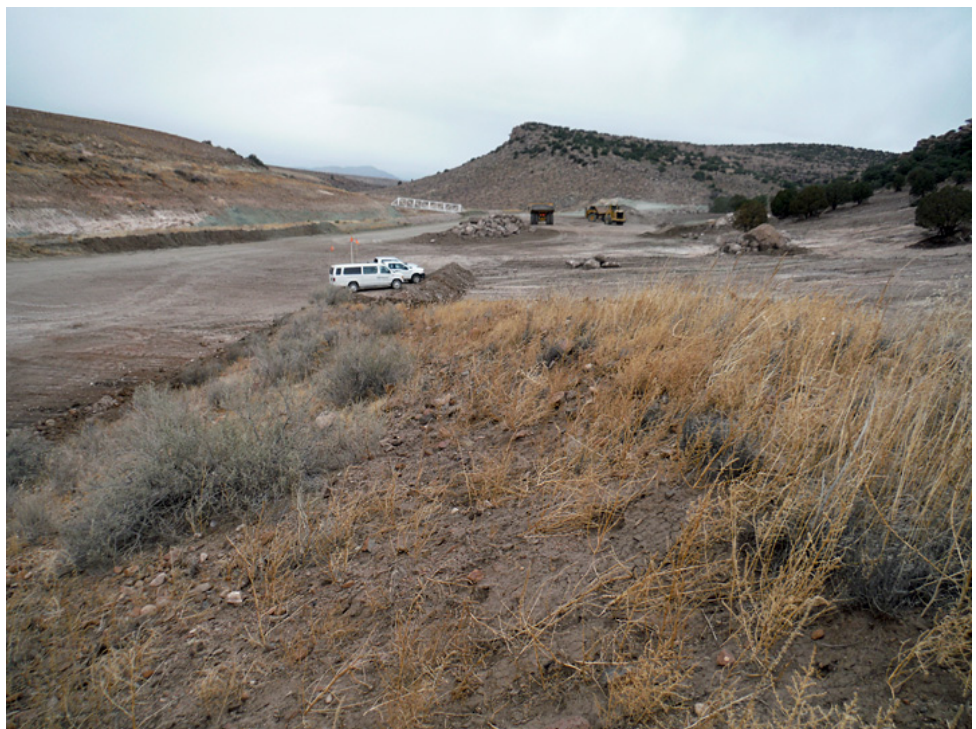
PHOTO 10

Facing north – Historic stockpiled borrow material at toe of East Removal Borrow Area with Razorback Ridge at upper left horizon (northwest).

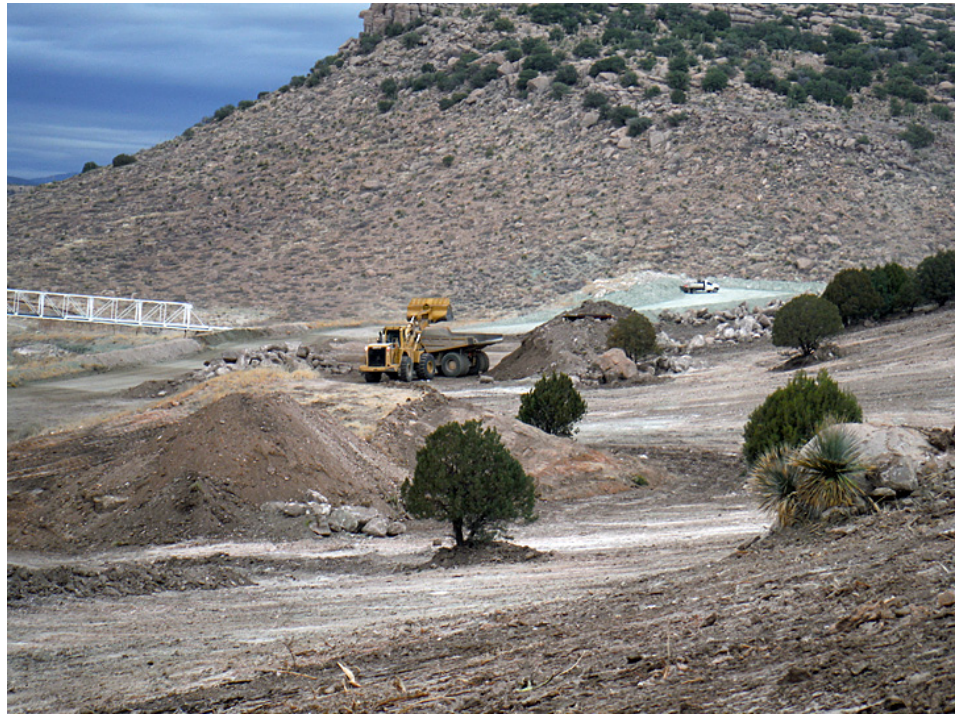
PHOTO 11

Facing north – soil removal activities at toe of East Removal Borrow Area.

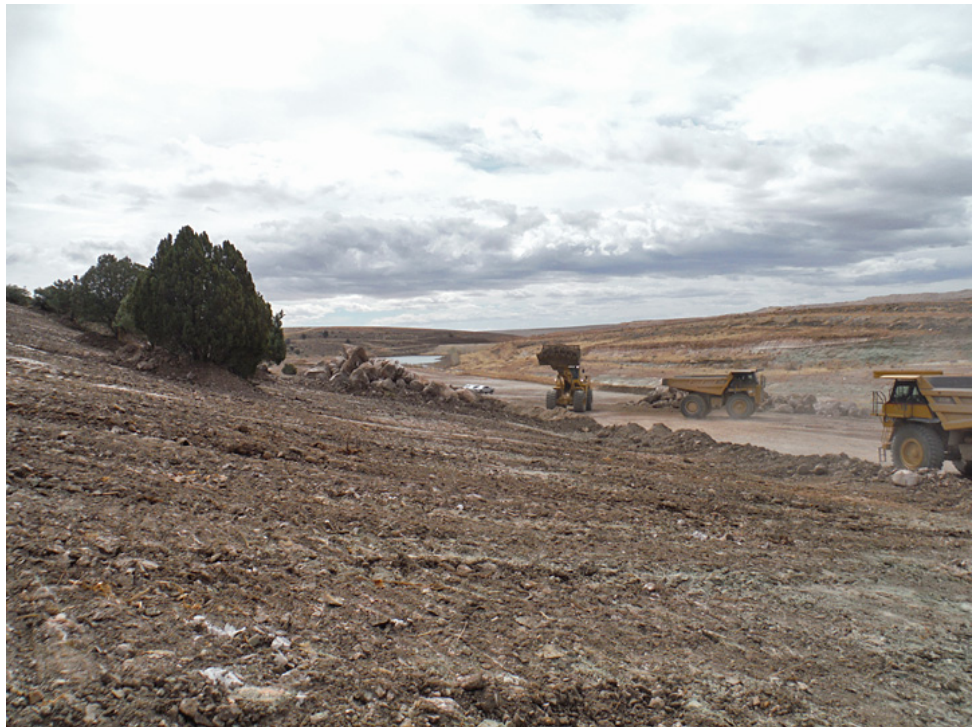
PHOTO 12

Facing south/southwest – soil removal activities near center of toe of East Removal Borrow Area with Razorback Ridge in background to right (southwest).

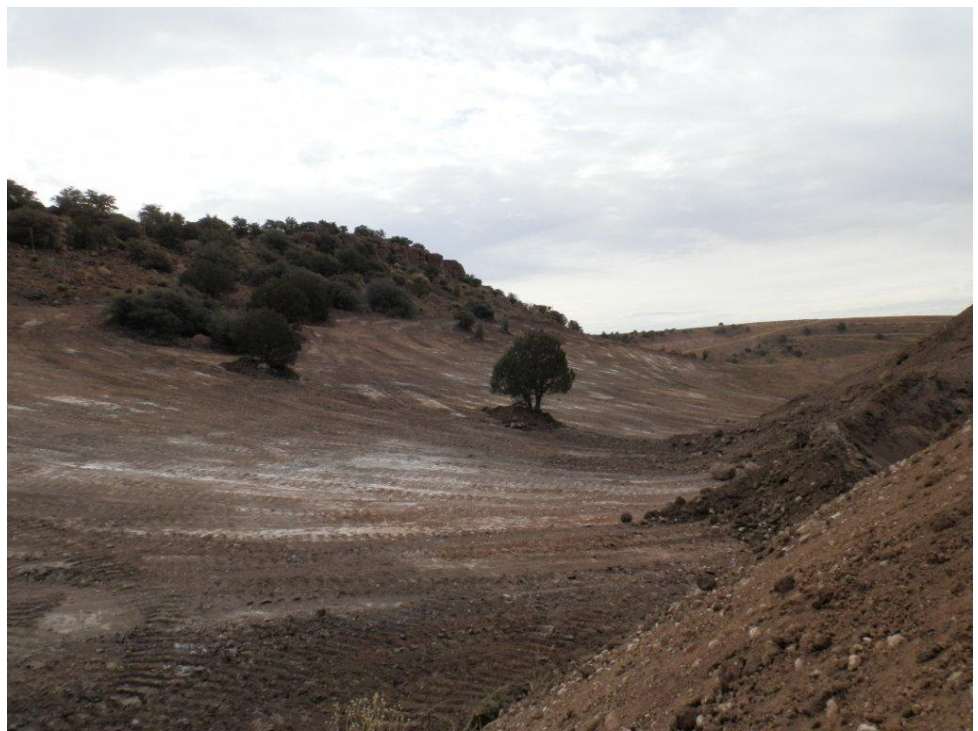
PHOTO 13

Facing south– soil removal activities in East Removal Borrow Area showing excavation around trees.

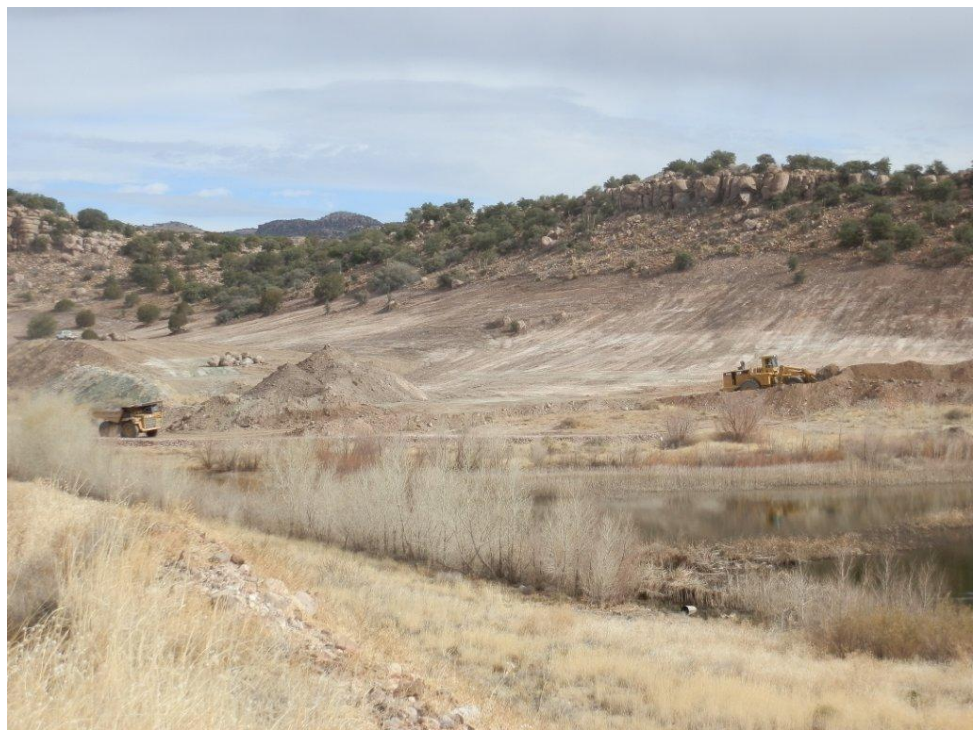
PHOTO 14

Facing northeast – East Removal Borrow Area view from across James Canyon Reservoir.

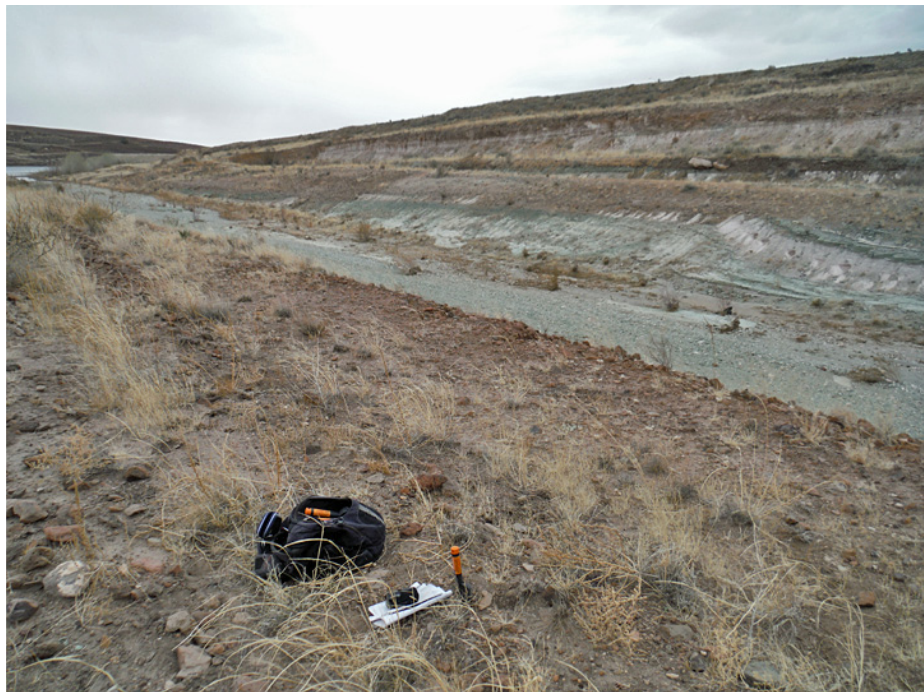
PHOTO 15

Facing south/southwest – representative sample location east of Whitewater Diversion with Razorback Ridge in back.

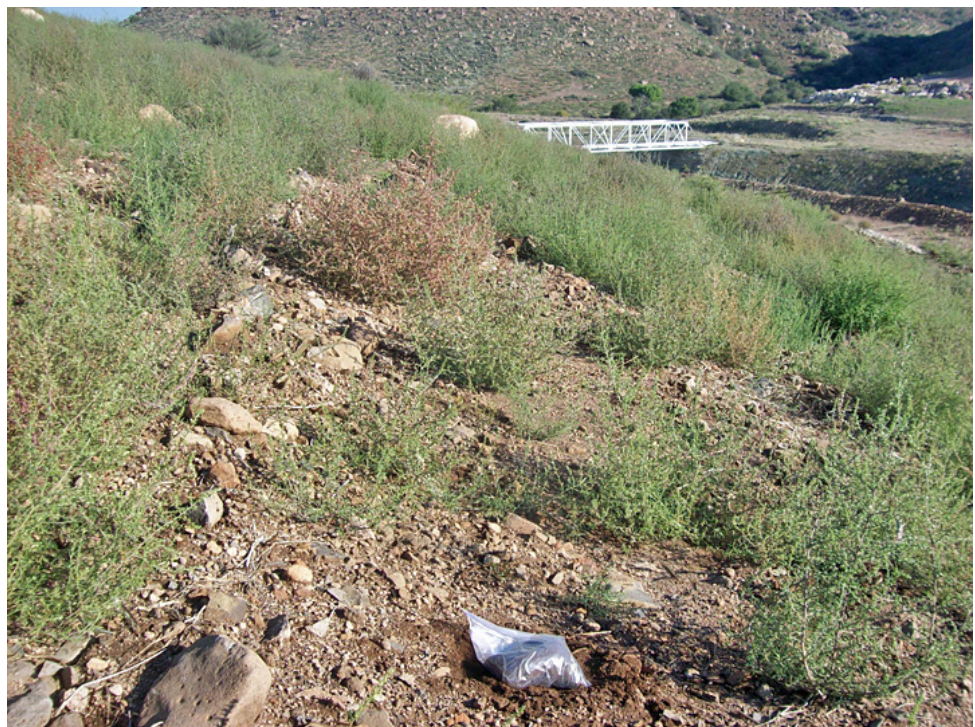
PHOTO 16

Facing north/northeast – representative sample location on northeast portion of Razorback Ridge.

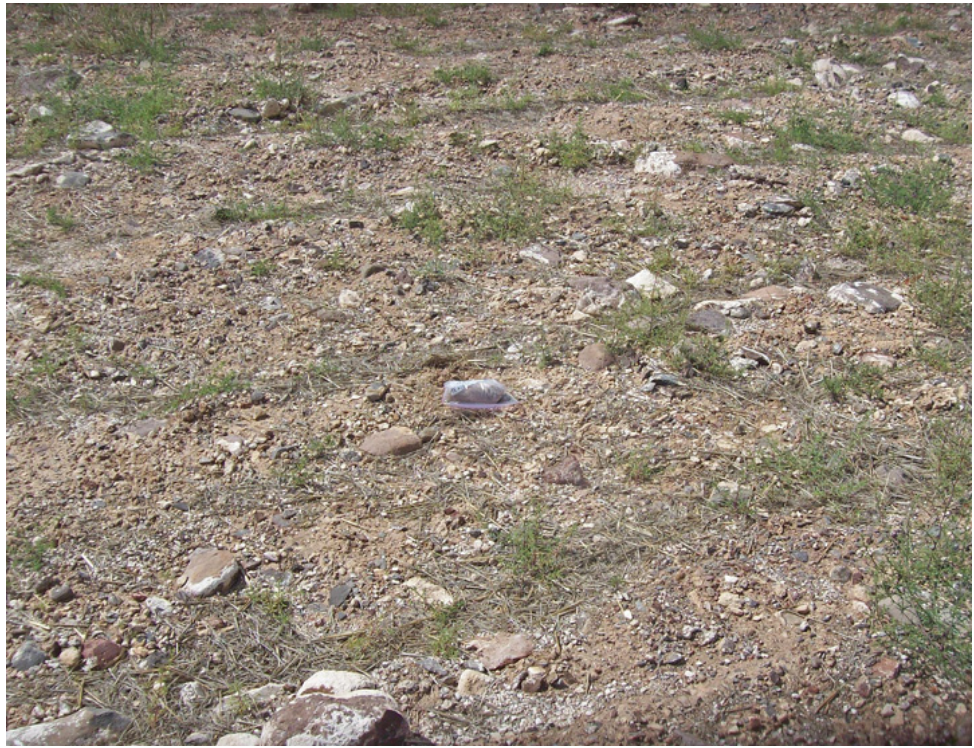
PHOTO 17

Facing east –
representative
sample location on
southwest portion of
Razorback Ridge.

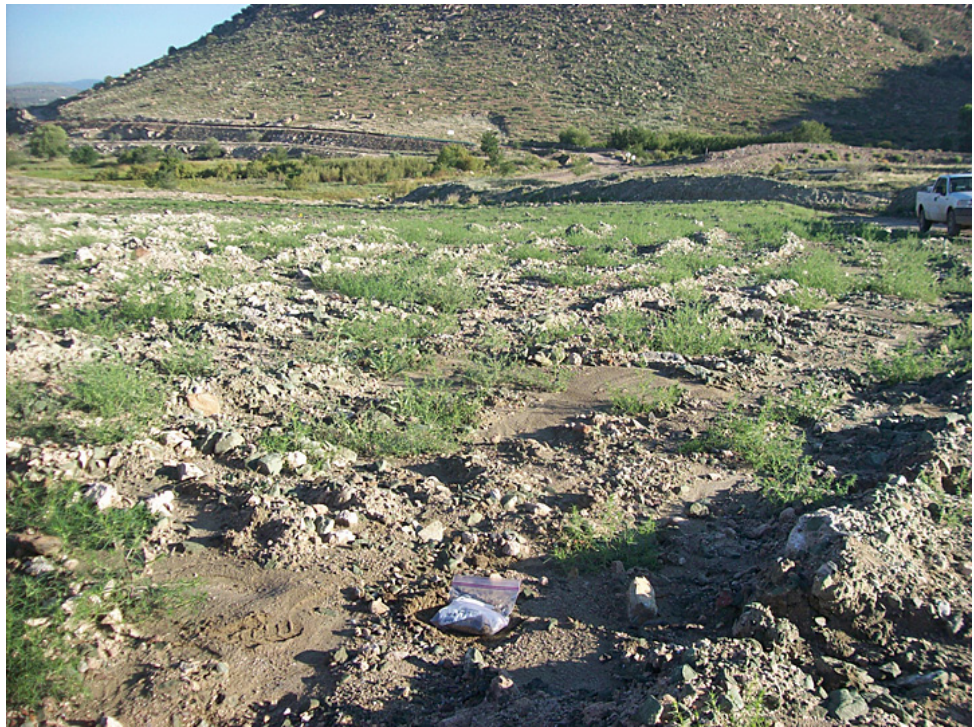
PHOTO 18

Facing north –
representative
sample location in
Borrow Area at
north end of
Razorback Ridge.

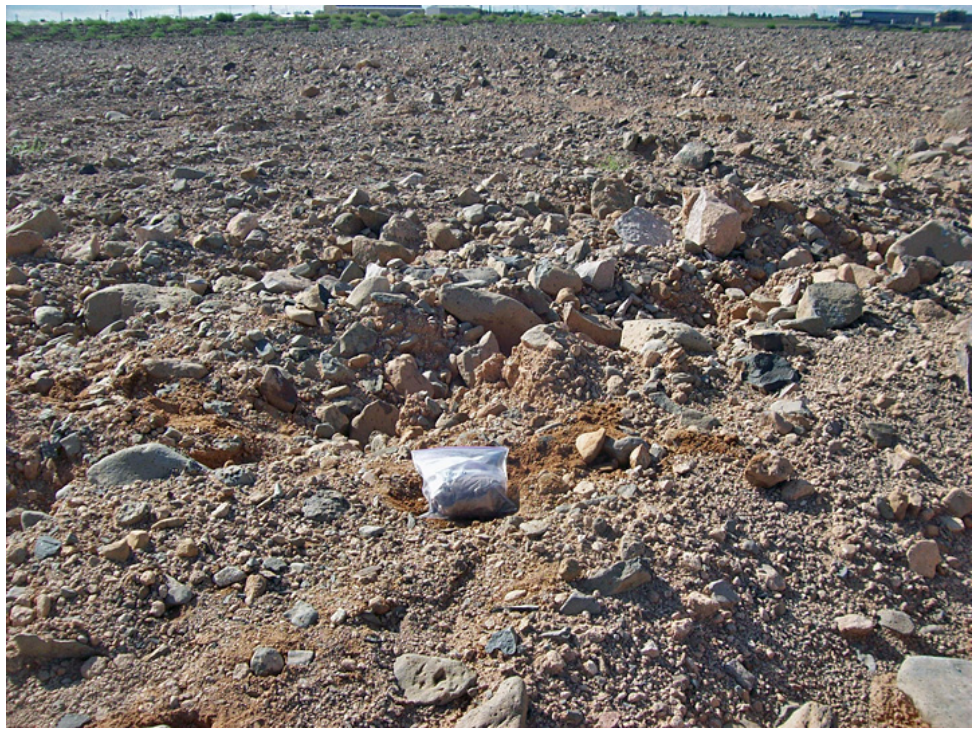
PHOTO 19

Facing west –
representative
sample location in
Borrow Area near
center of Razorback
Ridge.

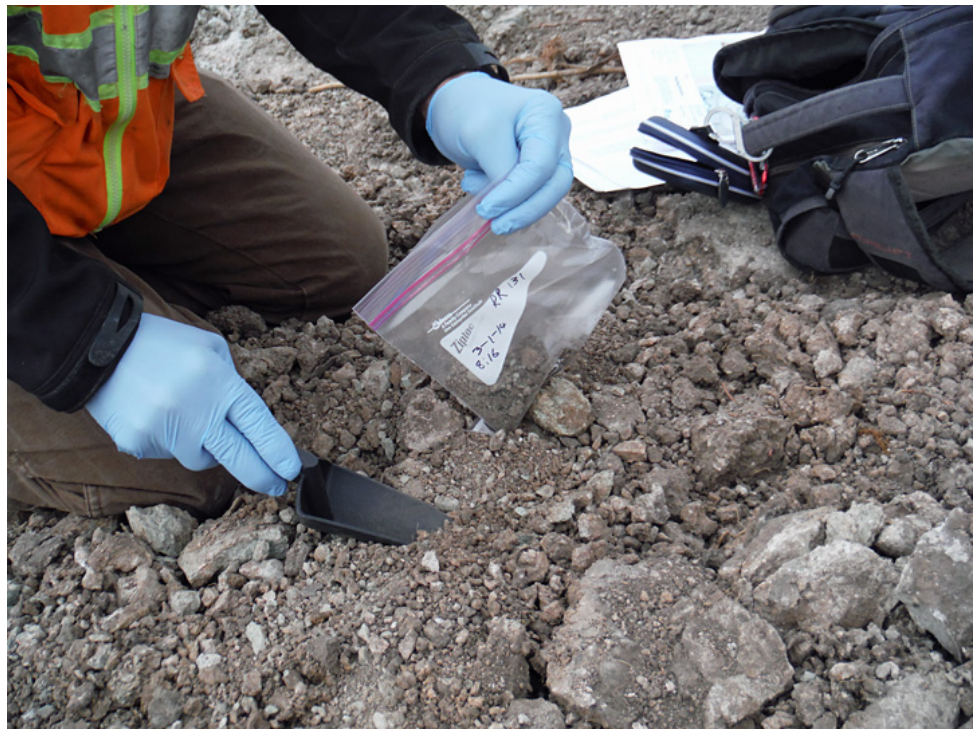
PHOTO 21

Representative soil sampling effort.

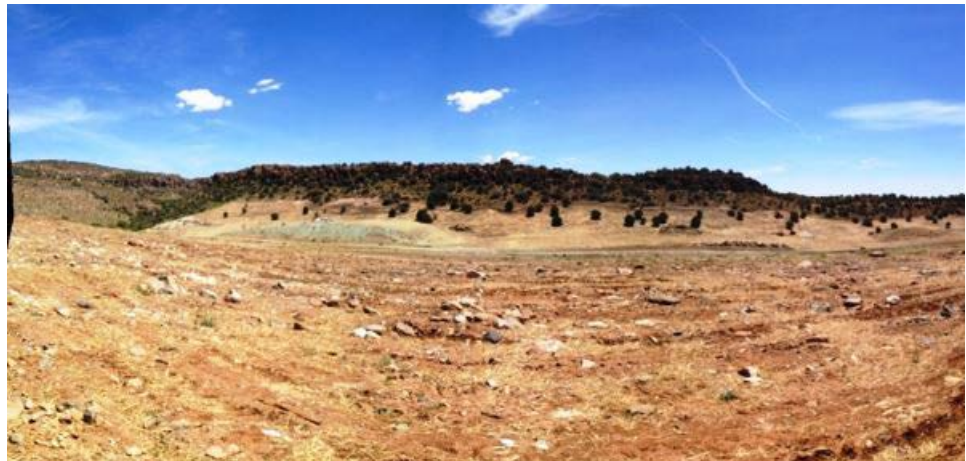
PHOTO 22

Panorama of mulched and seeded surface of Razorback Ridge in foreground and east area in background.
