Re: Revised B Ranch IRA Completion Report

Smelter Tailing Soils Investigation Unit - Chino AOC

Freeport-McMoRan Chino Mines Company – Administrative Order on Consent Response to New Mexico Environment Department Comments dated March 31, 2021 B Ranch Interim Remedial Action Completion Report (STSIU) April 30, 2021

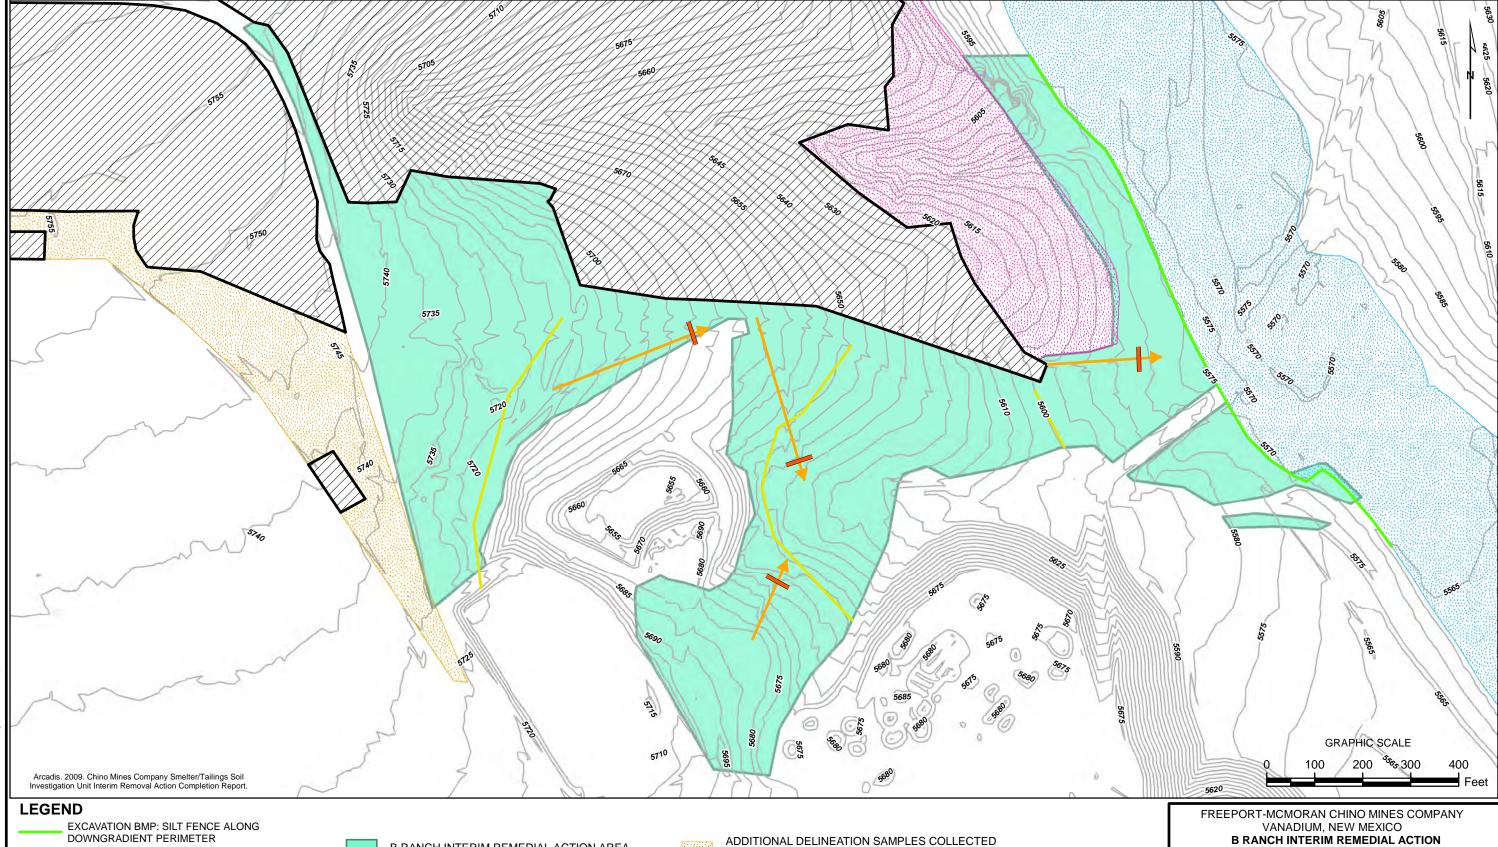
FIGURE 2

RESTORATION BMP: STRAW WATTLES PLACED EVERY 50' VERTICAL

RESTORATION BMP: DRAINAGE, INSTALL STRAW BALES ACROSS BOTTOM OF DRAINAGE

"As denoted on Figure 2 and in the FIP, the Hurley Operations Area extends into the B Ranch site and is excluded from the IRA. A correction was made to the IRA site demarcation to exclude additional areas when it was found that the Hurley Operations Area boundary was further out than first determined. In Section 3.4, the fourth paragraph, there is an example of how the adjustment was made to include more area into the operations boundary."

- As denoted on Figure 2 and in the FIP, the Hurley Operations Area extends into the B Ranch site and is
 excluded from the IRA. A correction was made to the IRA site demarcation to exclude additional areas
 when it was found that the Hurley Operations Area boundary was further out than first determined. In
 Section 3.4, the fourth paragraph, there is an example of how the adjustment was made to include more
 area into the operations boundary.

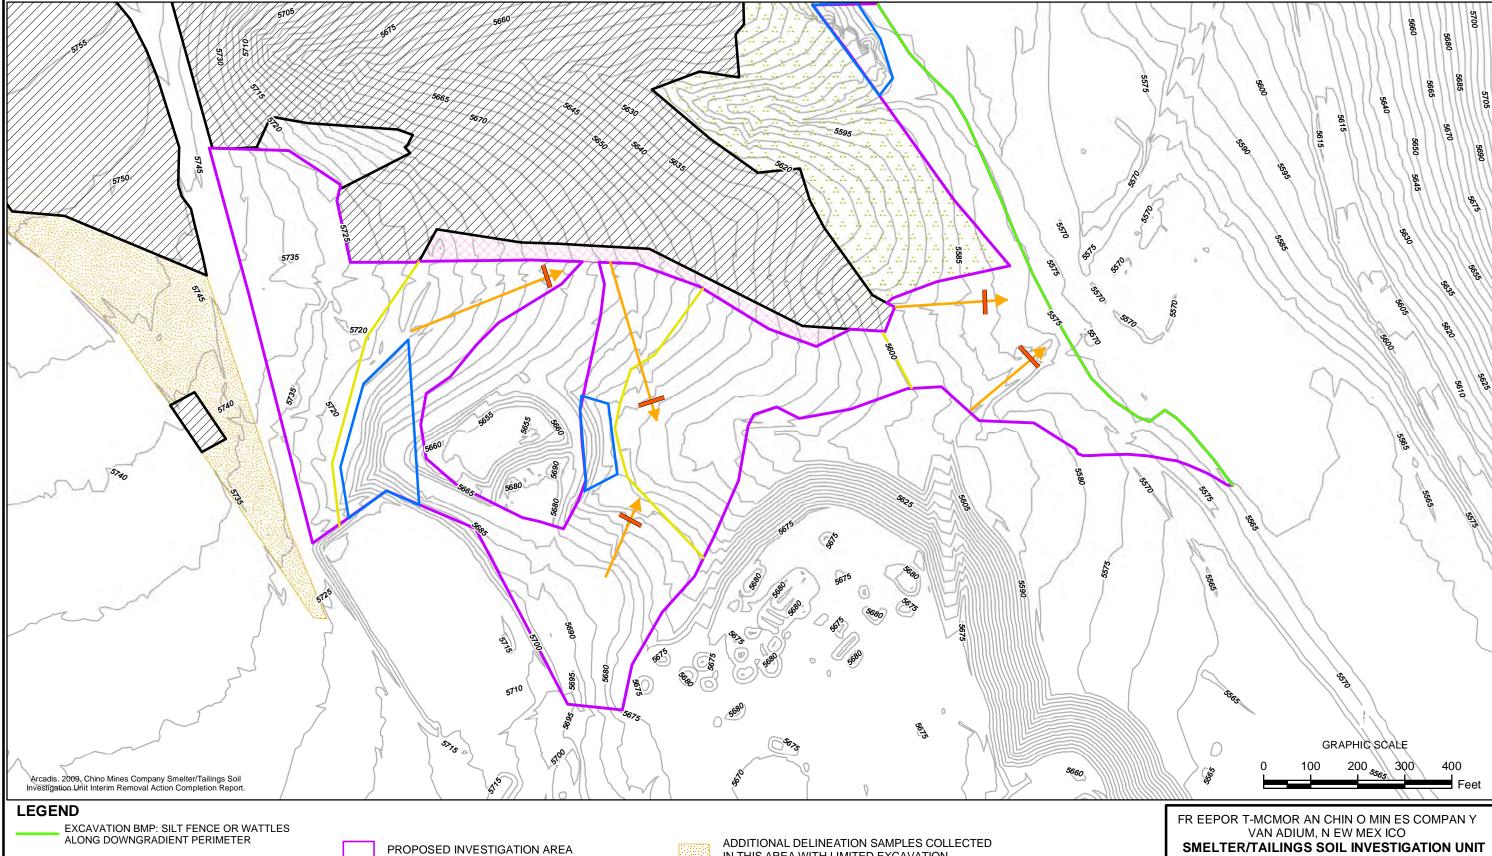
PROPOSED INVESTIGATION AREA

RESTORATION BMP: EROSION MAT IN AREA THAT EXHIBITS >3:1 SLOPE, OR WHERE CONCENTRATED FLOW IS LIKELY TO OCCUR

RESTORATION BMP: STRAW WATTLES PLACED **EVERY 50' VERTICAL**

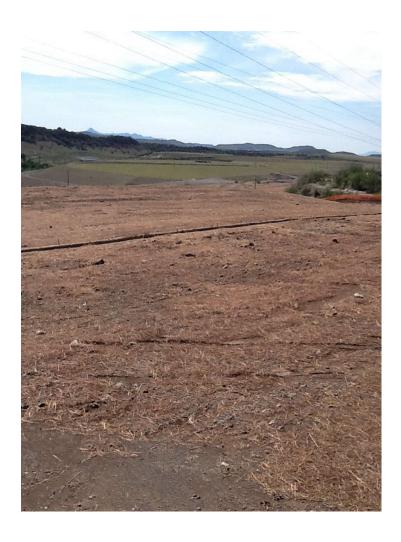
Photograph: 44

Description:BMP placement

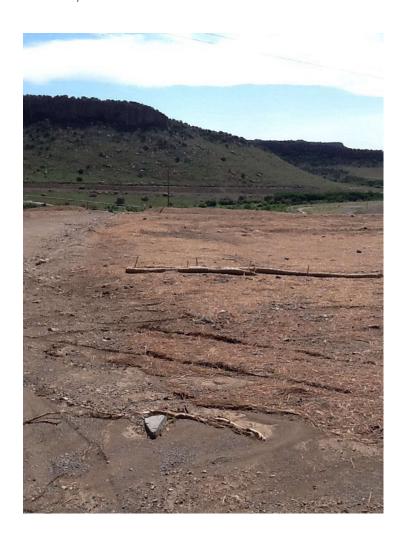
Photograph: 45

Description:BMP placement

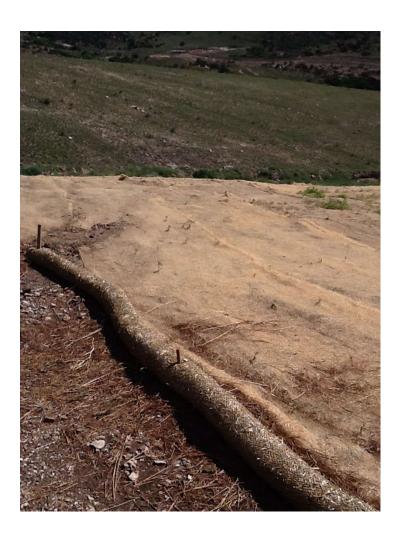
Photograph: 46

Description:BMP placement

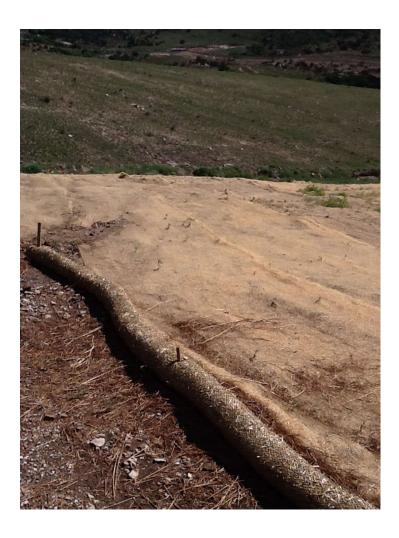
Photograph: 47

Description:BMP placement

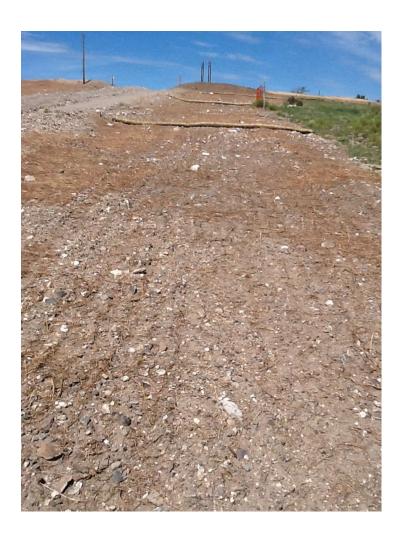
Photograph: 55

Description:BMP placement

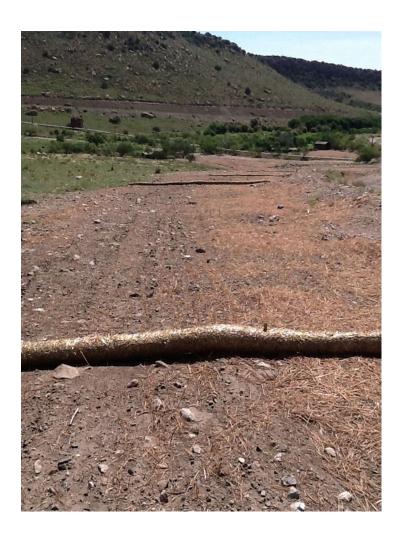
Photograph: 56

Description:BMP placement

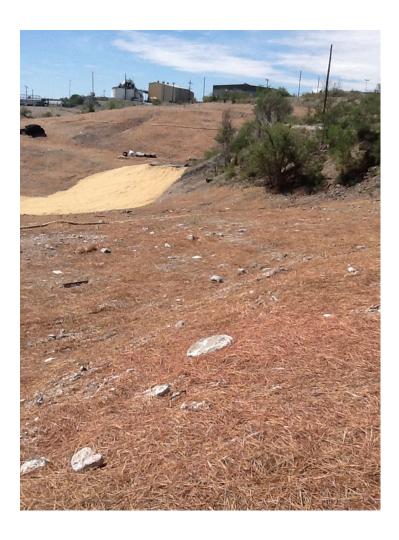
Photograph: 57

Description:BMP placement

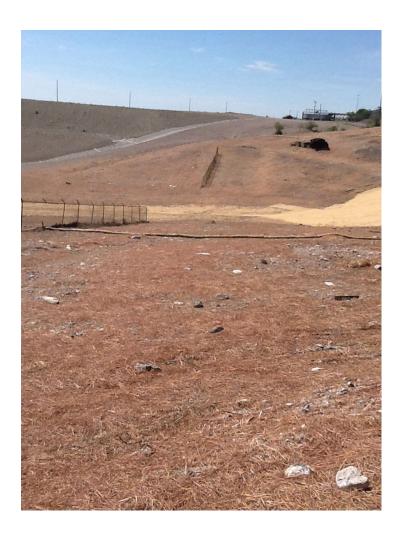
Photograph: 58

Description:BMP placement

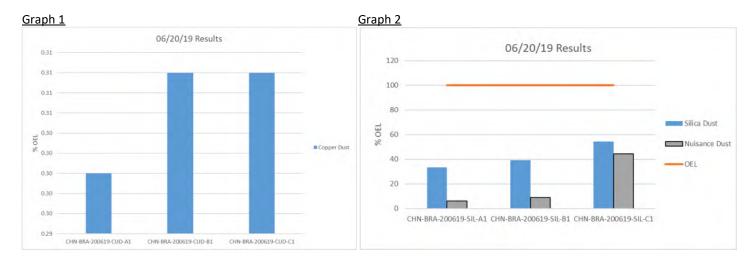
The results show the USA contractors were below the Freeport-McMoRan OEL¹ for respirable crystalline silica, nuisance dust, and copper dust. (Graph 1, 2) One data point in Graph 2 is over 50% OEL, however the concentration in Appendix A shows the exposure was less than 12 ug/m³, which would be under the limit of detection. Copper dust was negligent and will not be sampled in further testing.

- Remain in operator cab as much as possible
- Perform routine checks on cab seals on both trucks and equipment
- Routinely clean/replace cabin air filters
- Utilize water truck in area as needed
- Half-faced respirators with P100 filters may be worn at operator's discretion under the assumption that the operator has been fit tested
