Re: Interim Removal Action (IRA) Completion Report
Hanover Whitewater Creek Investigation Unit – Chino AOC

INTERIM REMOVAL ACTION COMPLETION REPORT

Hanover Whitewater Creek Investigation Unit
Vanadium, New Mexico

June 2021

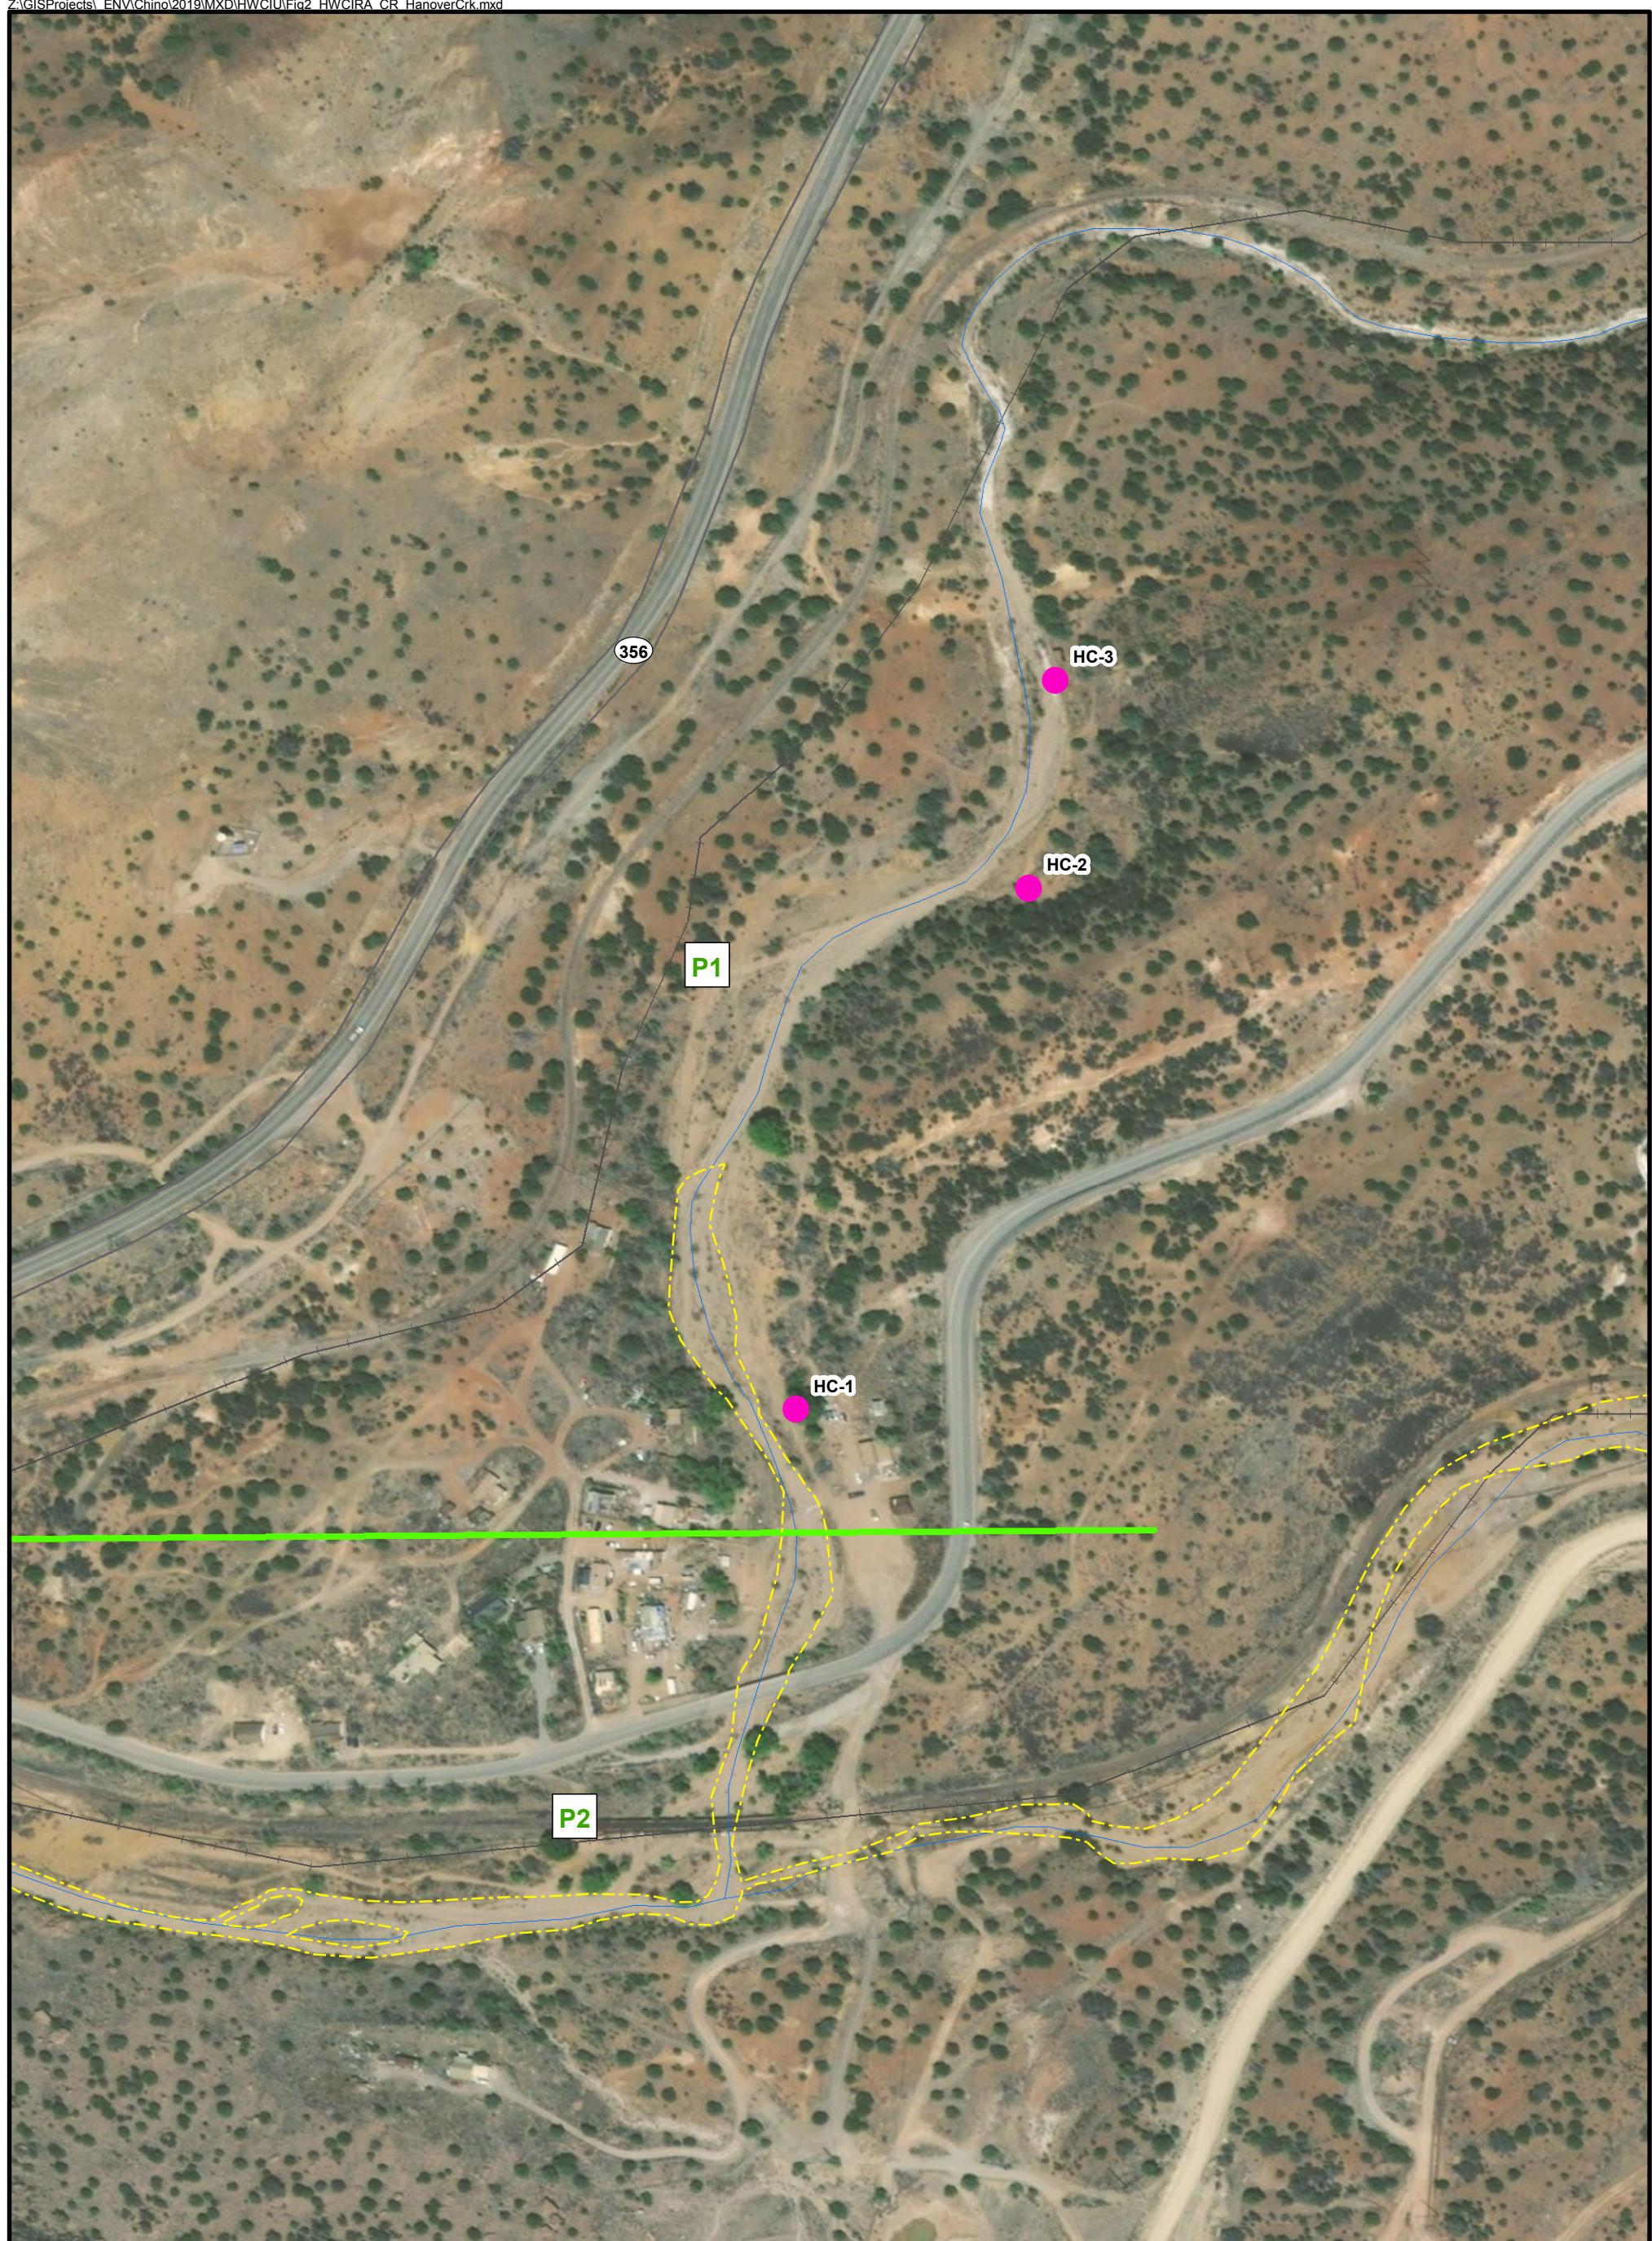
- Hanover Creek Removal Locations
- Major Roads
- +— Railroad
- Project Extent
- P1 Physical Reach
- HWC Centerline

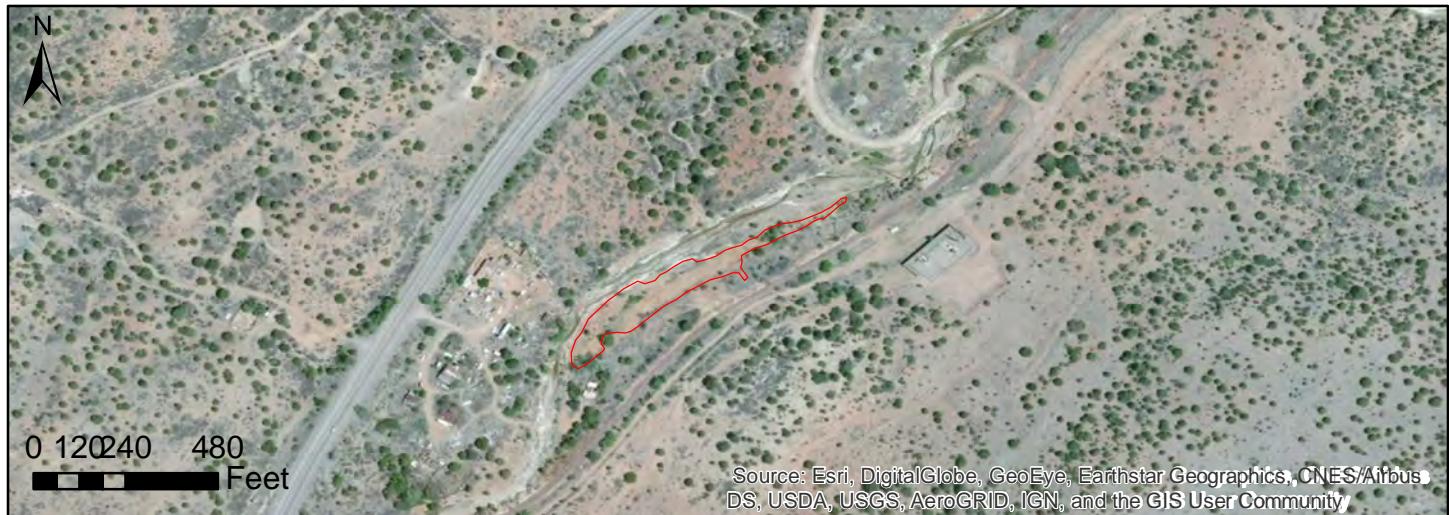
Removal Area R1

Pre-excavation

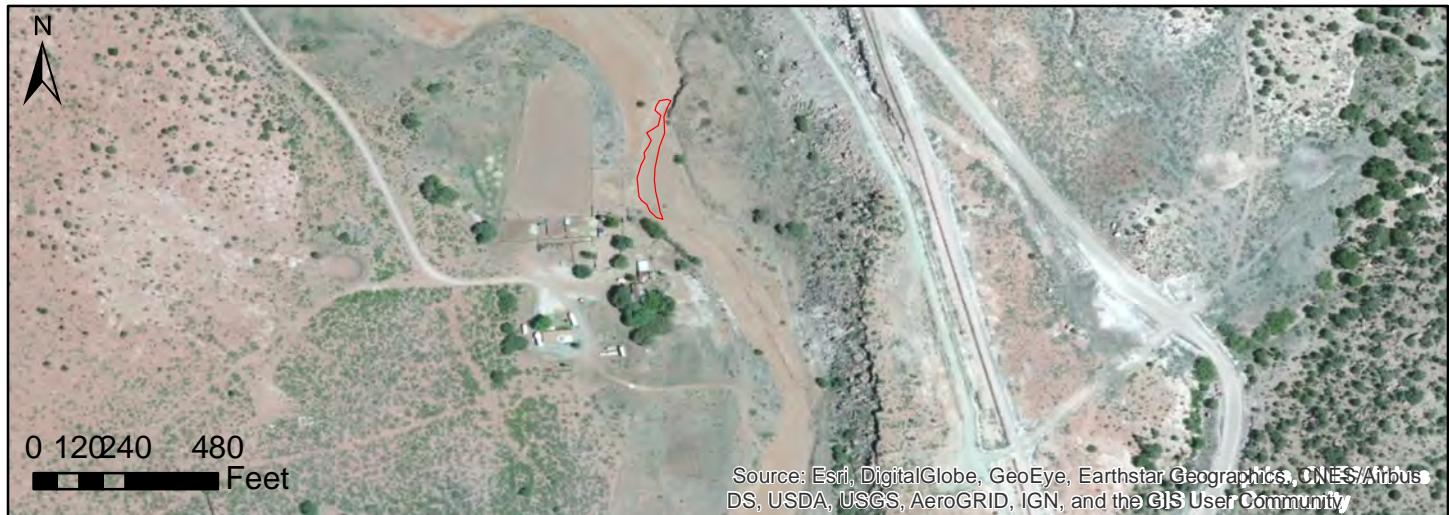
Removal Area R100

Pre-excavation

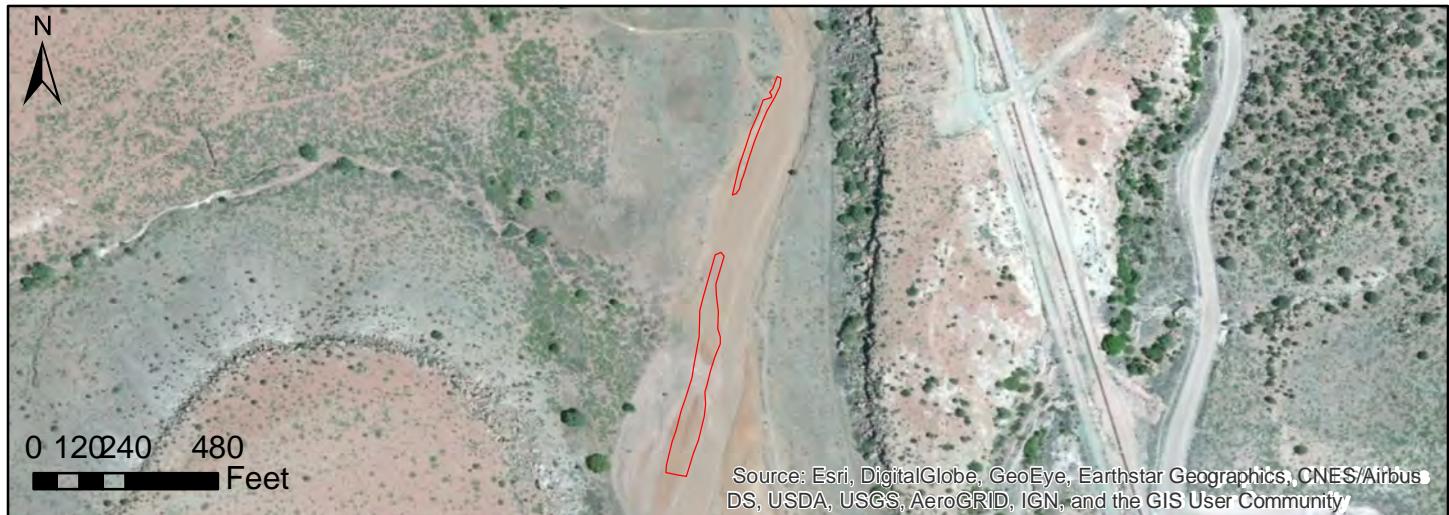
Removal Area R101

Pre-excavation

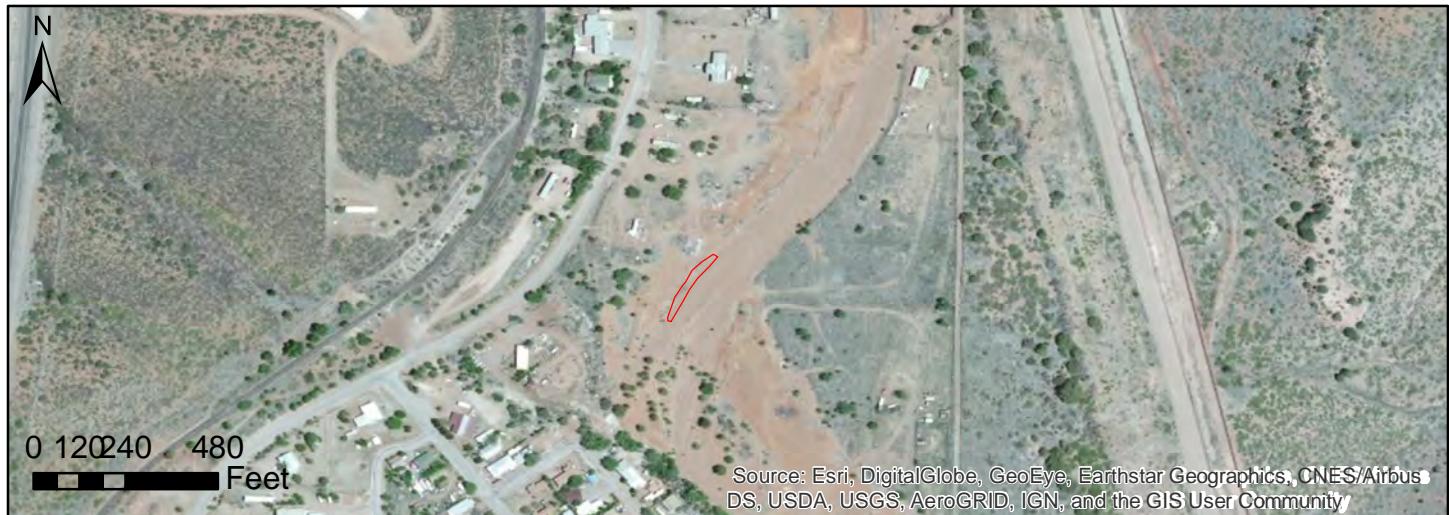
Removal Area R119

Pre-excavation

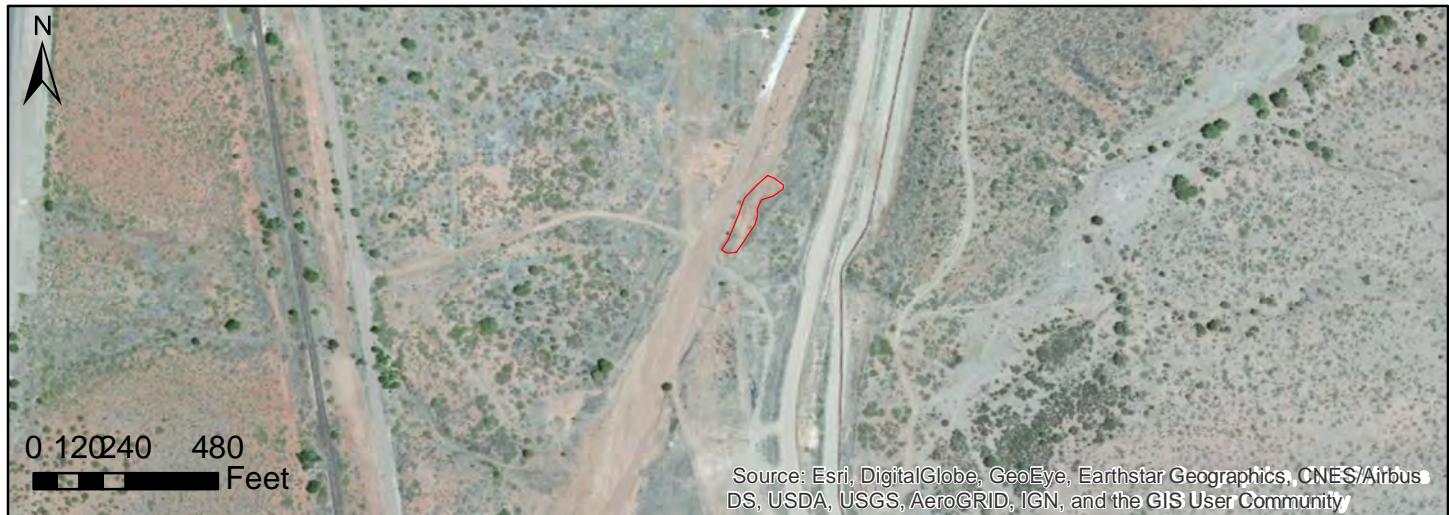
Removal Area R12

Pre-excavation

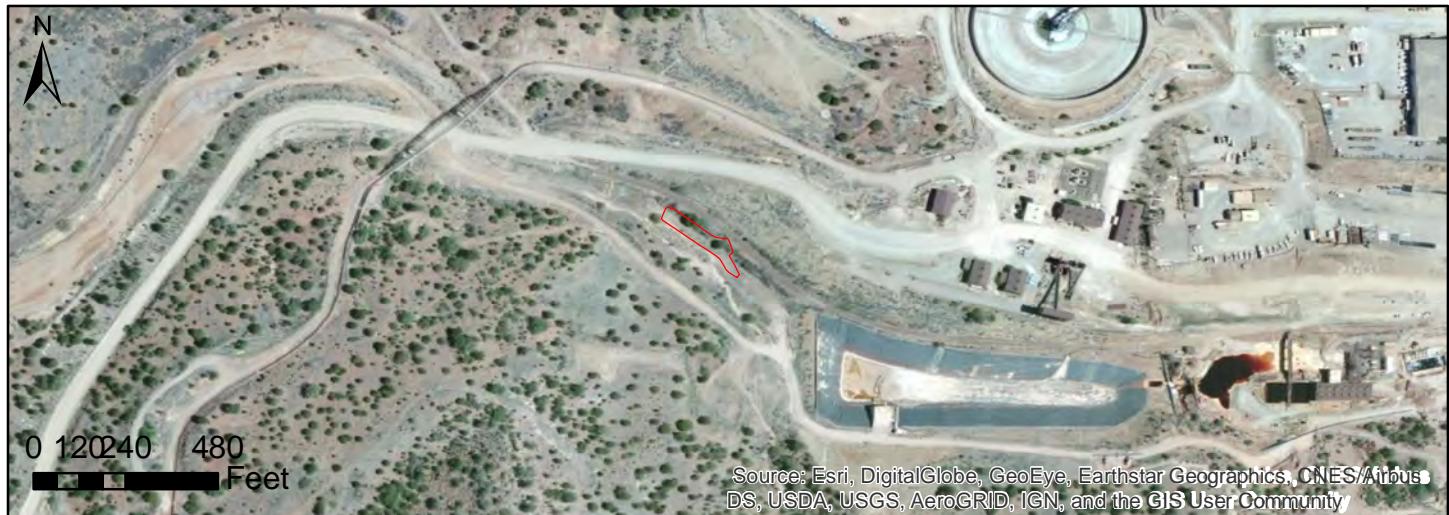
Removal Area R19

Pre-excavation

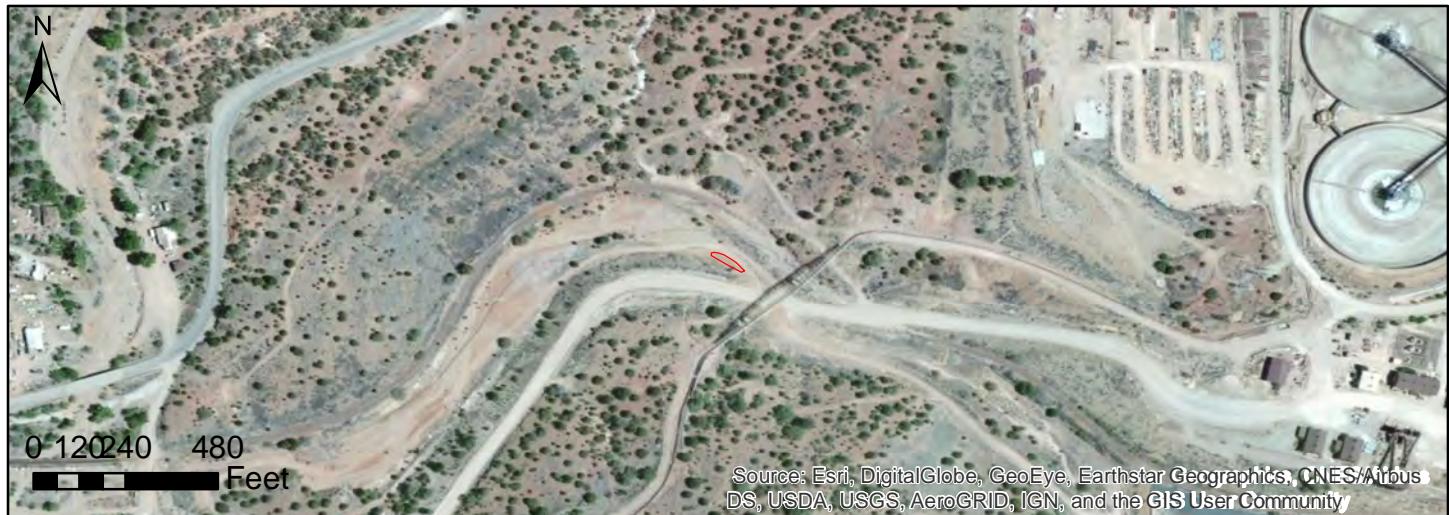
Removal Area R20

Pre-excavation

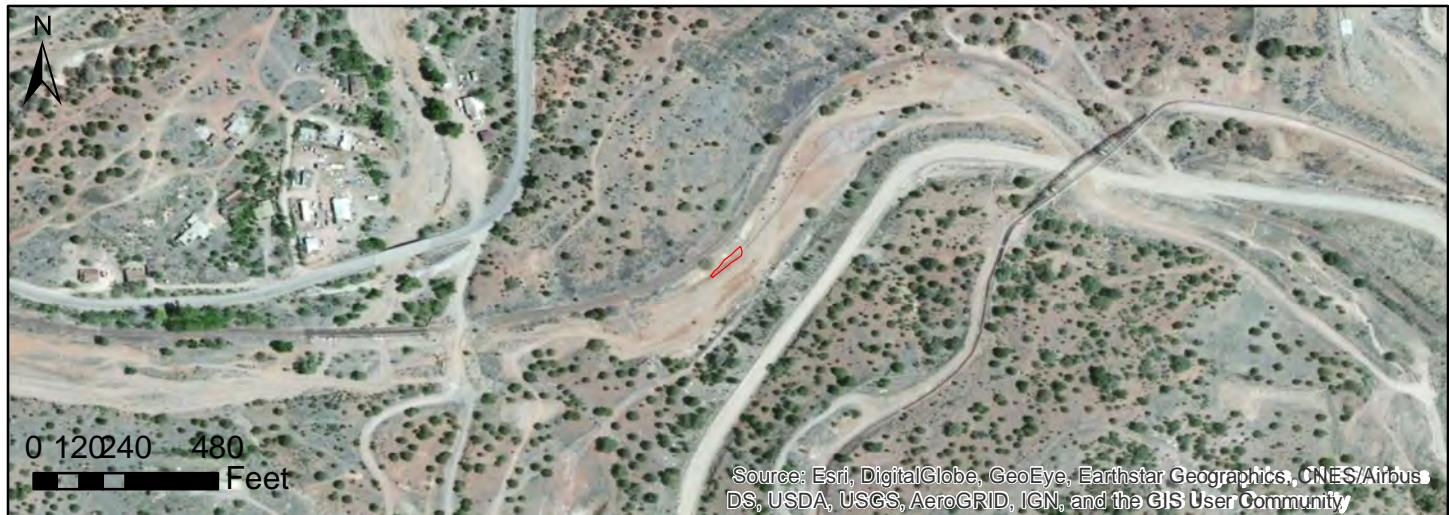
Removal Area R29

Pre-excavation

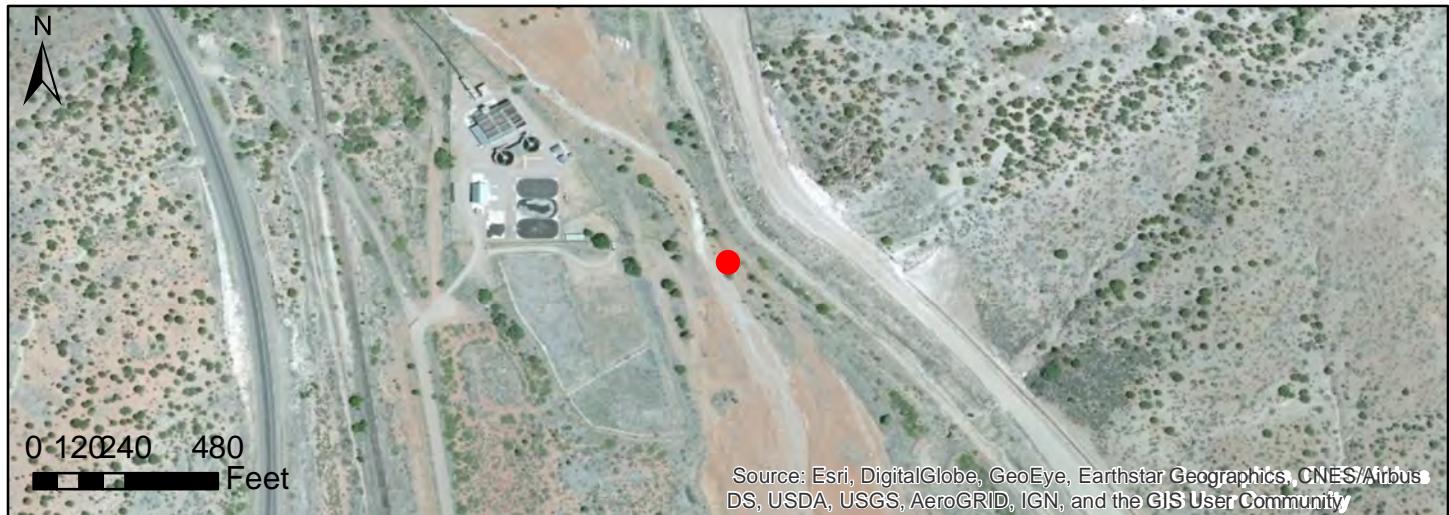
Removal Area R301 / DM17

Pre-excavation

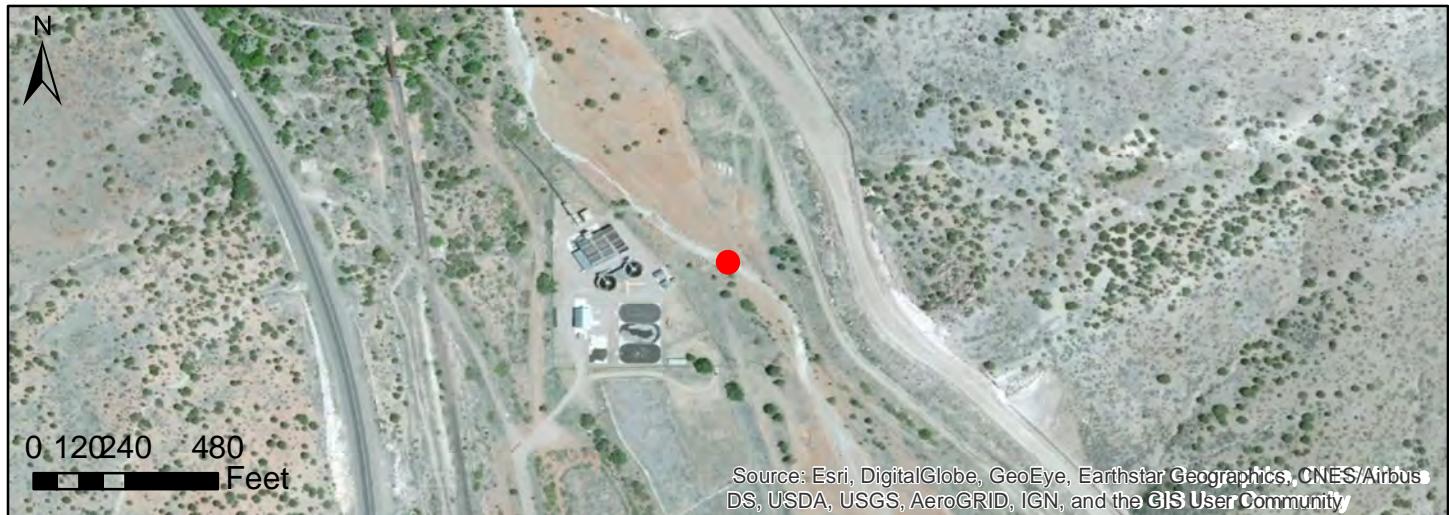
Removal Area R302 / DM18

Pre-excavation

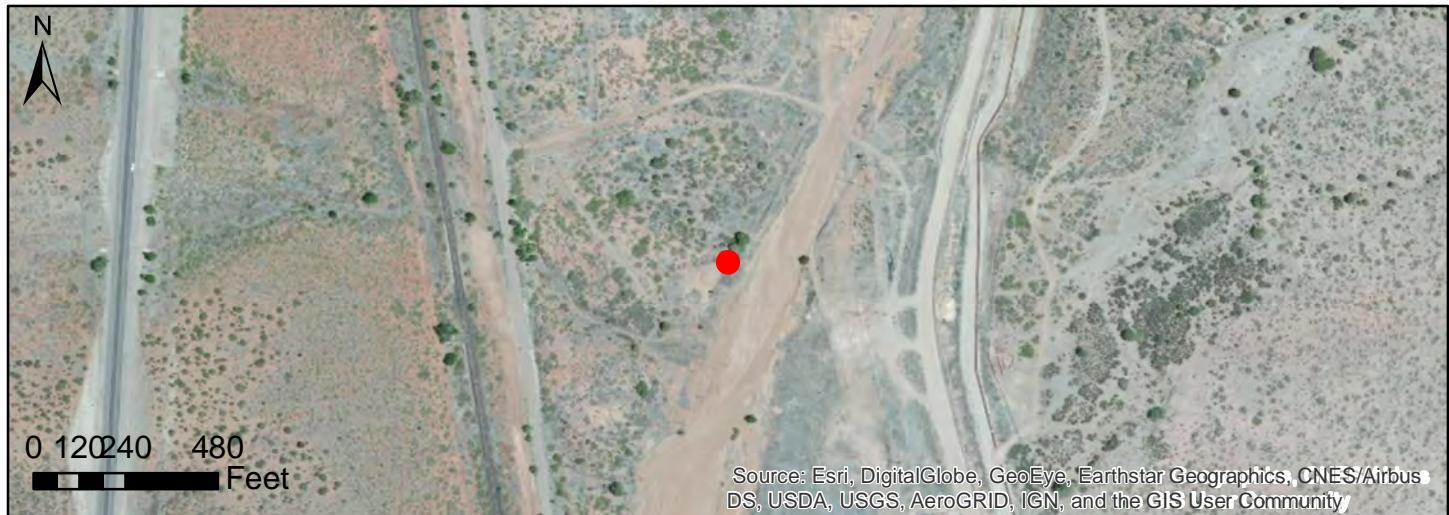
Removal Area R306 / DM26

Pre-excavation

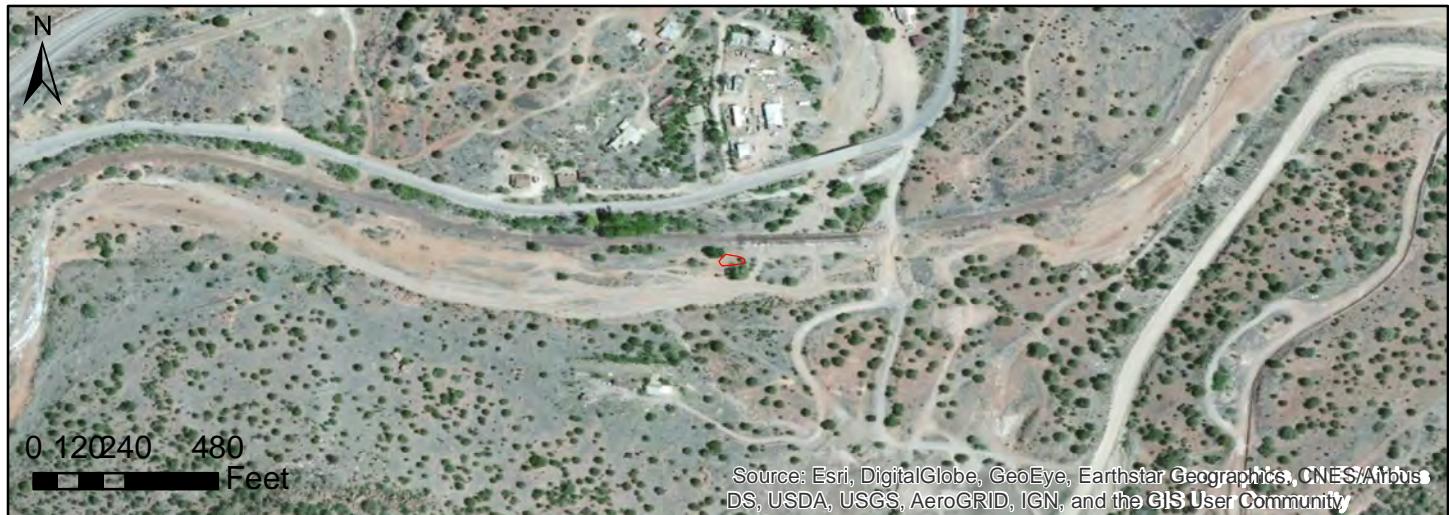
Removal Area R35

Pre-excavation

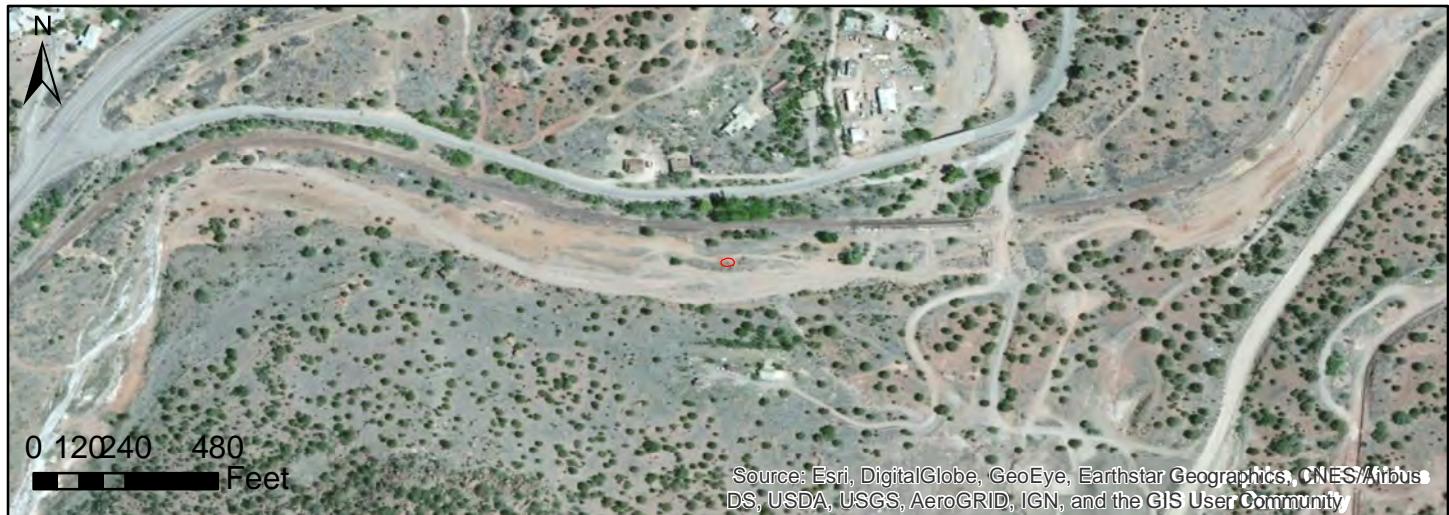
Removal Area R36

Pre-excavation

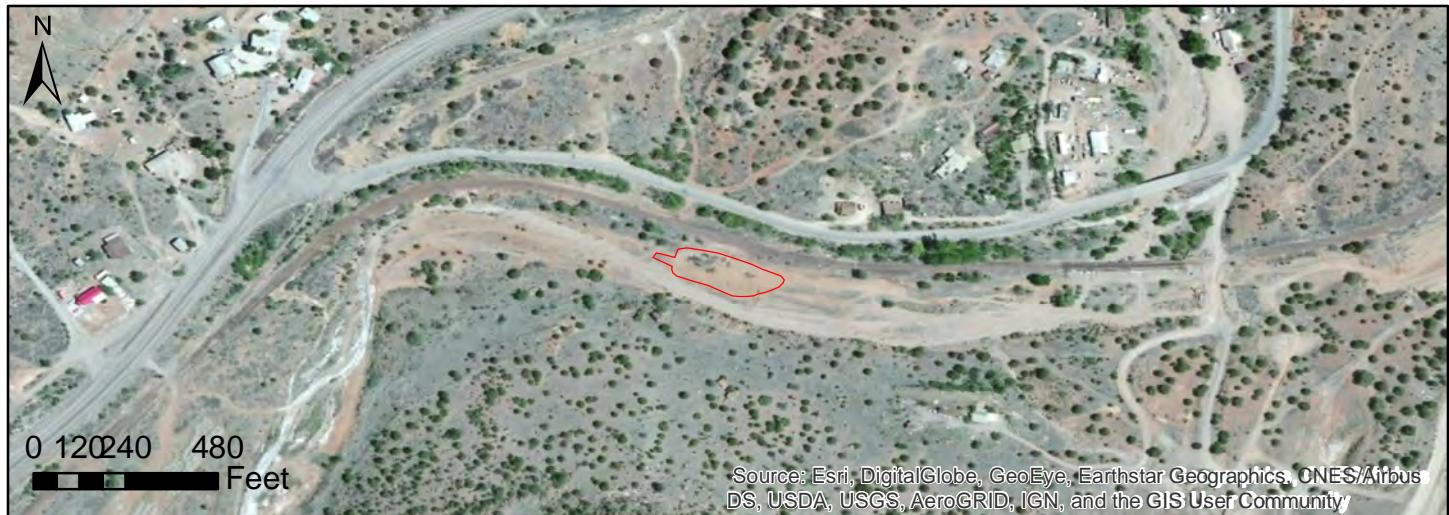
Removal Area R37

Pre-excavation

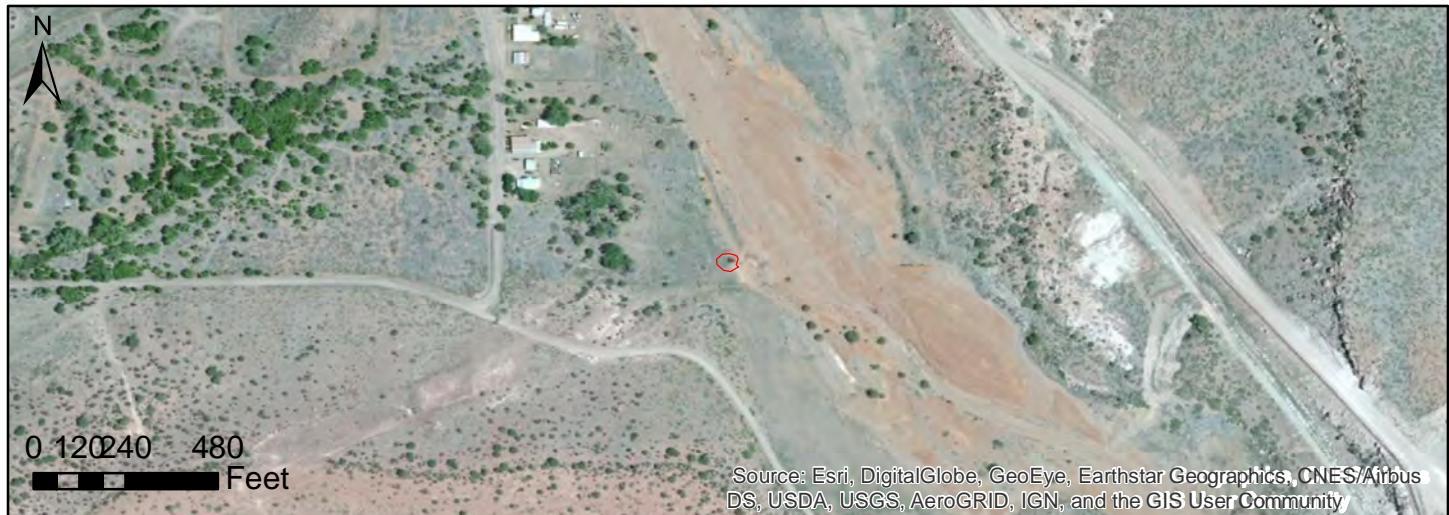
Removal Area R3A

Pre-excavation

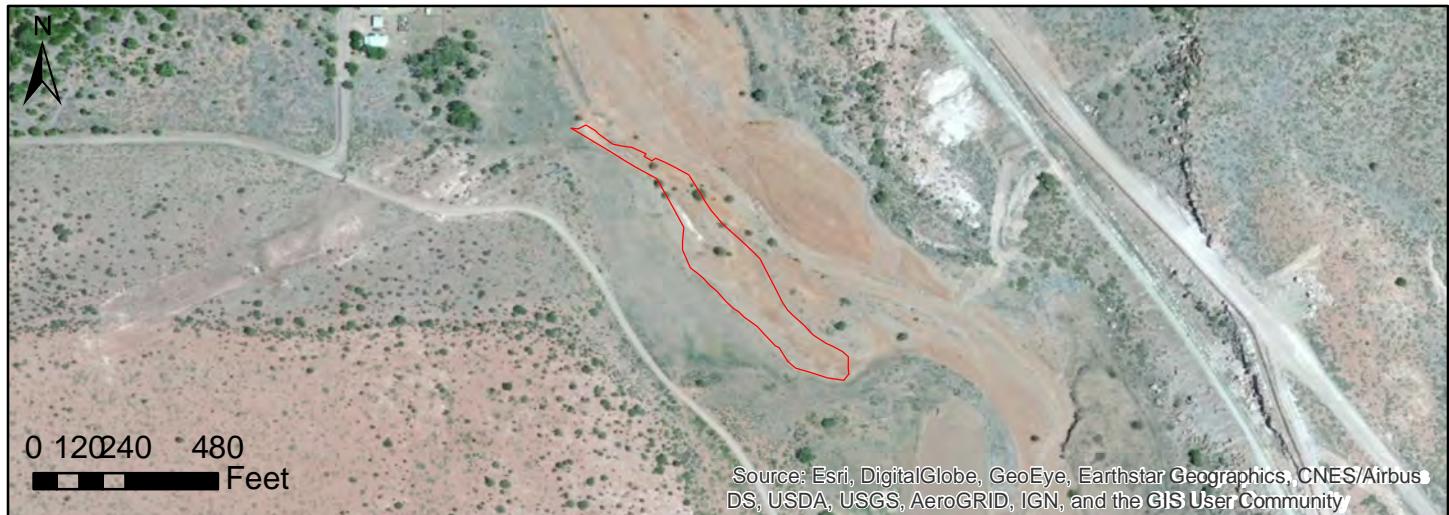
Removal Area R3B

Pre-excavation

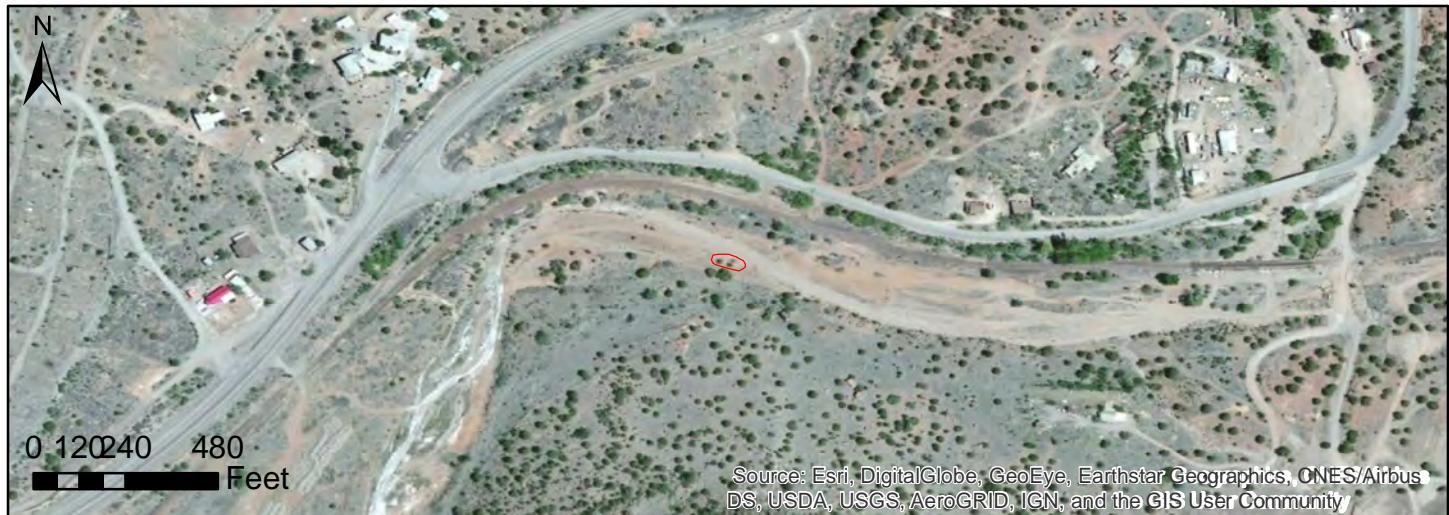
Removal Area R40

Pre-excavation

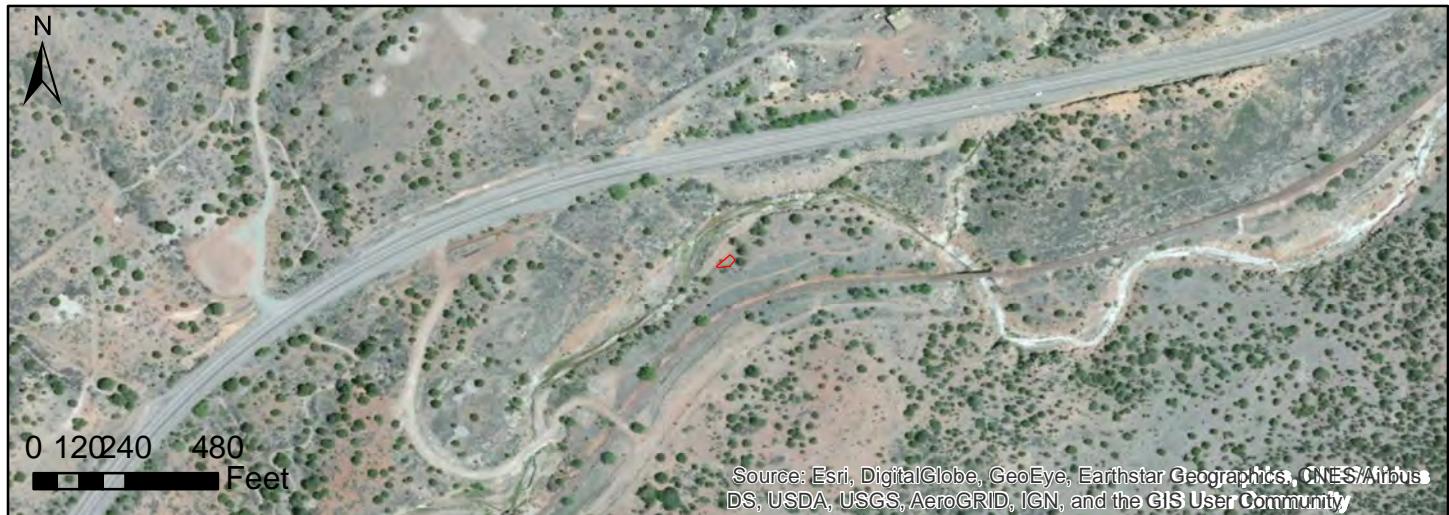
Removal Area R44

Pre-excavation

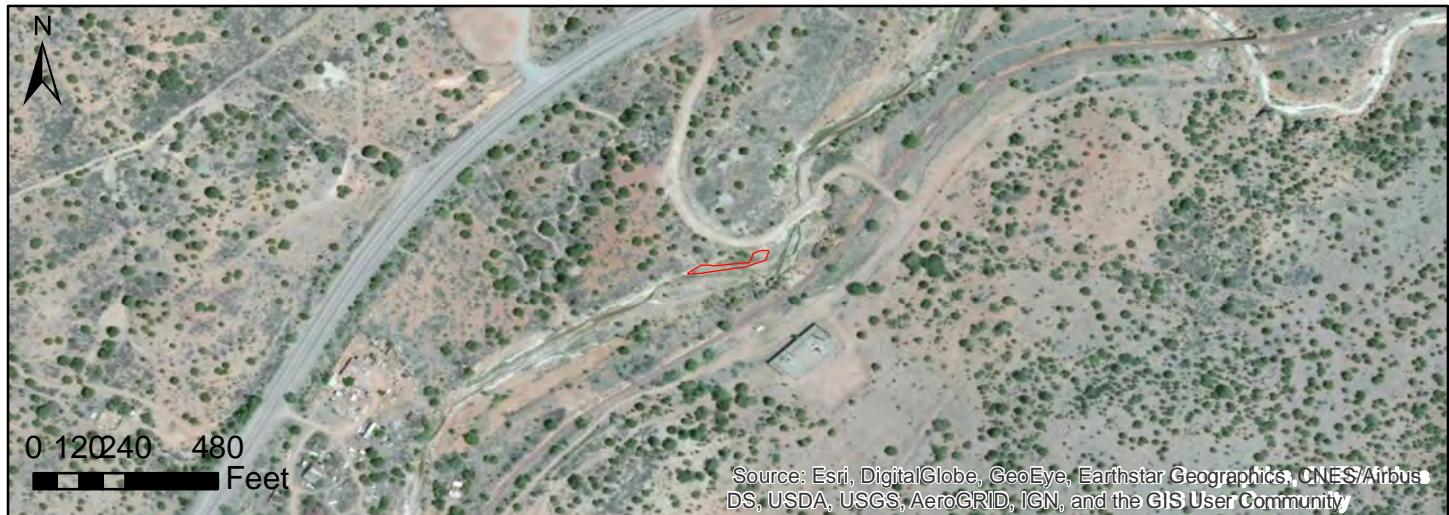
Removal Area R46

Pre-excavation
