**Vegetation Monitoring Report, Razorback Ridge IRA
Smelter/Tailing Soils Investigation Unit - Chino AOC**

2019 Quantitative Vegetation Monitoring
Razorback Ridge - East Removal Borrow Area

Golder Associates Inc.

July 30, 2021

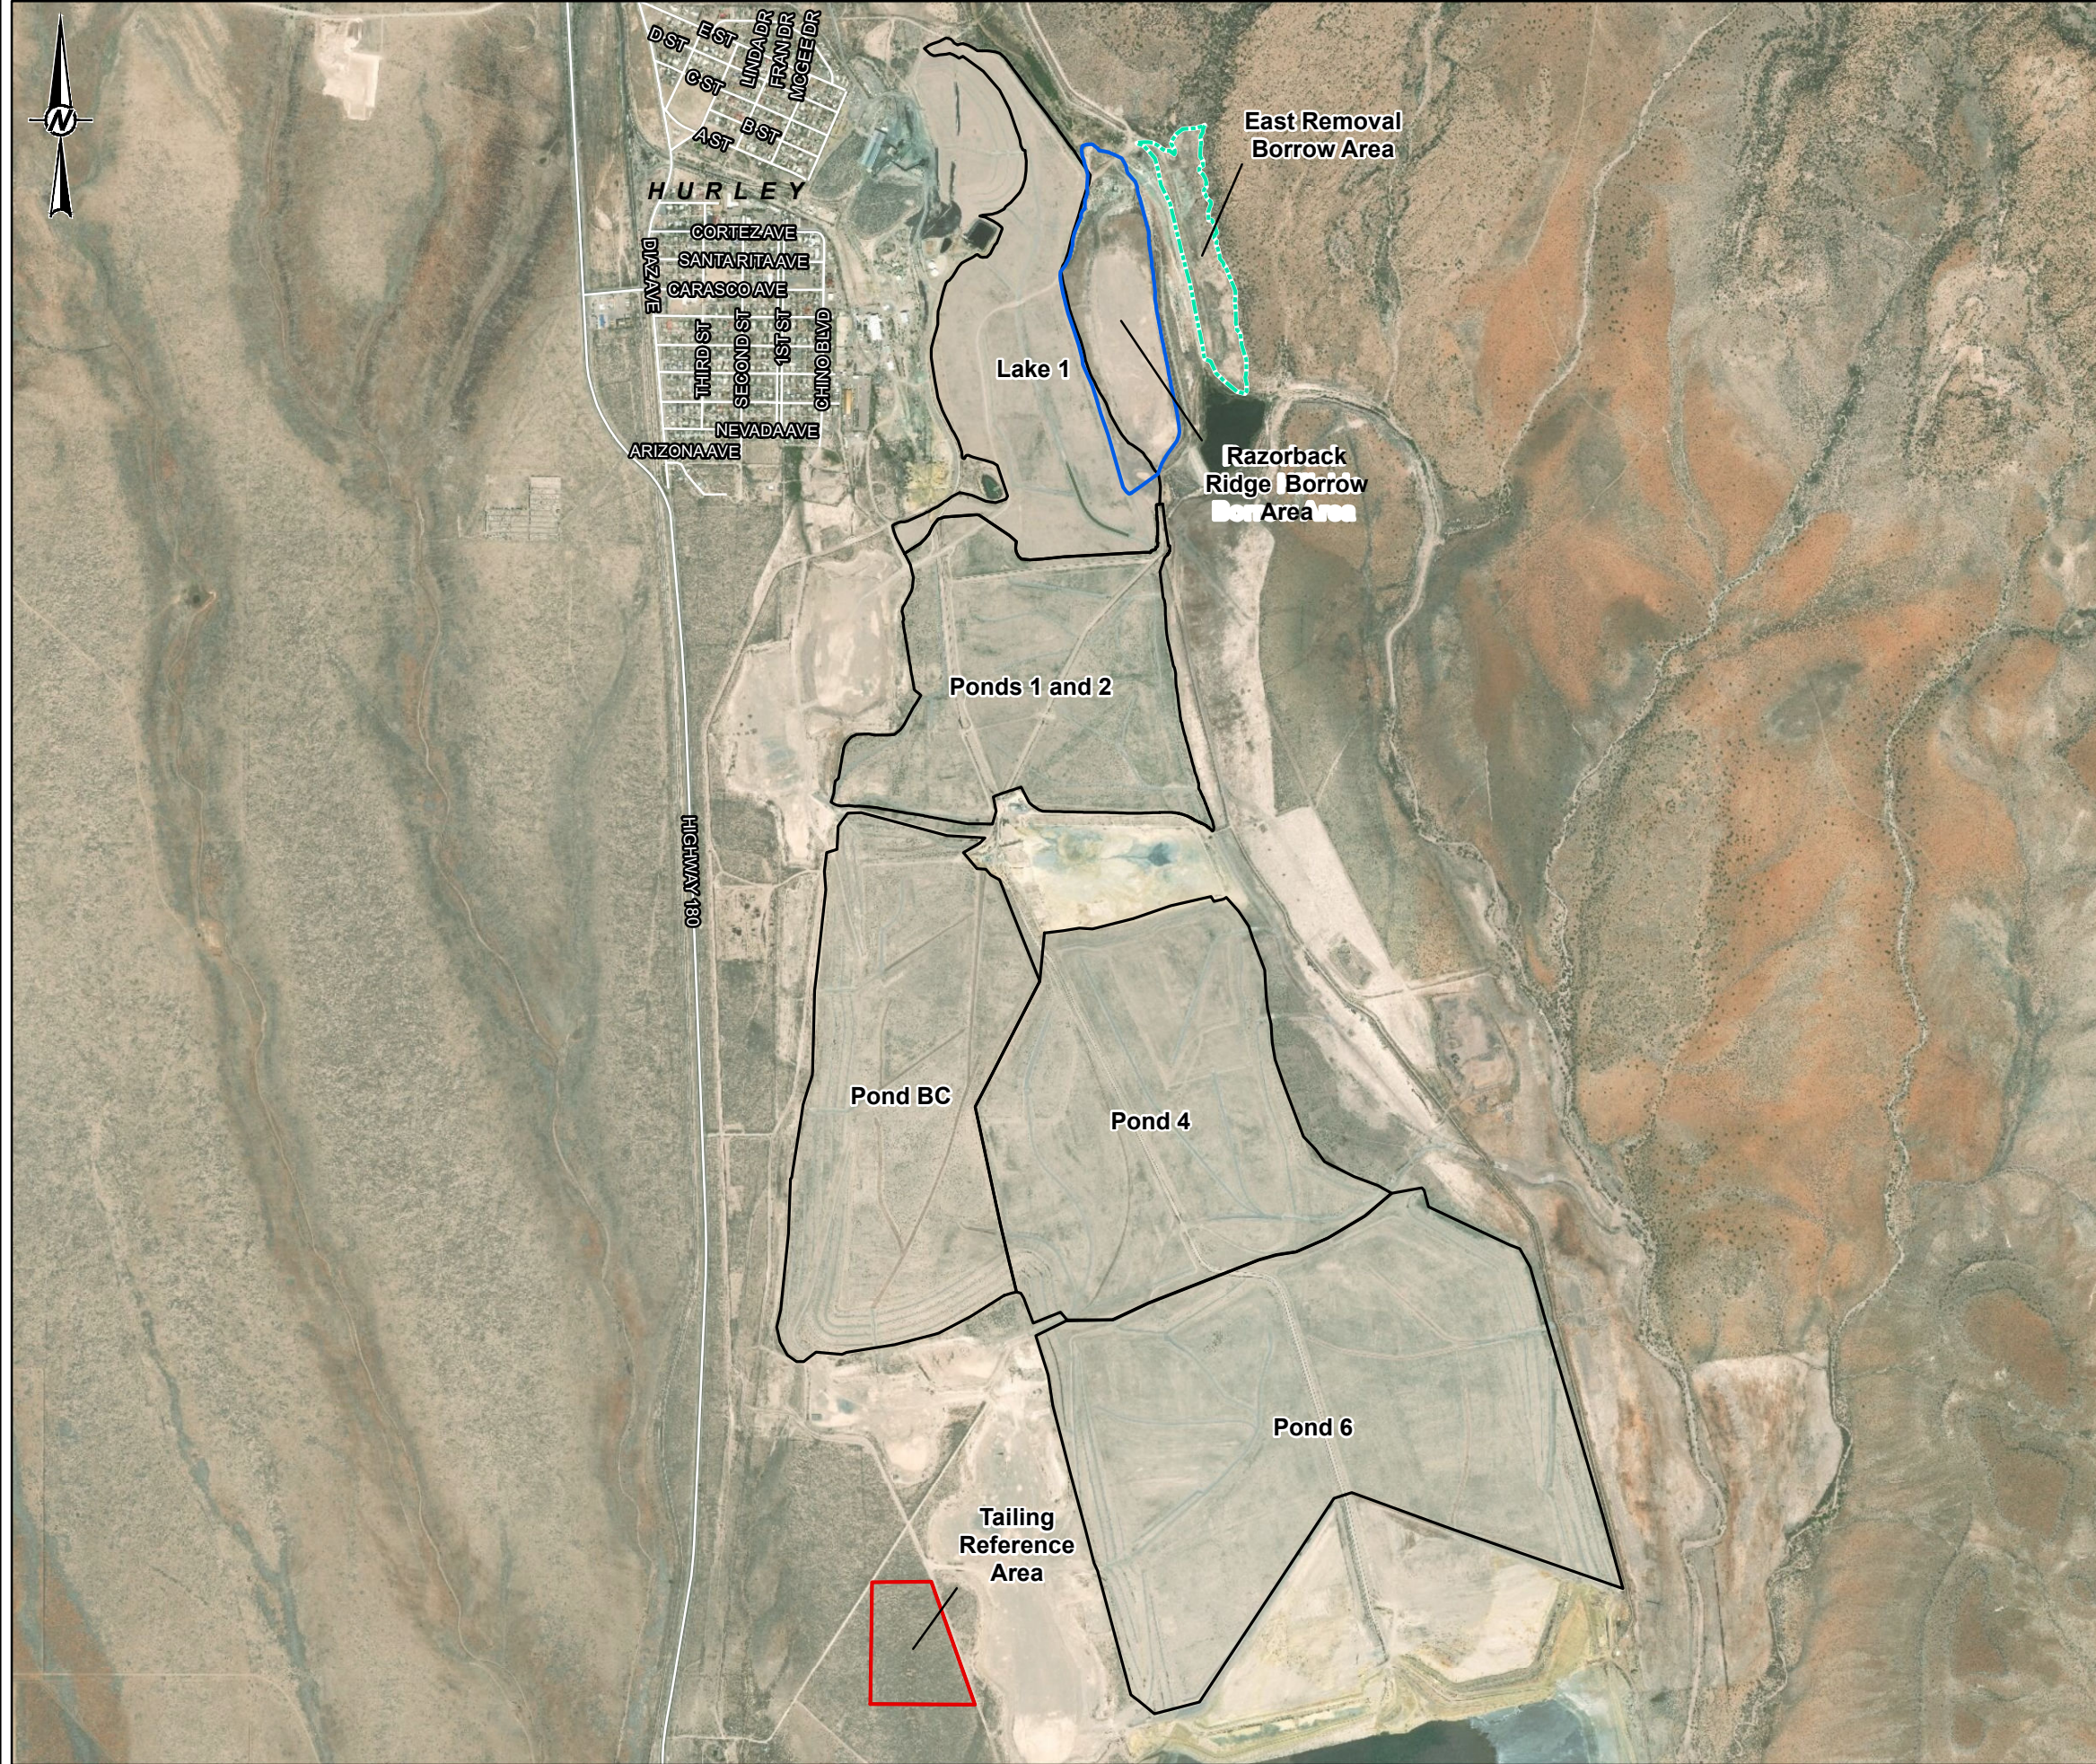
The Razorback Ridge Area is located near the Town of Hurley east of the Lake One reclamation. The area is divided into two sub-areas noted as Razorback Ridge and the East Removal Borrow Area on Figure 2. The two areas are separated by the operational pipeline corridor and the Whitewater Creek Diversion Channel.

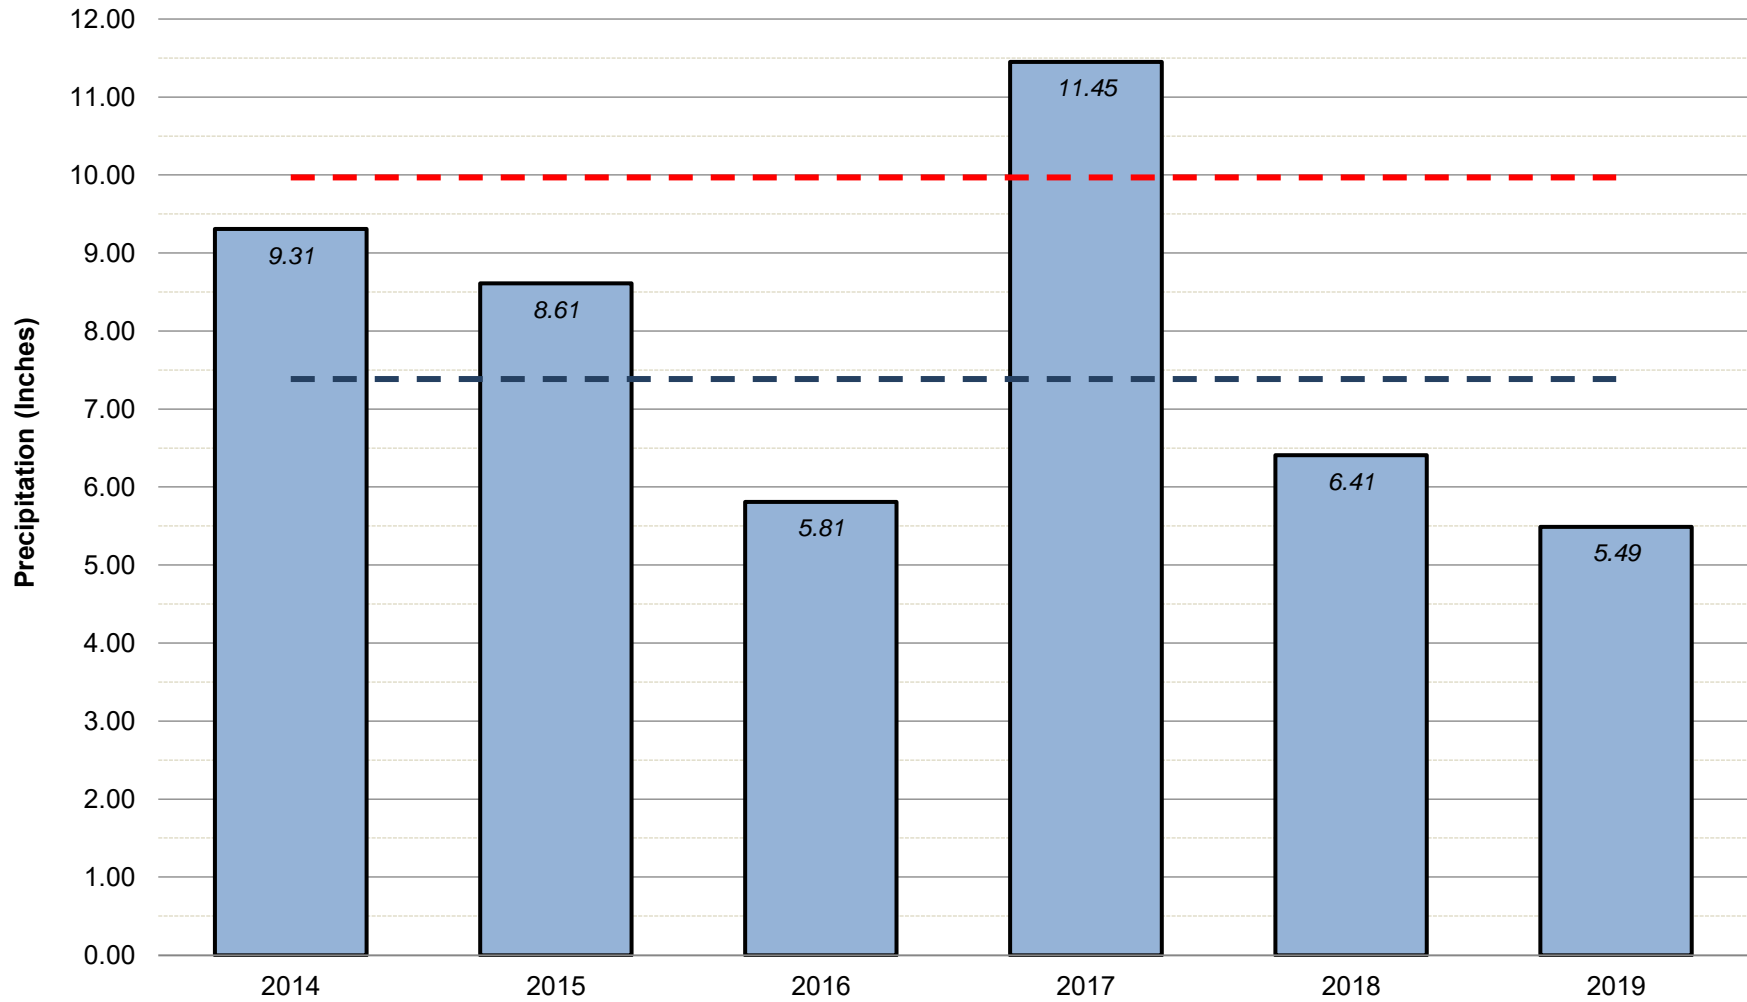
Figure 4: Growing Season Precipitation (2014-2019)

The nearest precipitation gauge to the East Removal Borrow Area is about 4 miles southwest, near Pond 7. Cumulative annual precipitation in 2019 was 13.46 inches and was below the long-term average of 15.8 inches (Table 3). The growing season precipitation in 2019 was 5.49 inches and was also below the long-term average of 9.97 inches. While the total annual precipitation was above the regional average of about 16 inches at Ft. Bayard (WRCC 2019) in 2017, pronounced annual and seasonal precipitation deficits have been common in the region. Since seeding the site in 2014, growing season precipitation has been slightly to well below average for six of the last seven years, with 2017 being above average (Figure 4).

Fort Bayard Average Based on 1897 - 2006
Pond 7 Average Based on 2010 - 2019

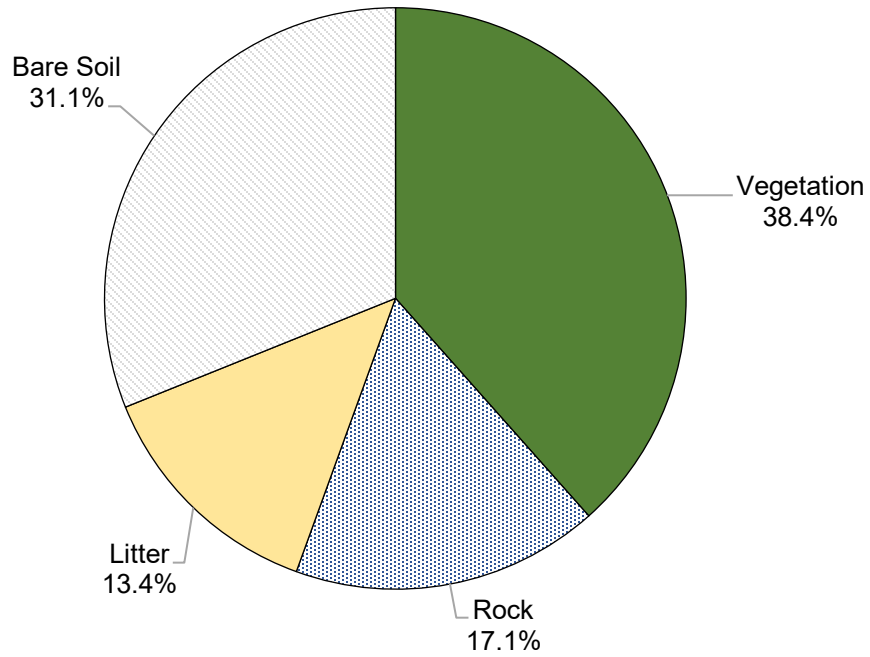
Figure 5a: Canopy Cover Components

Canopy cover at the East Removal Borrow Area was less than the proportional cover requirement of 70% of the Reference Area (Table 4). Mean total canopy cover was $38.4\% \pm 7.7\%$ (90% CI), which is about 59% of the Reference Area average total canopy cover (64.6%). Vegetation canopy cover in the 20 individual quadrats ranged from 3.3 to 77.5% (Appendix A, Table A1). Mean perennial canopy cover was $36.0\% \pm 8.0\%$ (90% CI) and ranged from 2.7 to 79.2% in the individual quadrats. The ground cover components for the East Removal Borrow Area are displayed on Figure 5a and consists of 38.4% vegetation, 17.1% rock, 13.4% litter, and 31.1% bare soil.

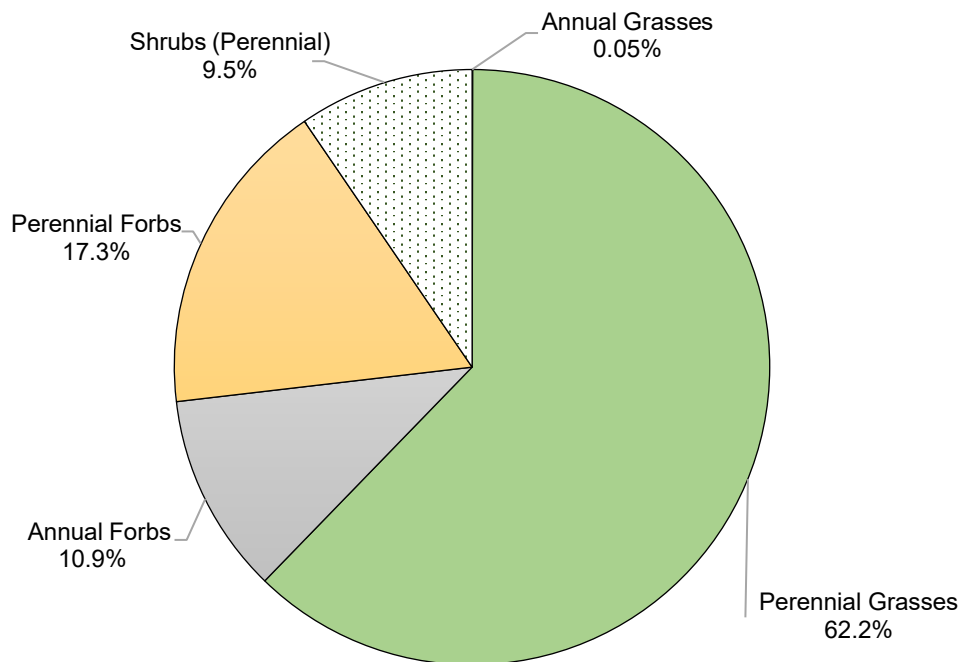
Figure 5b: Proportional Canopy Cover by Plant Class

The proportional or relative canopy cover for the plant classes (annual grasses, perennial grasses, annual forbs, perennial forbs, and shrubs) is illustrated in Figure 5b for the East Removal Borrow Area. Perennial grasses contribute the most to vegetation canopy cover with a relative contribution of 62.2%. Sideoats grama (*Bouteloua curtipendula*), a warm-season perennial grass and spike dropseed (*Sporobolus contractus*) an intermediate season perennial grass, were the most abundant (Table 5). Perennial forbs represented 17.3% of the total relative canopy, with Wright's thimblehead (*Hymenothrix wrightii*) contributing the most canopy cover of the forb species recorded by the quadrats. Relative annual forb cover was 10.88% and included eight species, with New Mexico goosefoot (*Chenopodium neomexicanum*) contributing the most canopy cover (Figure 5). Relative shrub cover was 9.55% and included four species, with four-wing saltbush (*Atriplex canescens*) contributing the most canopy cover. Annual grasses contributed the least to canopy cover with 0.05% relative canopy cover on the reclamation.

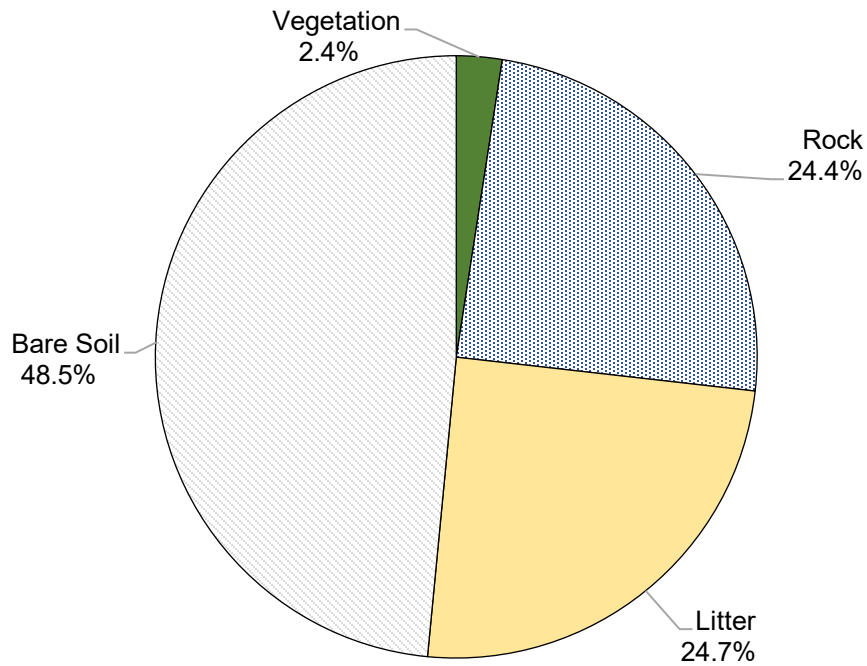
Figure 6a: Basal Cover Components

The mean basal cover at the East Removal Borrow Area was $2.4\% \pm 0.6\%$ (90% CI, Table 4). Vegetation basal cover in the individual quadrats ($n=20$) ranged from 0.1 to 5.7% (Appendix A, Table A2). The ground cover components on a basal basis for the East Removal Borrow Area are displayed on Figure 6a and consists of 2.4% vegetation, 24.4% rock, 24.7% litter, and 48.5% bare soil. The calculated N_{\min} for basal cover was 123 samples (Table 4).

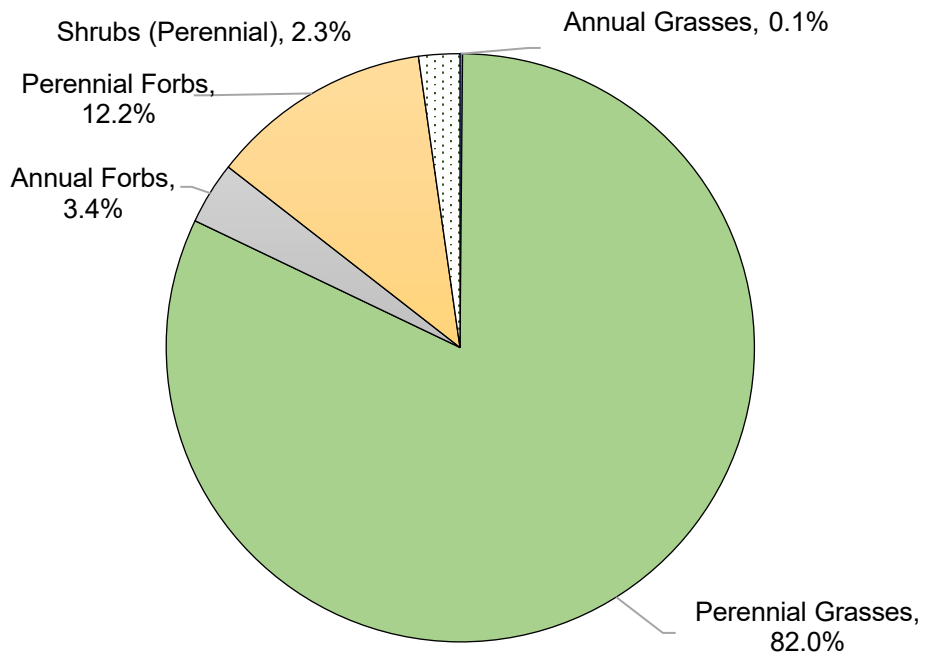
Figure 6b: Proportional Basal Cover by Plant Class

The proportional or relative basal cover for the plant classes (annual grasses, perennial grasses, annual forbs, perennial forbs, and shrubs) is illustrated in Figure 6b for the East Removal Borrow Area. Basal cover on the reclamation is dominated by perennial grasses with almost 82% relative basal cover.

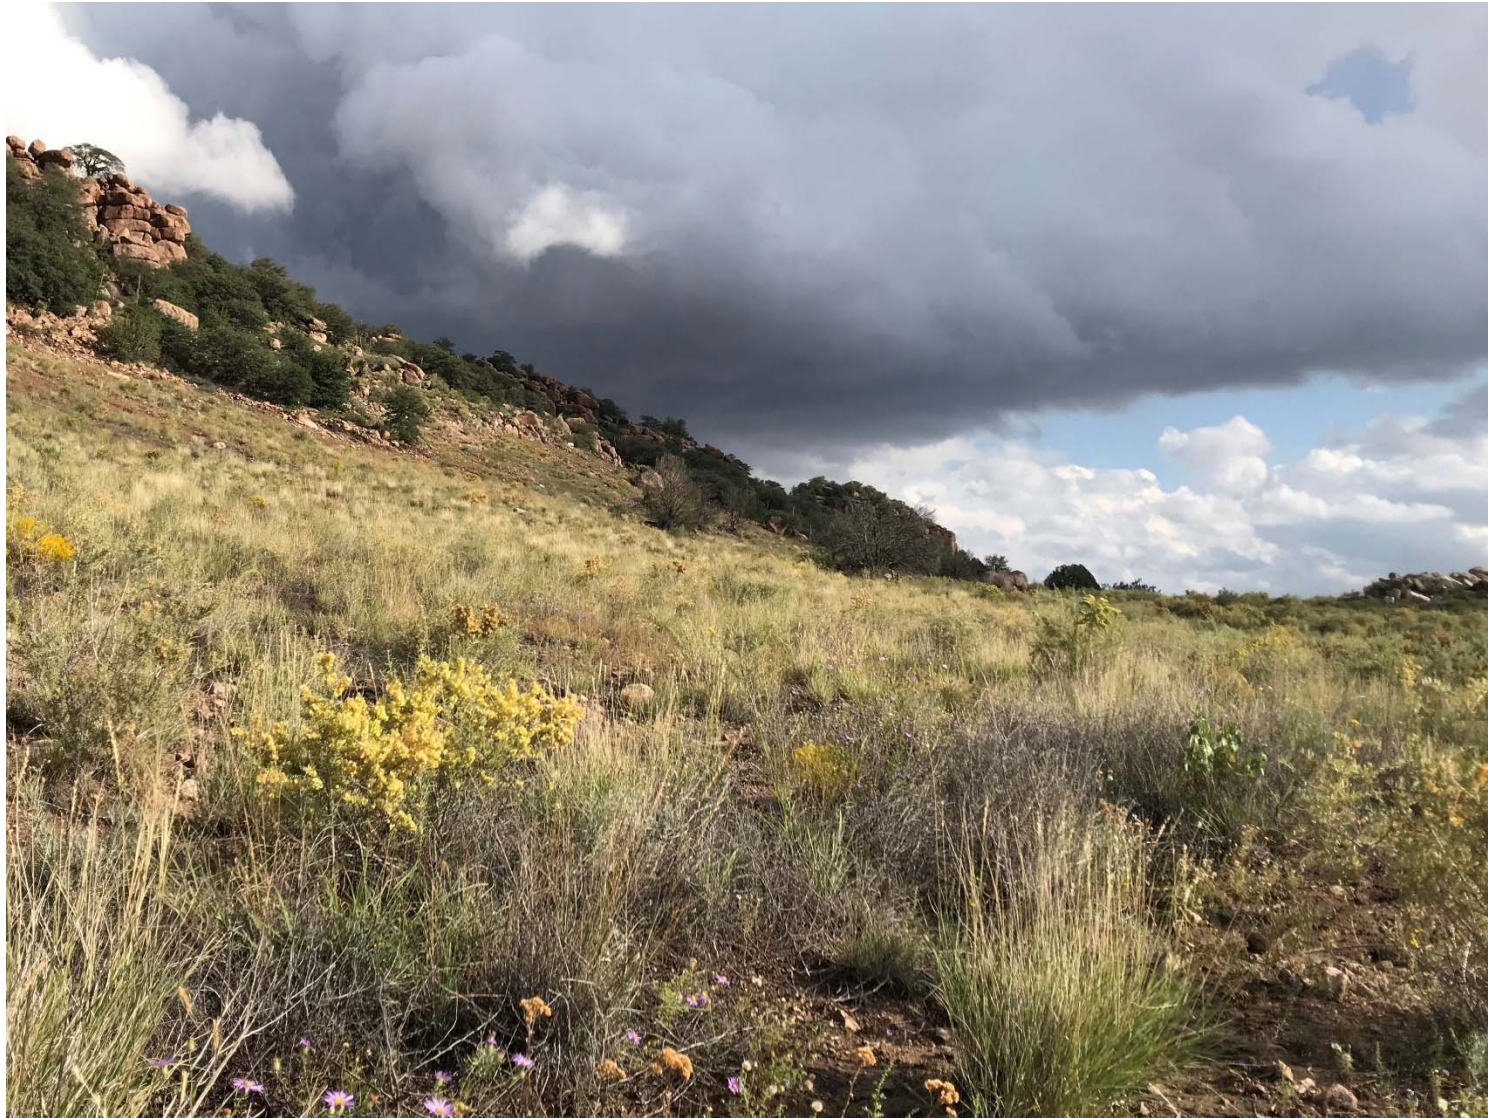
Figure 7: Typical Vegetation in the East Removal Borrow Area, October 2019

The vegetation on the East Removal Borrow Area meets the diversity requirements for warm-season grasses, cool/intermediate-season grasses, and forbs but not for shrubs. Four warm-season perennial grasses met the 1.0% cover diversity standard, including sideoats grama (8.6%), James' galleta (4.1%, *Pleuraphis jamesii*), blue grama (4.0%, *Bouteloua gracilis*), and green sprangletop (3.7%, *Leptochloa dubia*) (Table 5). The intermediate season grass spike dropseed (4.3%) meets the diversity standard for one cool- or intermediate season grass with 0.5% cover. Without consideration for duration, 17 forbs exceed the 0.1% cover diversity standard for forb cover. Excluding annuals, the forbs with the greatest canopy cover are Wright's thimblehead (1.7%) and tansyleaf tansyaster (1.5%, *Machaeranthera tanacetifolia*). Four-wing saltbush was the only shrub meeting the 1.0% canopy cover diversity standard, with canopy cover estimated at 3.5%. Other shrubs that contributed to canopy cover included soaptree yucca (0.4%, *Yucca elata*), with both broom snakeweed (*Gutierrezia sarothrae*), and threadleaf groundsel (*Senecio flaccidus*) contributing <0.1% each. Although four-wing saltbush is recorded as dominant, 14 woody plants are present on the reclamation in the East Removal Borrow Area. A representative photograph of the vegetation on the East Removal Borrow Area for 2019 is shown in Figure 7.
