Re: Razorback Ridge Area Supplemental Completion Report
Smelter Tailing Soils Investigation Unit - Chino AOC

SUPPLEMENTAL COMPLETION REPORT

RAZORBACK RIDGE AREA

Interim Remedial Action
Smelter/Tailing Soils Investigation Unit

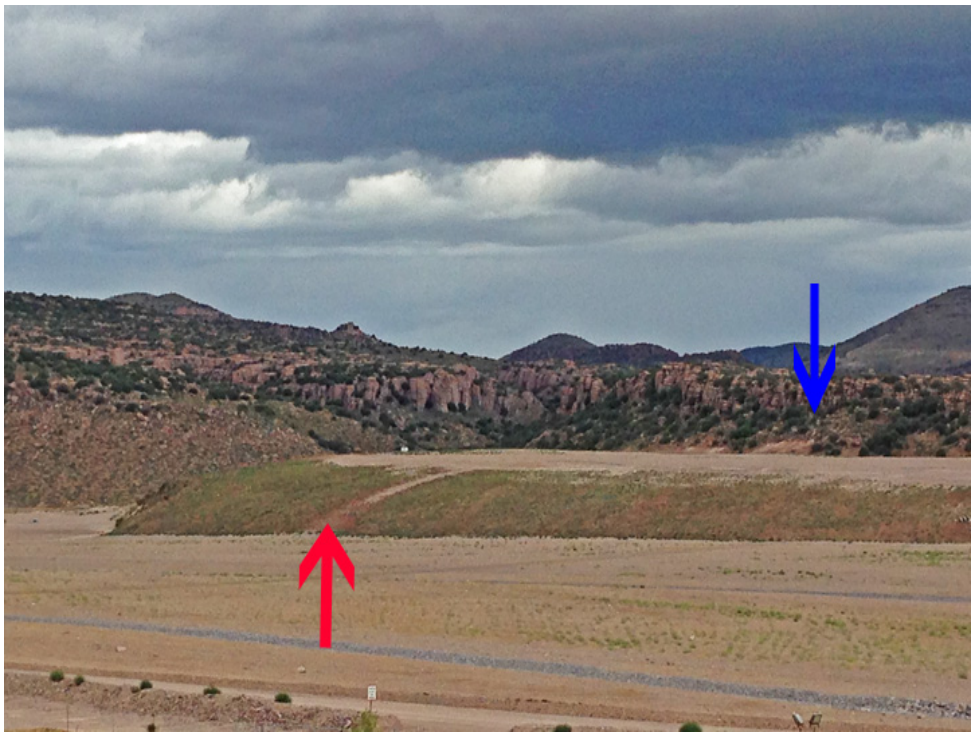
Razorback Ridge Area Excavation Photographs	
PHOTO 1 Facing east – north end of Razorback Ridge (red) with East Removal Borrow Area in background (blue).

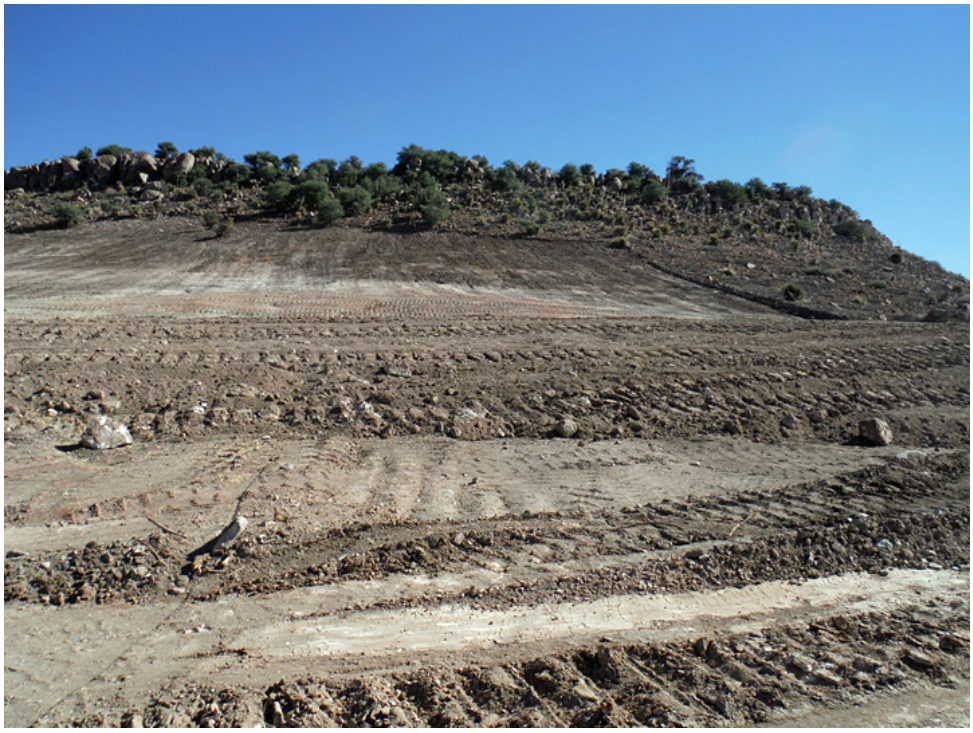
PHOTO 5 Facing east – southern end of East Removal Borrow Area at southeast corner of site.

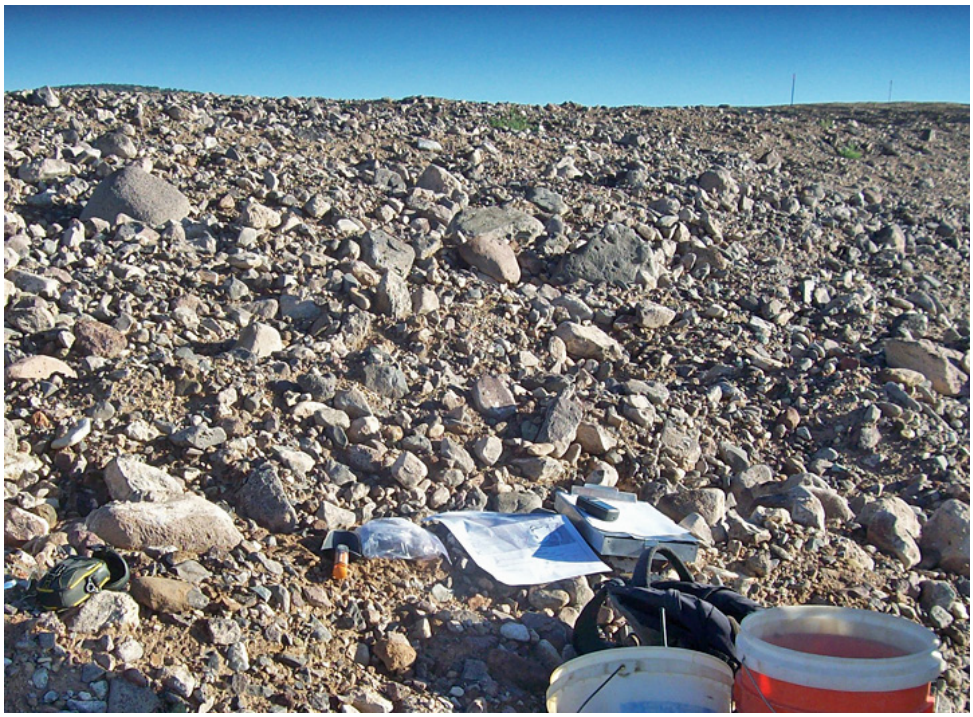
PHOTO 21 Representative soil sampling effort.	
PHOTO 22 Panorama of mulched and seeded surface of Razorback Ridge in foreground and east area in background.
