Re: B Ranch Interim Removal Action Completion Report
Smelter Tailing Soils Investigation Unit – Chino AOC

COMPLETION REPORT

B RANCH AREA

INTERIM REMEDIAL ACTION SMELTER/TAILING

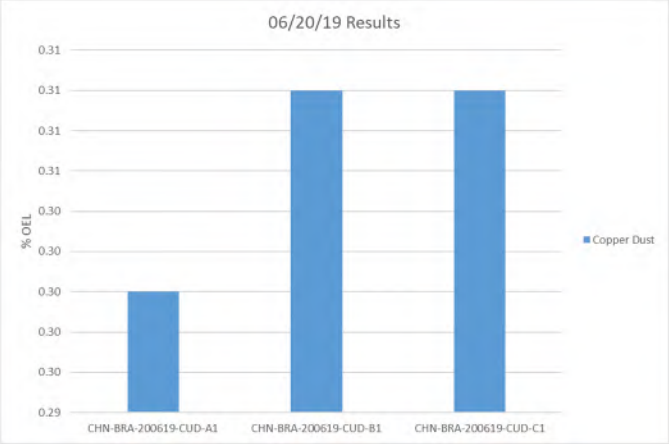
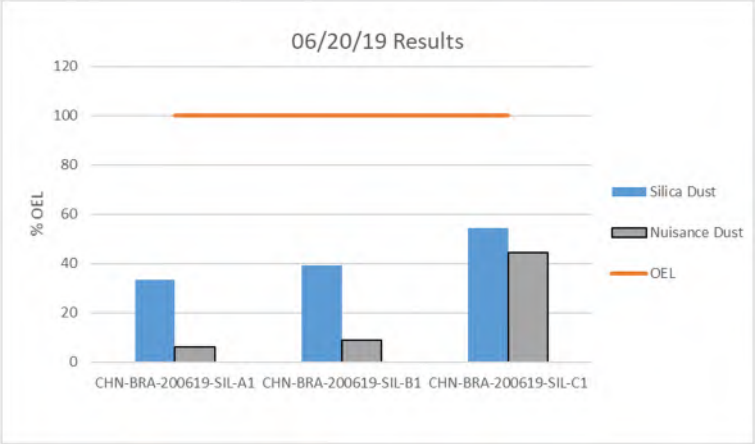
Graph 1

The results show the USA contractors were below the Freeport-McMoRan OEL[1] for respirable crystalline silica, nuisance dust, and copper dust. (Graph 1, 2) One data point in Graph 2 is over 50% OEL, however the concentration in Appendix A shows the exposure was less than 12 ug/m^3, which would be under the limit of detection. Copper dust was negligent and will not be sampled in further testing.

- Remain in operator cab as much as possible
- Perform routine checks on cab seals on both trucks and equipment
- Routinely clean/replace cabin air filters
- Utilize water truck in area as needed
- Half-faced respirators with P100 filters may be worn at operator's discretion under the assumption that the operator has been fit tested

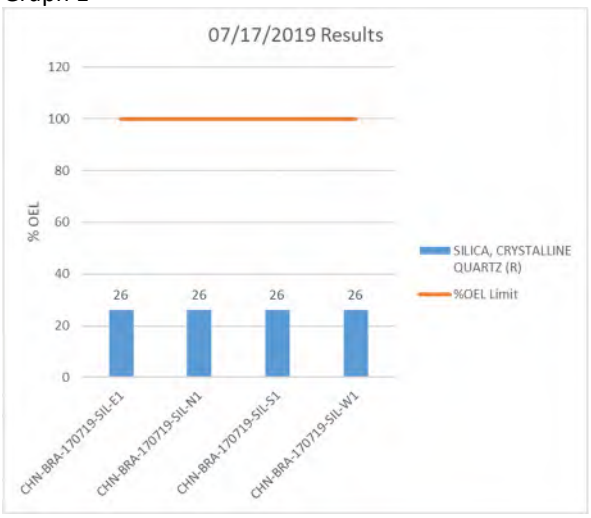
Graph 1

The results show the contractors were under the Freeport-McMoRan OELs[1] for respirable crystalline silica and nuisance dust (ND). (See Graph 1) No action required at this time for silica dust or ND. ND was negligent and will not be included in the graph. (For results, see Appendix A for data on ND)

- Continue use of water truck in area
- Routinely replace cabin air filters with P100 filters
- Remain in operator cab as often as possible
- Perform routine checks on cab seals on both trucks and equipment
