# **BAYARD CANYON SUPPLEMENTAL INTERIM REMOVAL ACTION COMPLETION REPORT**

Hanover Whitewater Creek Investigation Unit  
Vanadium, New Mexico

July 2022

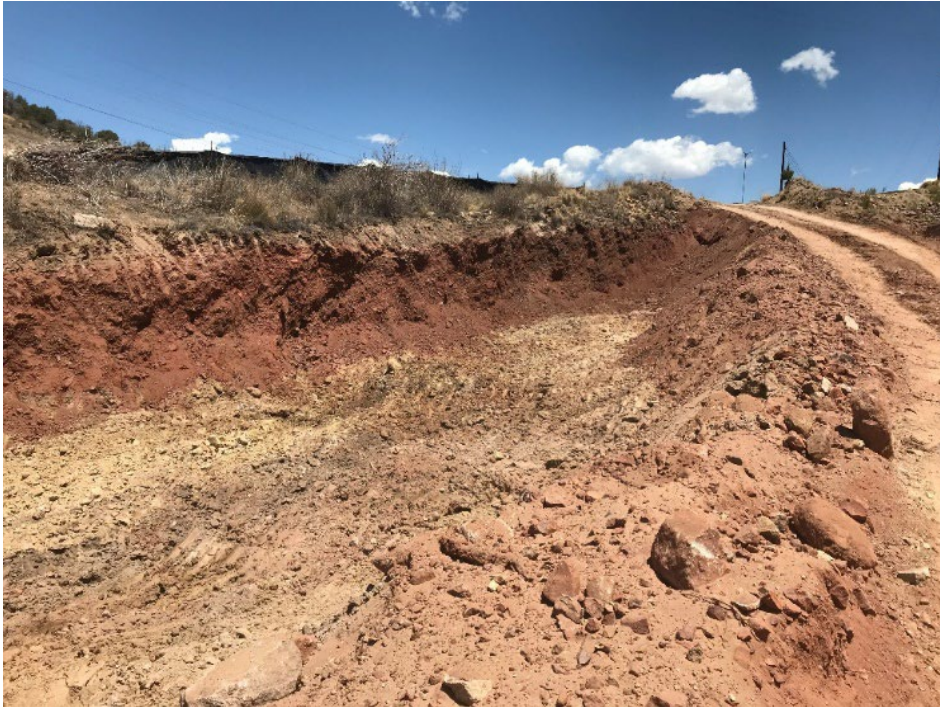
- Shaft 1 – An area approximately 18,673 square feet (ft<sup>2</sup>) in size and an average depth of 4 feet (approximately 2,766 yd<sup>3</sup>) was removed in the vicinity of this shaft. Reddish material exposed through excavation on the west side of the drainage was observed to be within the active mine operations high-density polyethylene pipeline corridor located west of Shaft 1 (see **Exhibit 5a**). This area was determined by a Chino geologist to be an outcrop of the jasperoid vein covered by

stockpile material (**Exhibit 5b**). The remaining stockpile was not removed due to concerns of undermining the pipeline corridor. Instead, the outcrop and remaining stockpile materials were covered with clean backfill.

**Exhibit 5a – Photograph showing the remaining stockpile left in place under the stockpile and pipeline corridor.**

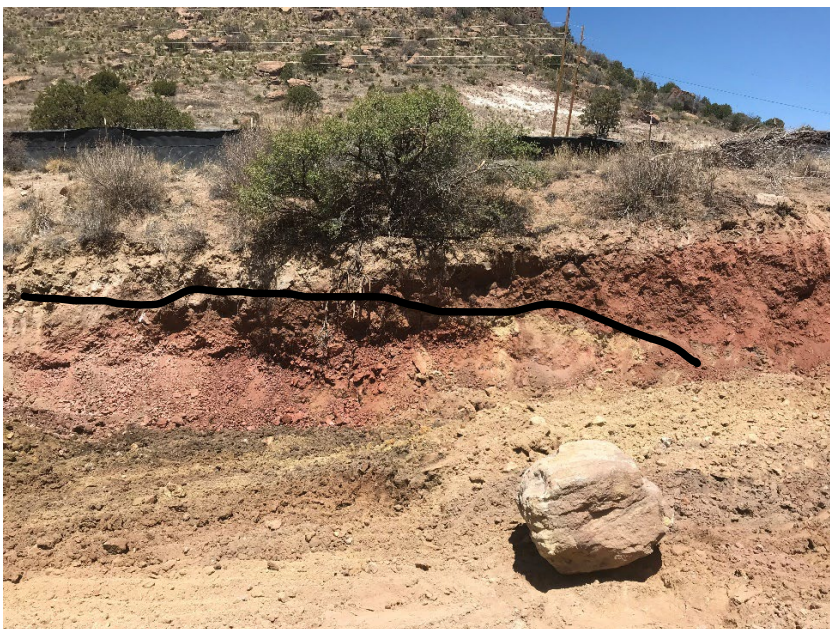
**Exhibit 5b – Photograph showing the jasperoid vein outcrop (marked by bold, black line) under the stockpile and pipeline corridor.**

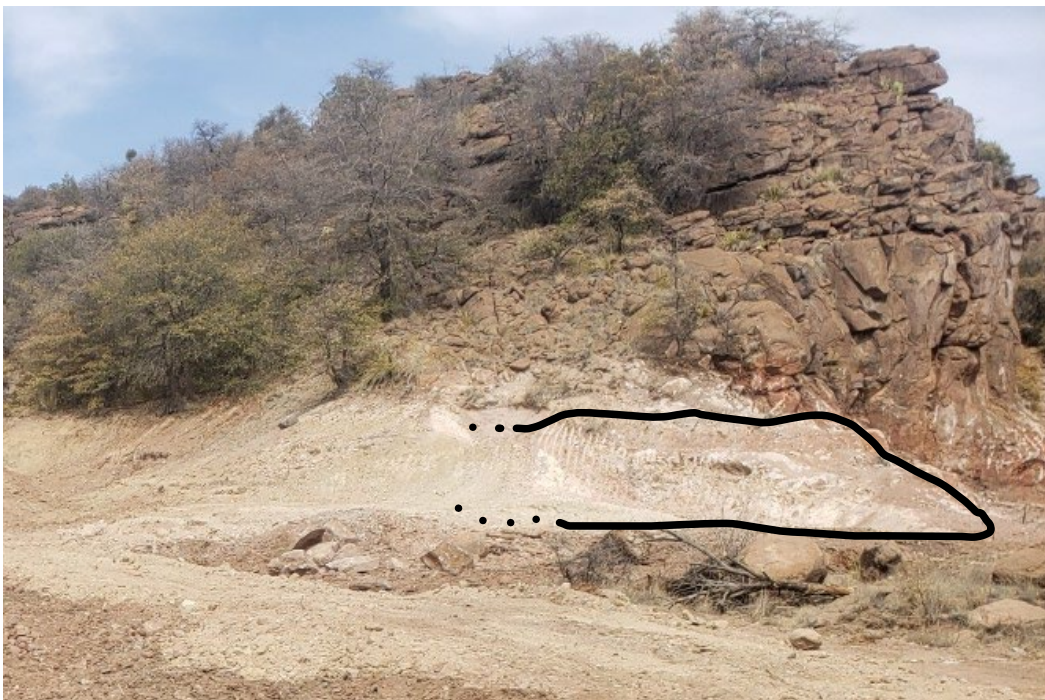
- Shaft 3 and Adit 1 – Ten areas ranging from 75 ft<sup>2</sup> to 15,519 ft<sup>2</sup> in size and between 0.5 and 6 feet deep were removed in the vicinity of these two features, including areas inside and outside of the adjacent drainage. In total, approximately 4,718 yd<sup>3</sup> was removed from this area. The excavation of stockpile material exposed a prominent ridge of the jasperoid vein at the mouth of Lucky Bill Canyon on its north wall, as discussed in Lasky, 1936 (see **Exhibit 7** below and Photograph 18, **Appendix B**).

**Exhibit 7 – Ridge of Jasperoid outcrop (black outline) at mouth of Lucky Bill Canyon following stockpile removal.**

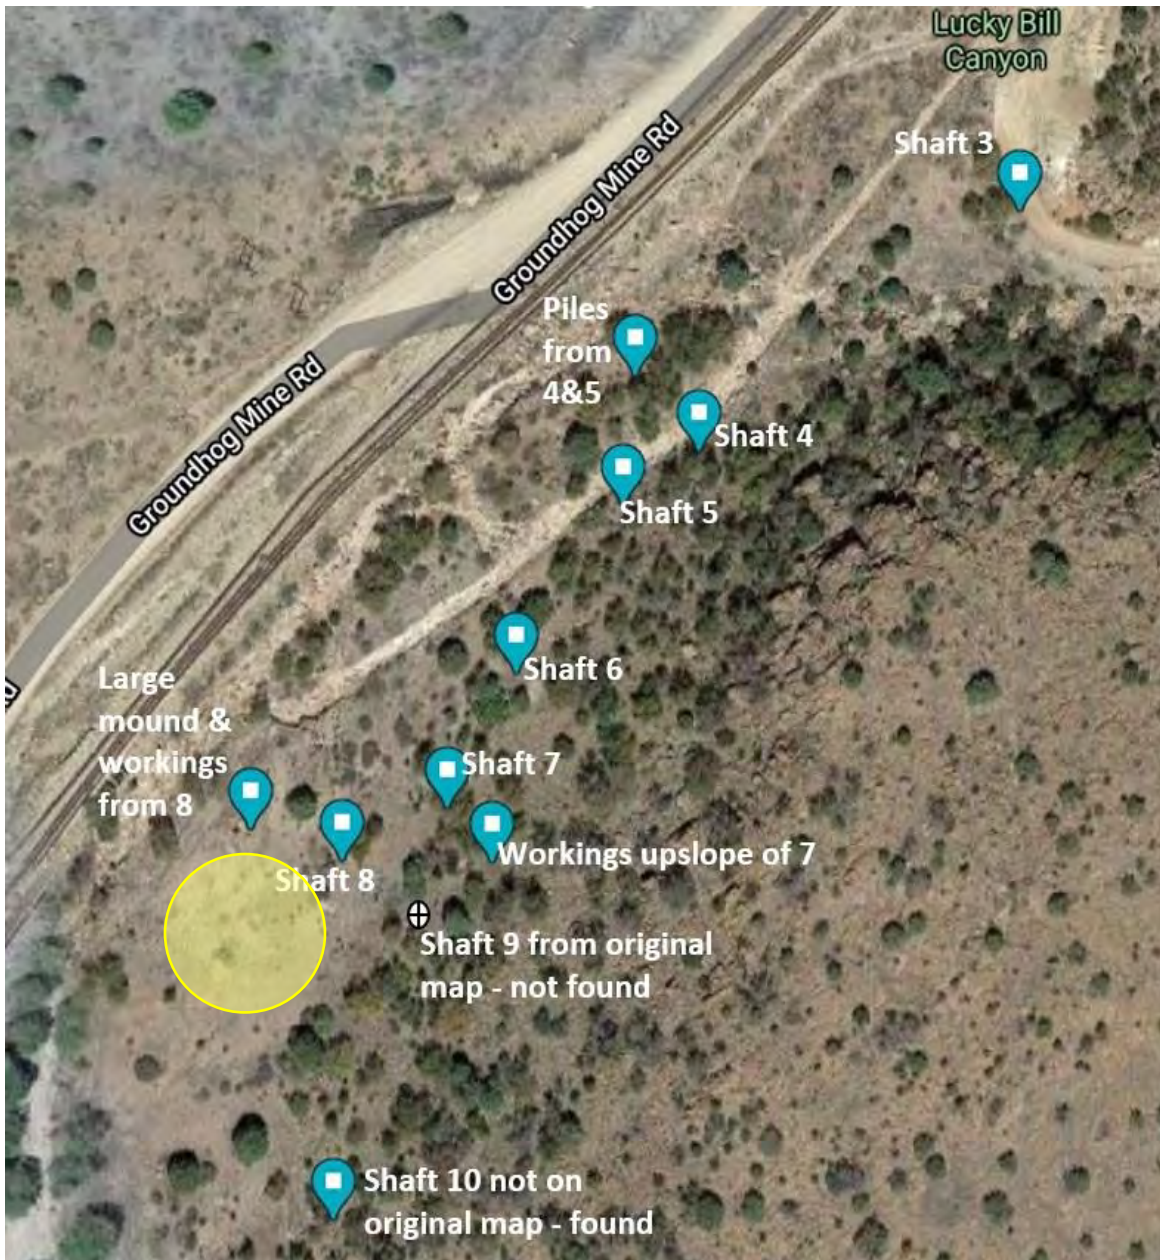
Figure 1: Central portion of site. Shared Services began excavation of surface material in broad area south of Shaft 8 and large mound.

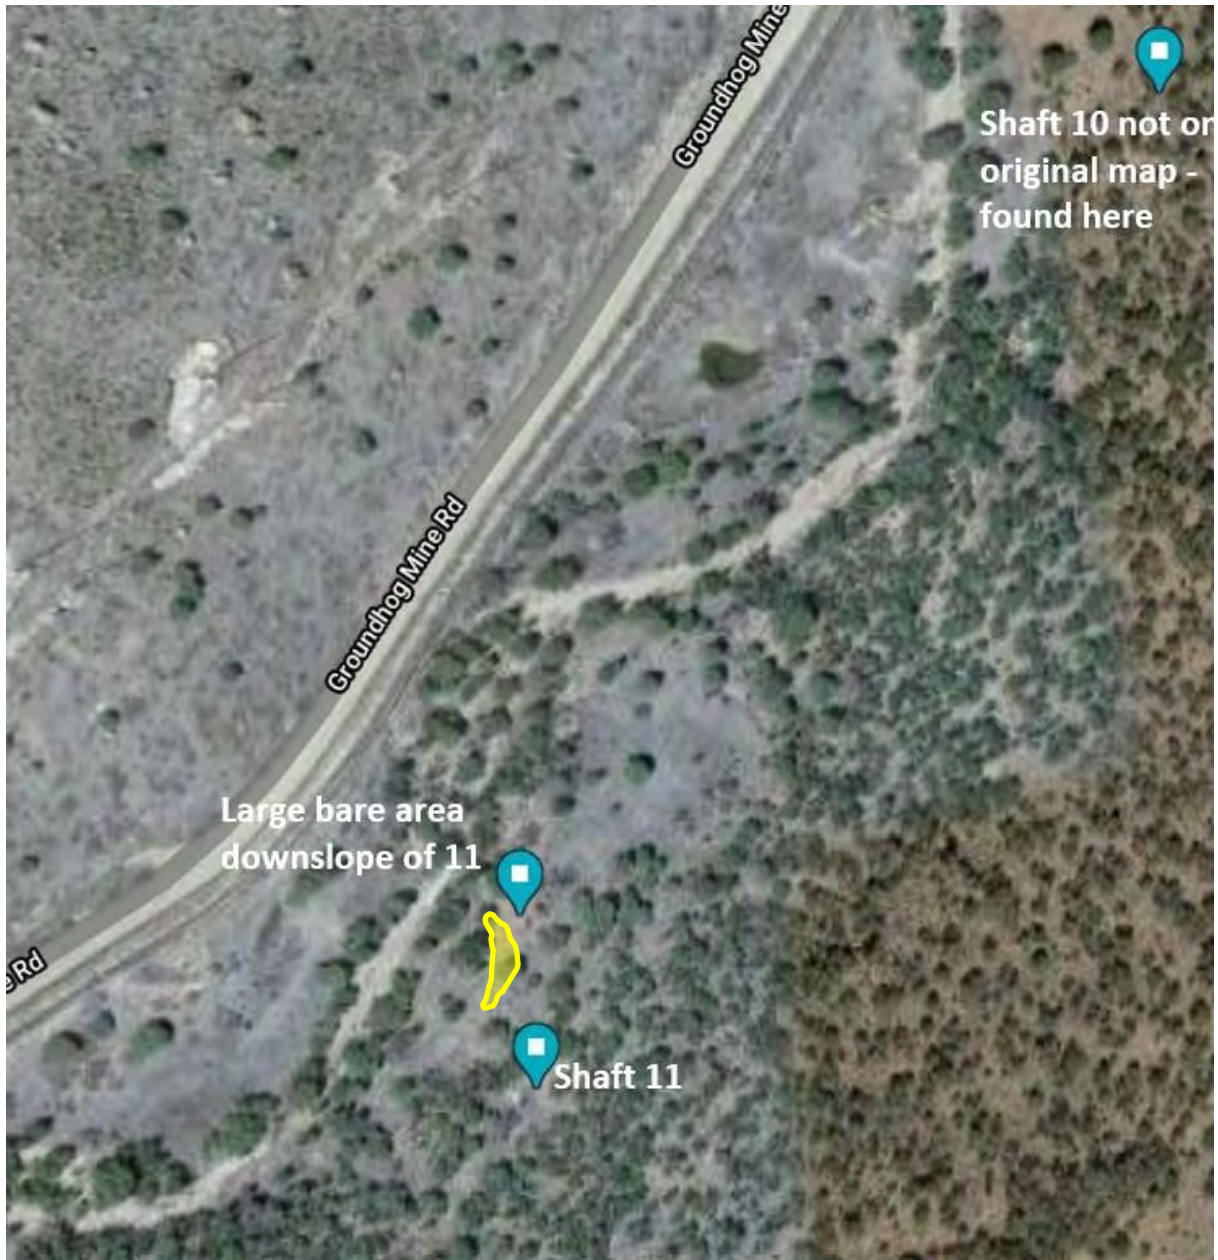
Figure 2: Southern portion of site. Shared Services removed soil from a broad shallow area at southernmost end.

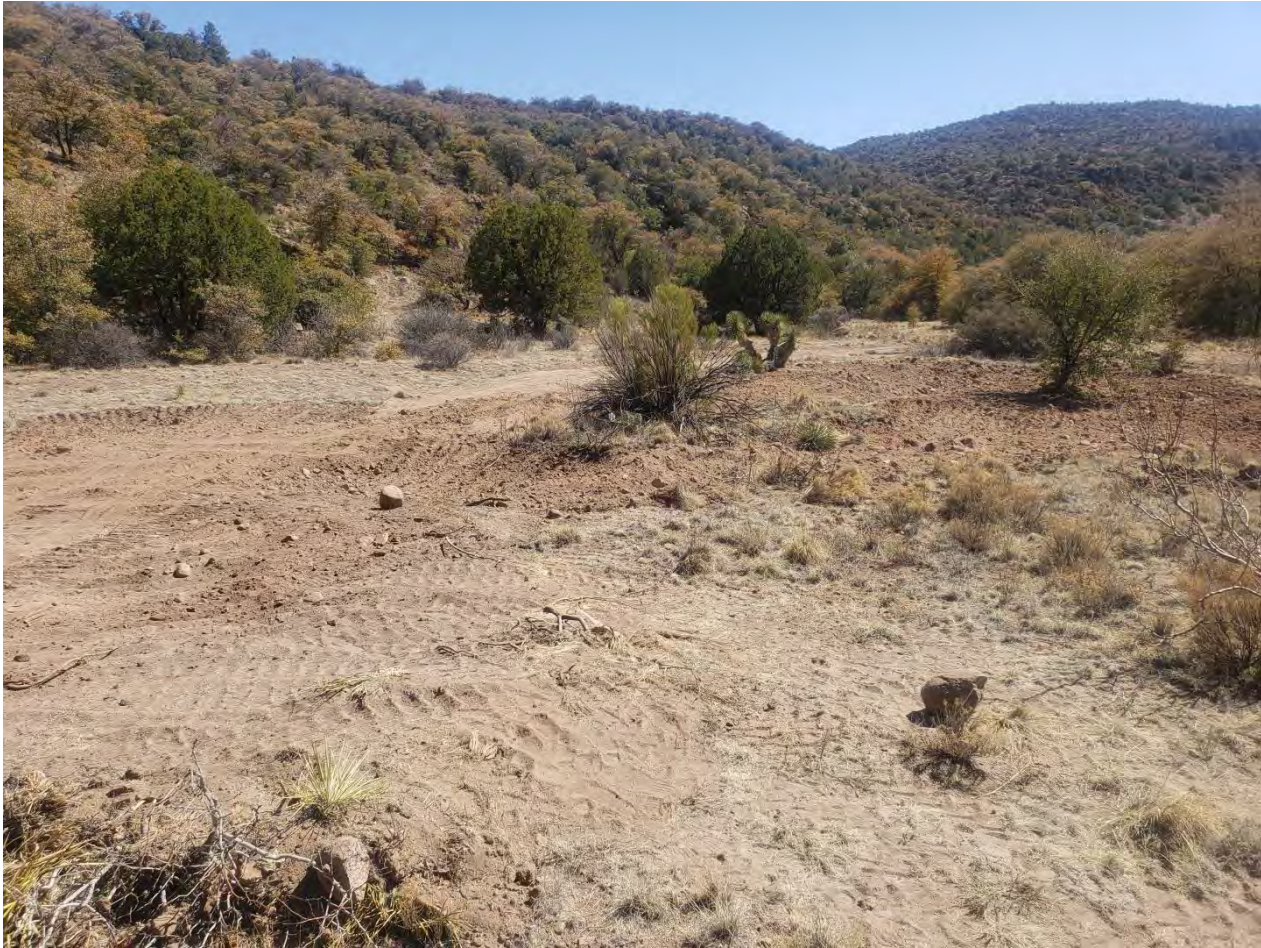
Photo 1: Shared Services removed red material from varying depths across broad area in central portion of jobsite.

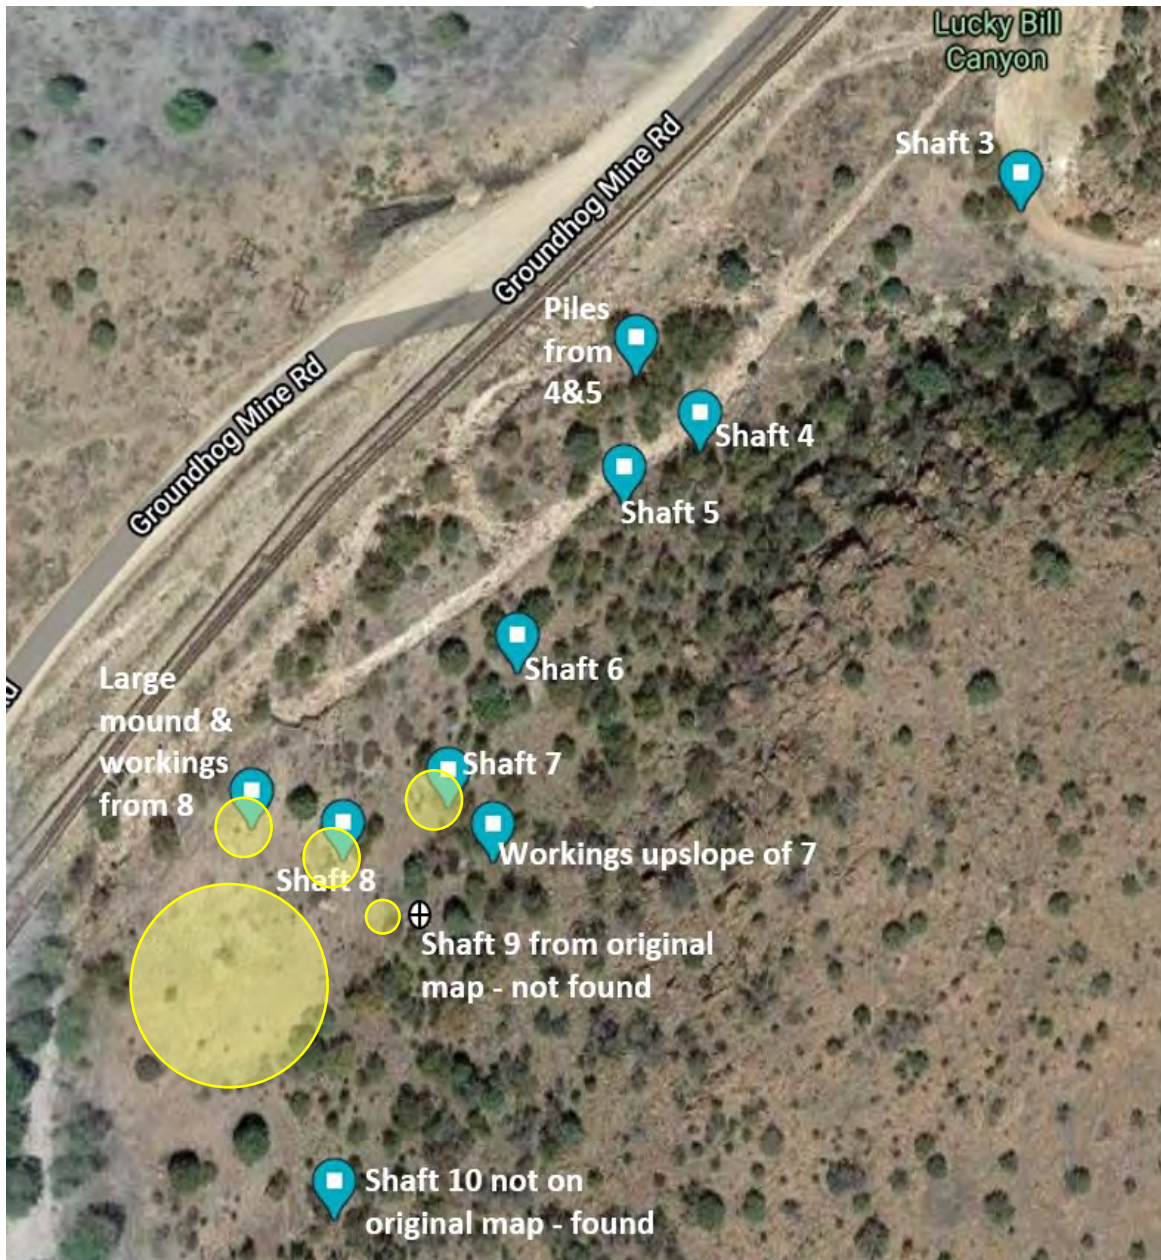
Figure 1: Central portion of site. Shared Services expanded boundaries and depth of primary excavation within large circle. Crew also removed soil associated with Shaft 7, Shaft 8, a large earthen mound, and a small reddish area east of Shaft 8.

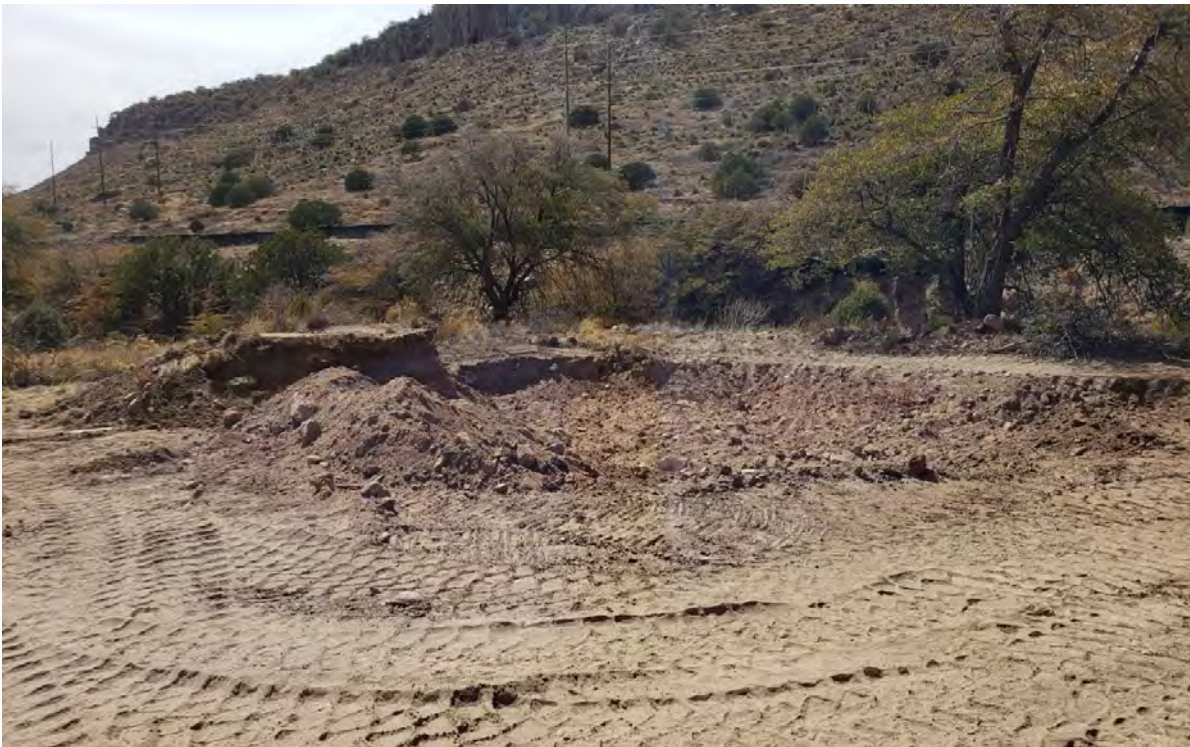
Photo 2: Material beneath a former mound was removed.

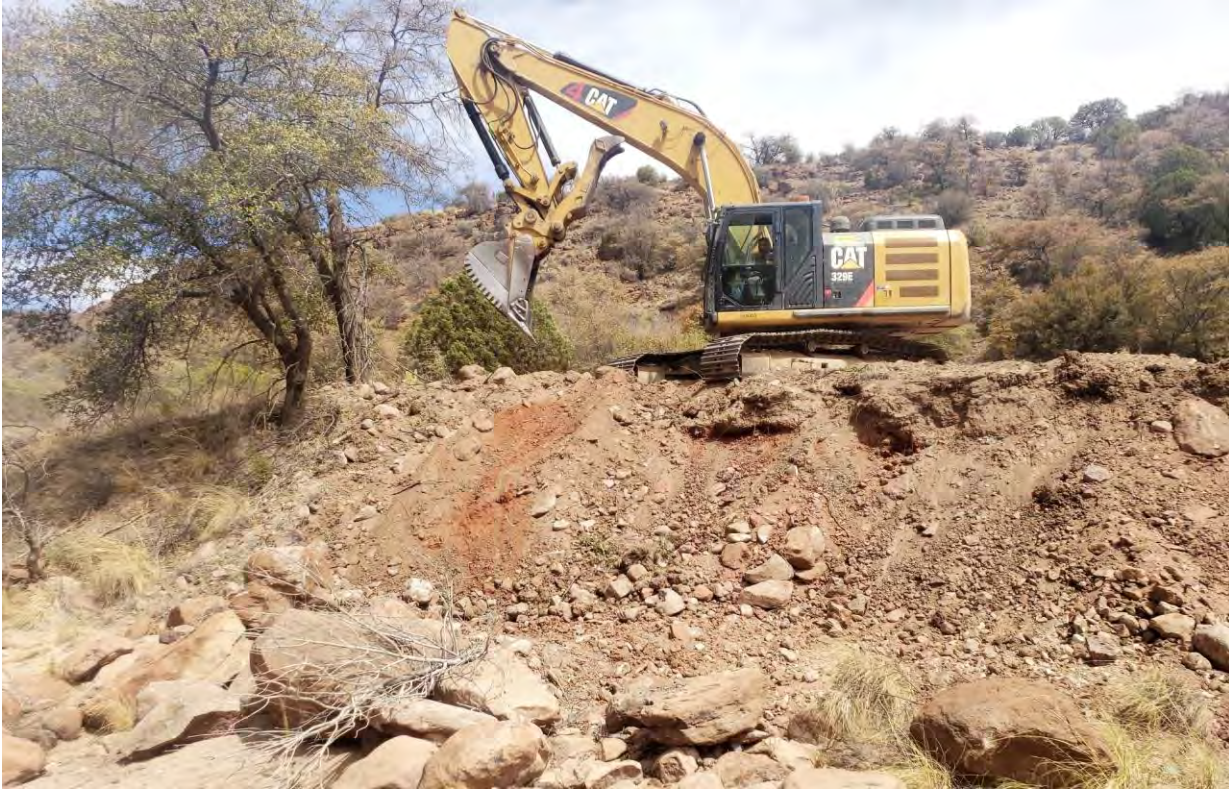
Photo 1: Shared Services removed red material from east bank of creek, adjacent to former mound

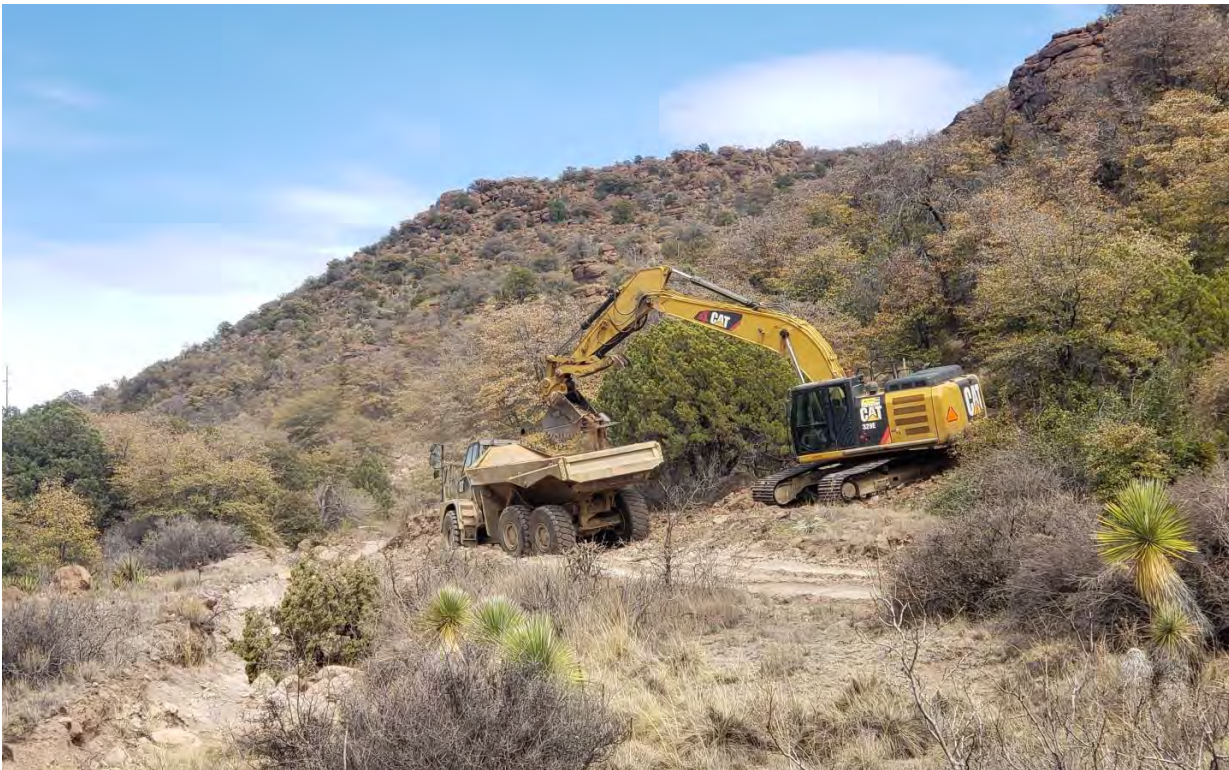
Photo 2: Material from above and around Shaft 6 was removed 4/15/21.

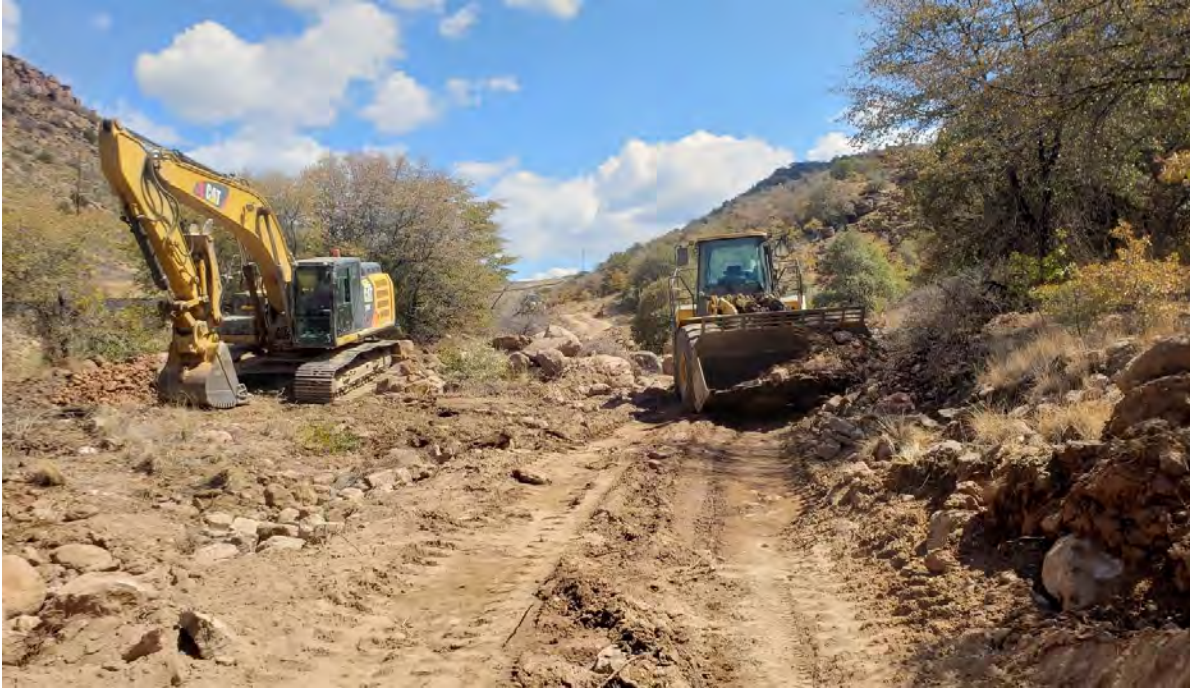
Photo 1: Shared Services removed stockpiled material east of access road (left) while also removing material from around Shafts 4 and 5 on west side of access road (right).

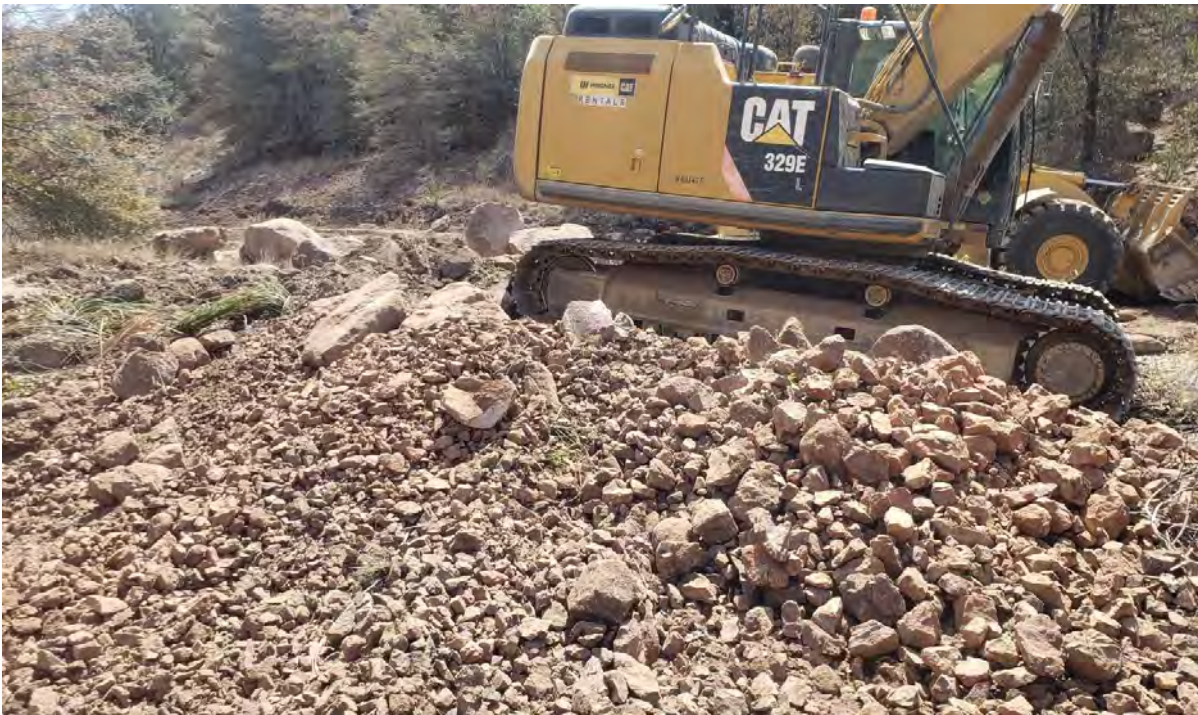
Photo 2: Small stockpiles east of Shafts 4 and 5 were gathered for removal.

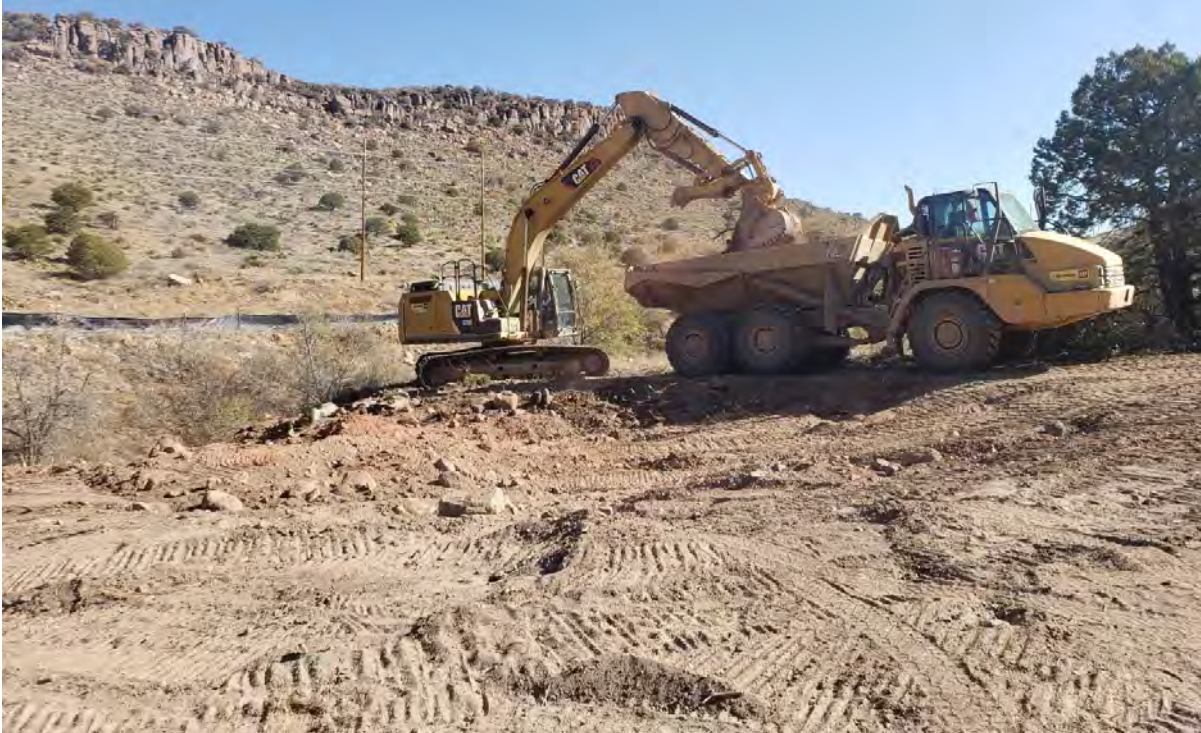
Photo 1: Shared Services continued removing red material from creek bank west of Shaft 8.

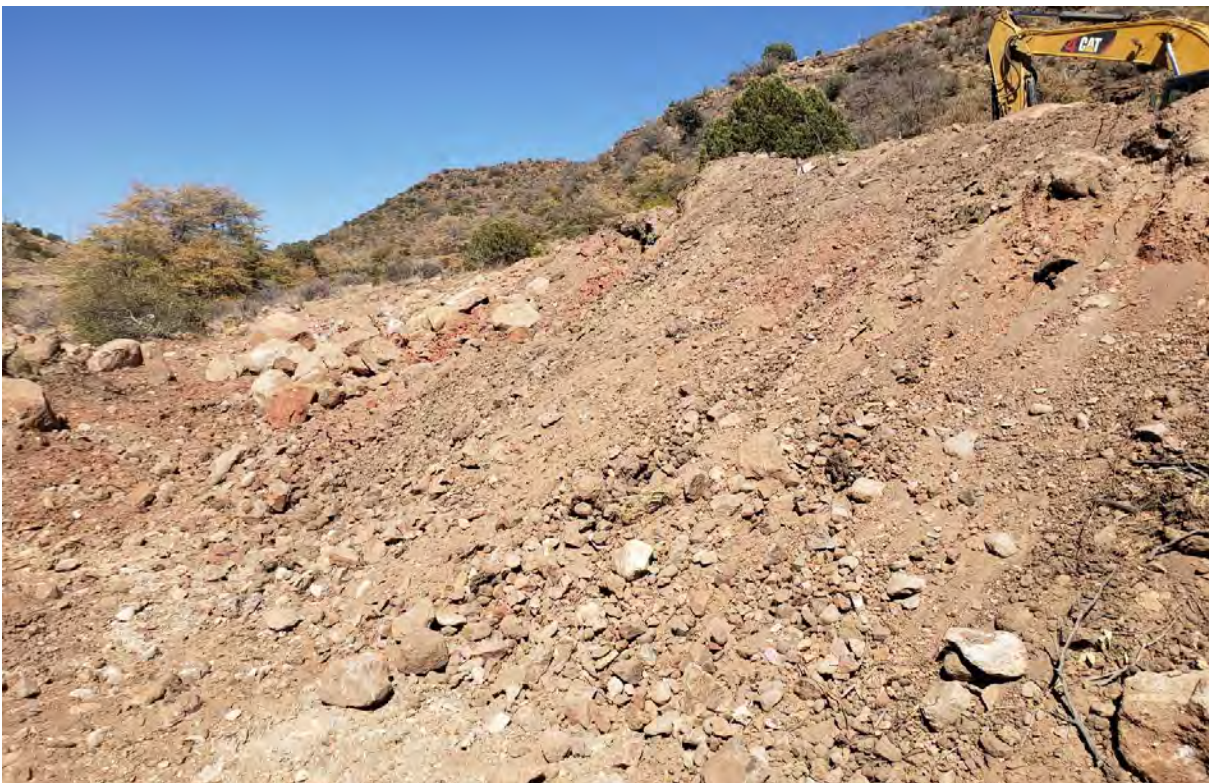
Photo 2: After full day of removing red material from same location along creek bank, red material was beginning to taper off.

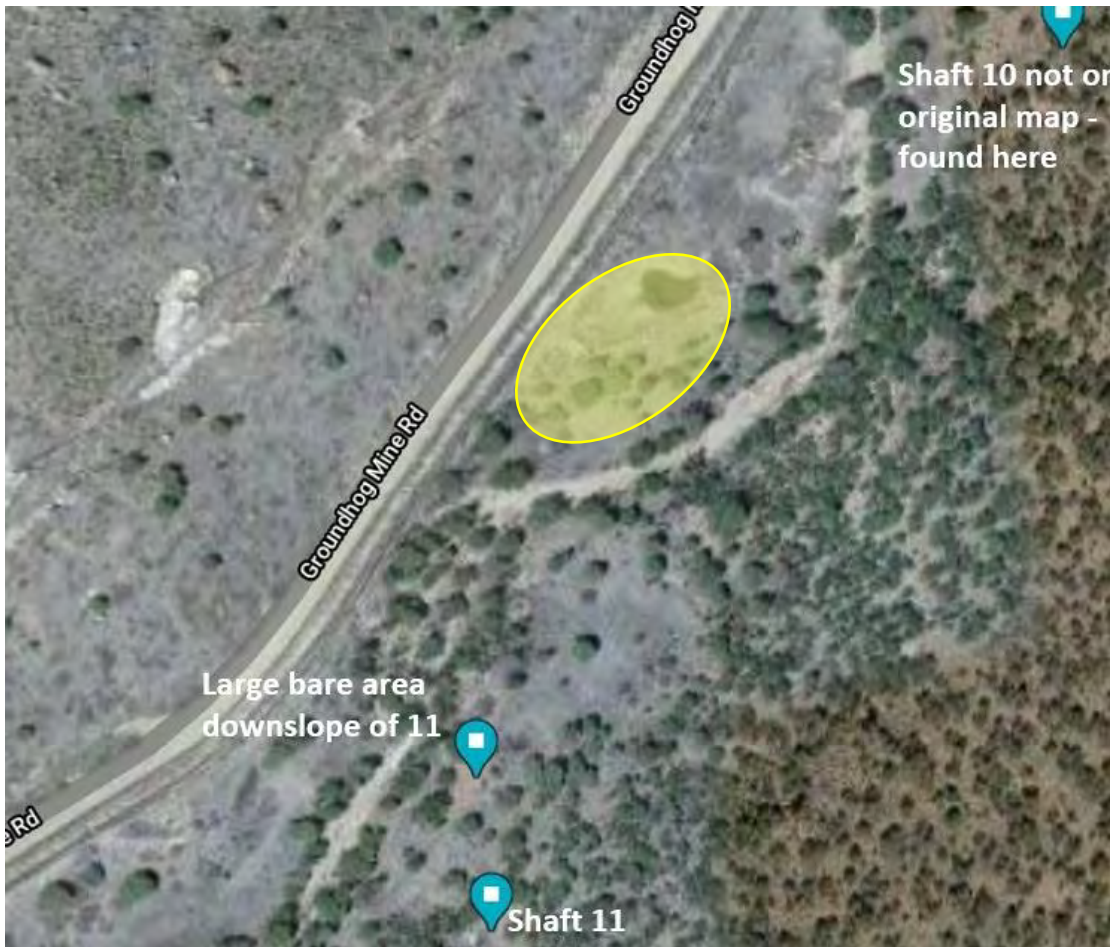
**Figure 2: Southern Area.** Shared Services used dozer to stockpile backfill material from designated borrow source onsite.

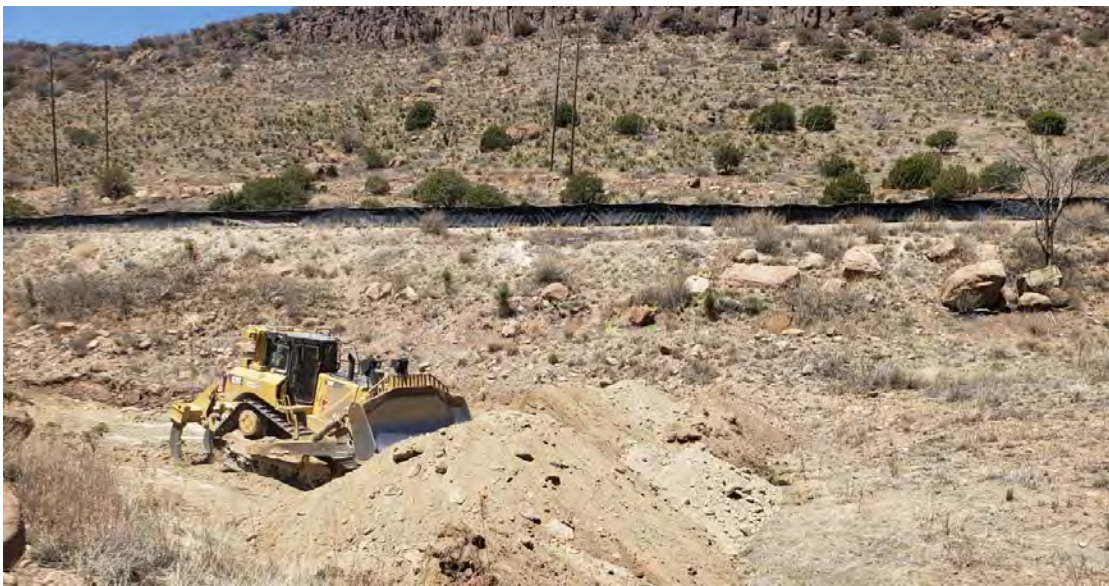
**Photo 1:** D8 dozer stockpiling backfill material at borrow source as shown in Figure 2.

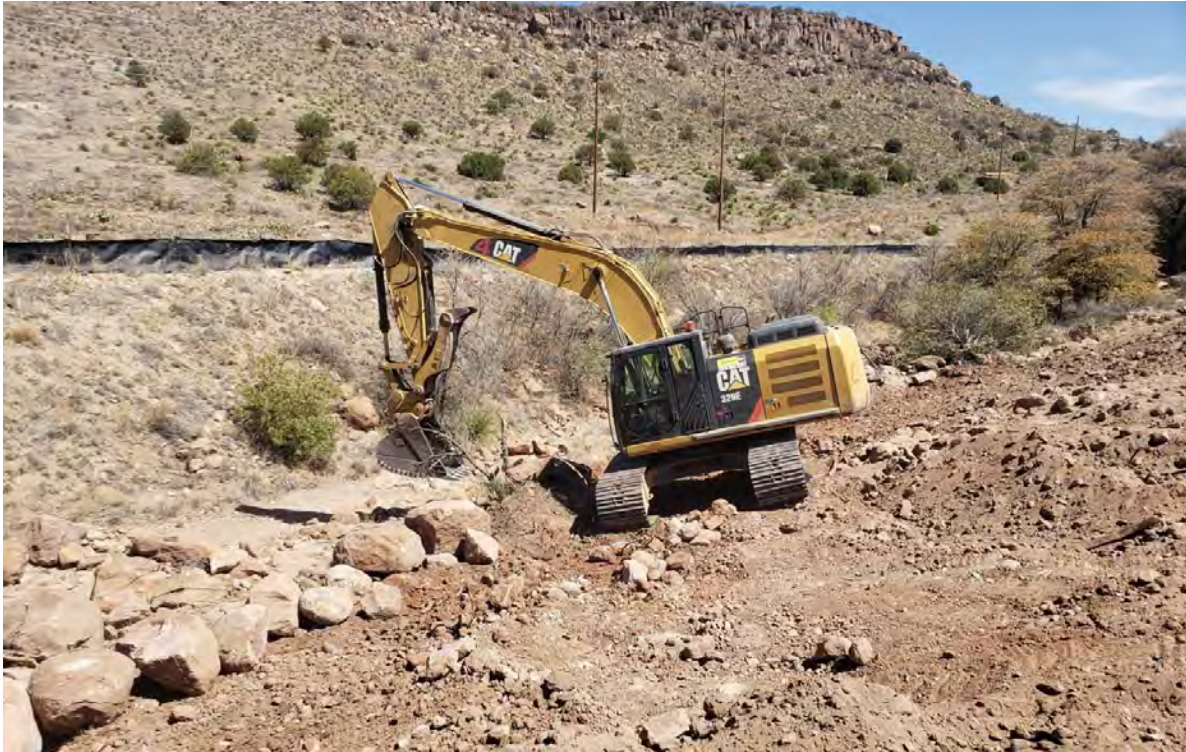
**Photo 2:** Primary focus of day was removing red material from creek bank west of Shaft 8 and placing existing boulders along toe of new slope for backfill stabilization.

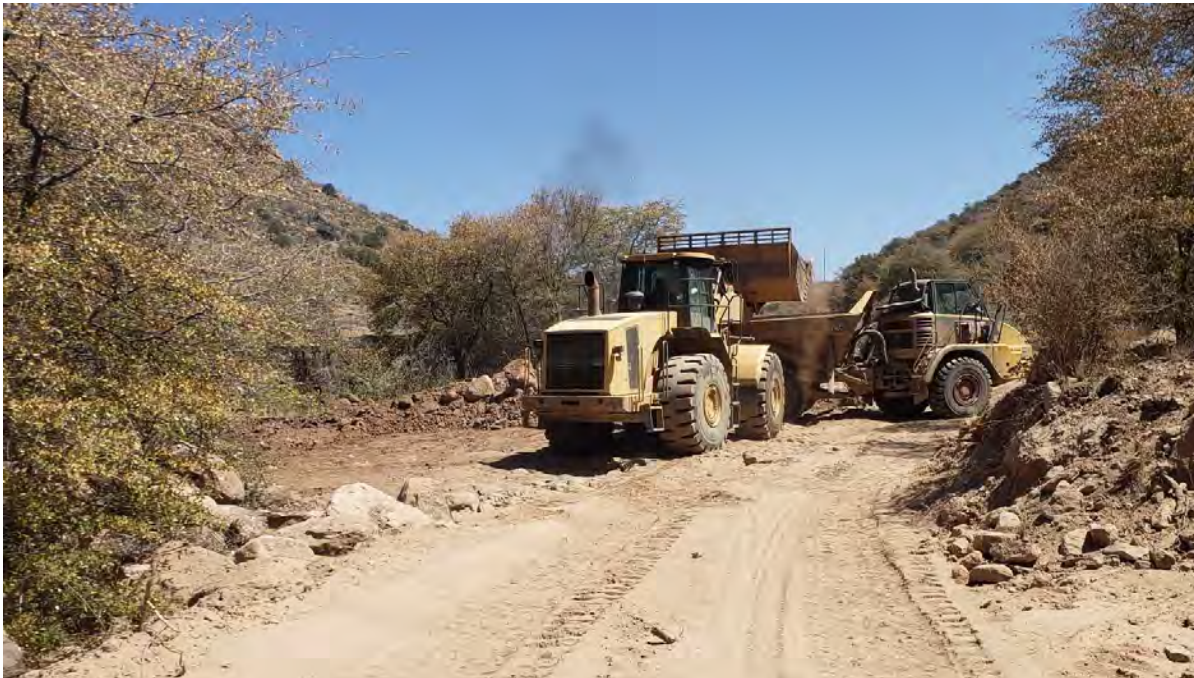
**Photo 3:** Using loader to remove stockpiles of reddish material across from Shafts 4 & 5.

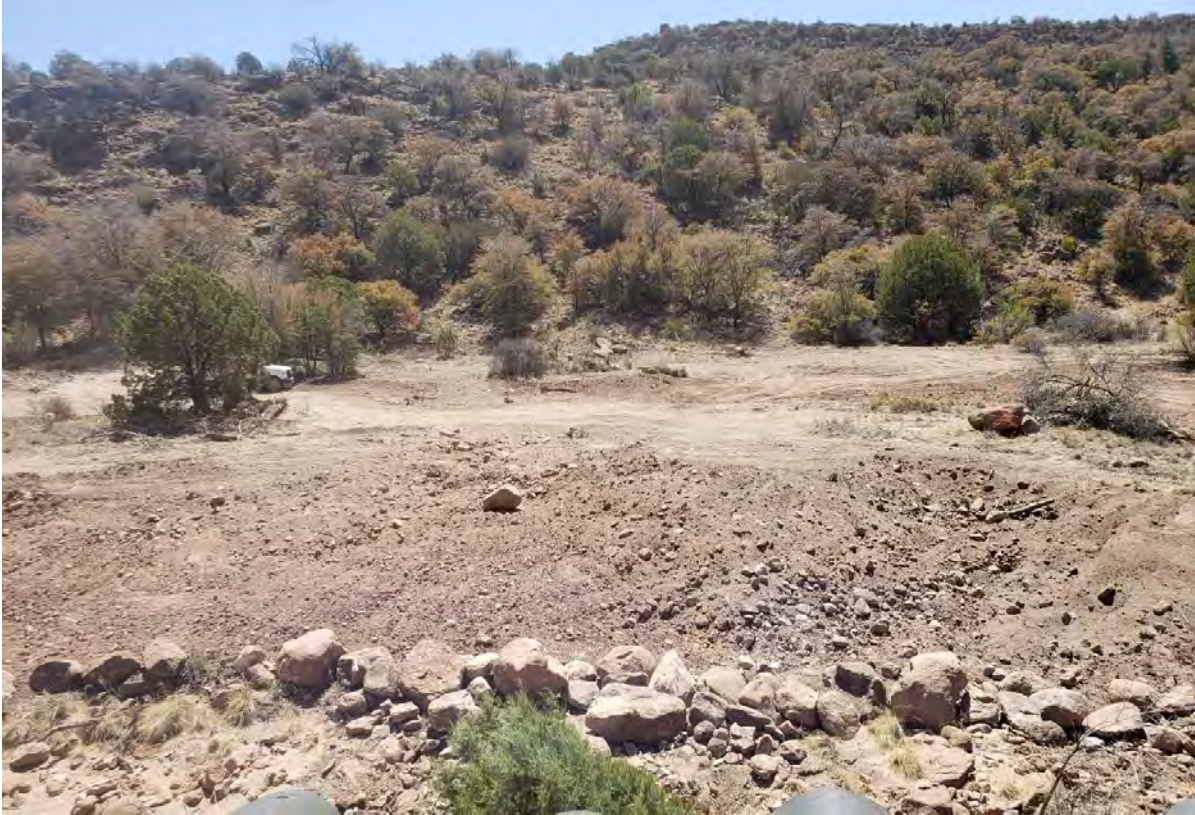
**Photo 1:** Excavation is complete in large area and creek bank near Shaft 8.

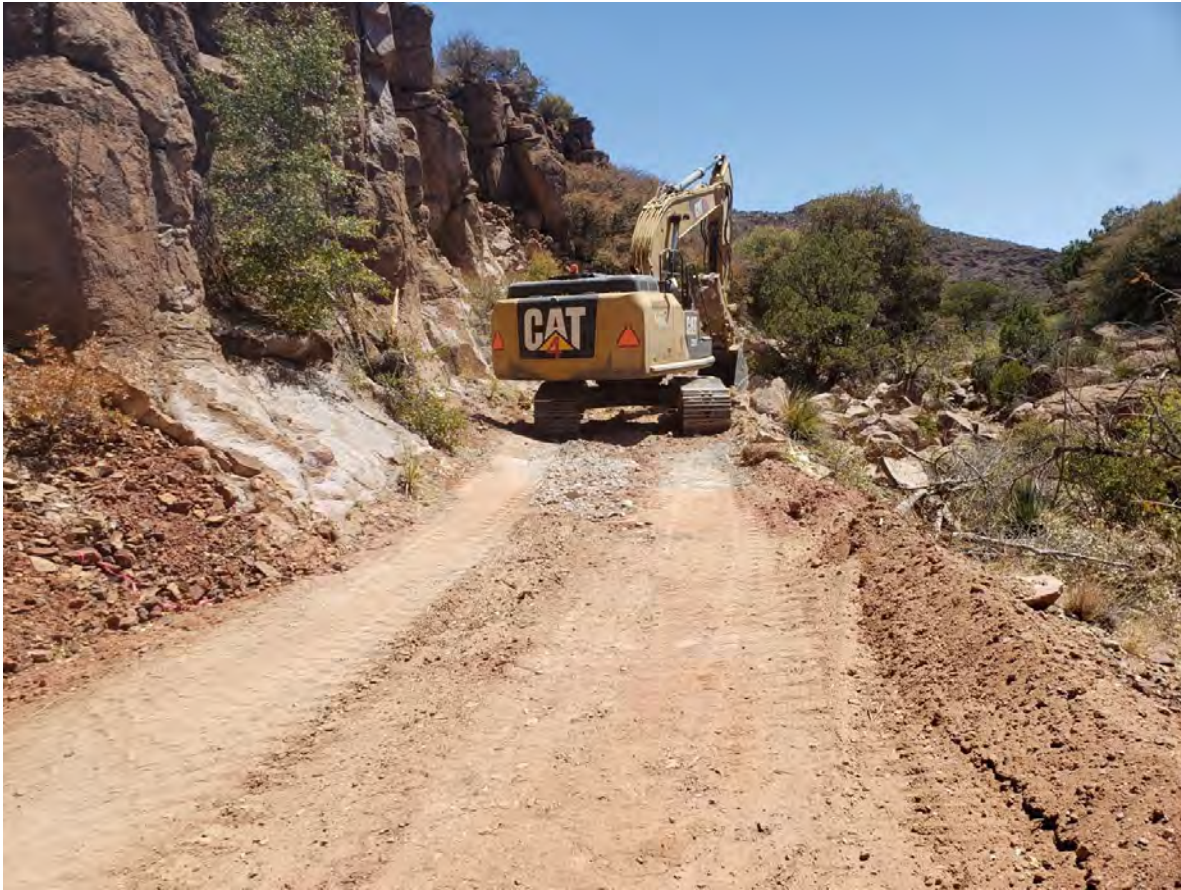
**Photo 3:** Removal of red, yellow, and gray material comprising road into Lucky Bill Canyon.

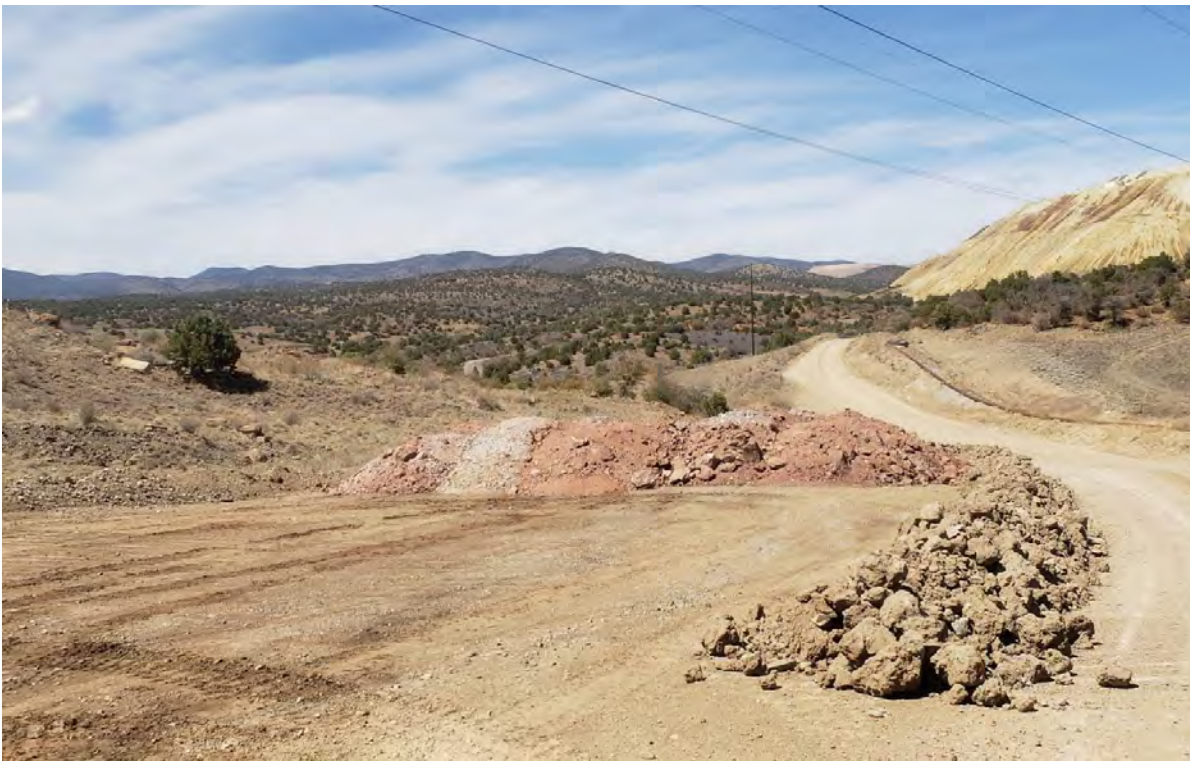
**Photo 2:** Shared Services built containment berms for a new stockpile and began hauling to it.

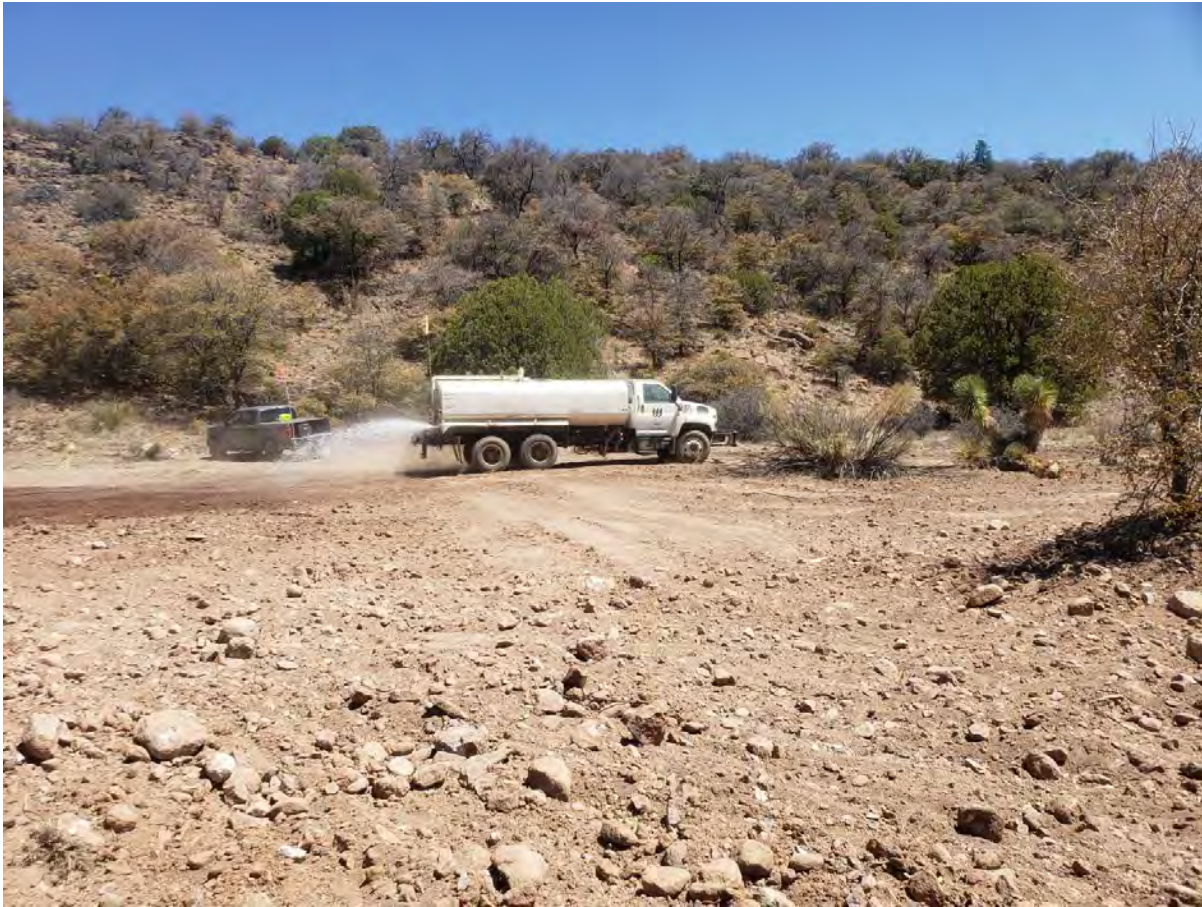
**Photo 3:** Recently-repaired water truck was used for dust suppression on haul roads and both stockpiles.
