# **BAYARD CANYON SUPPLEMENTAL INTERIM REMOVAL ACTION COMPLETION REPORT**

Hanover Whitewater Creek Investigation Unit  
Vanadium, New Mexico

July 2022

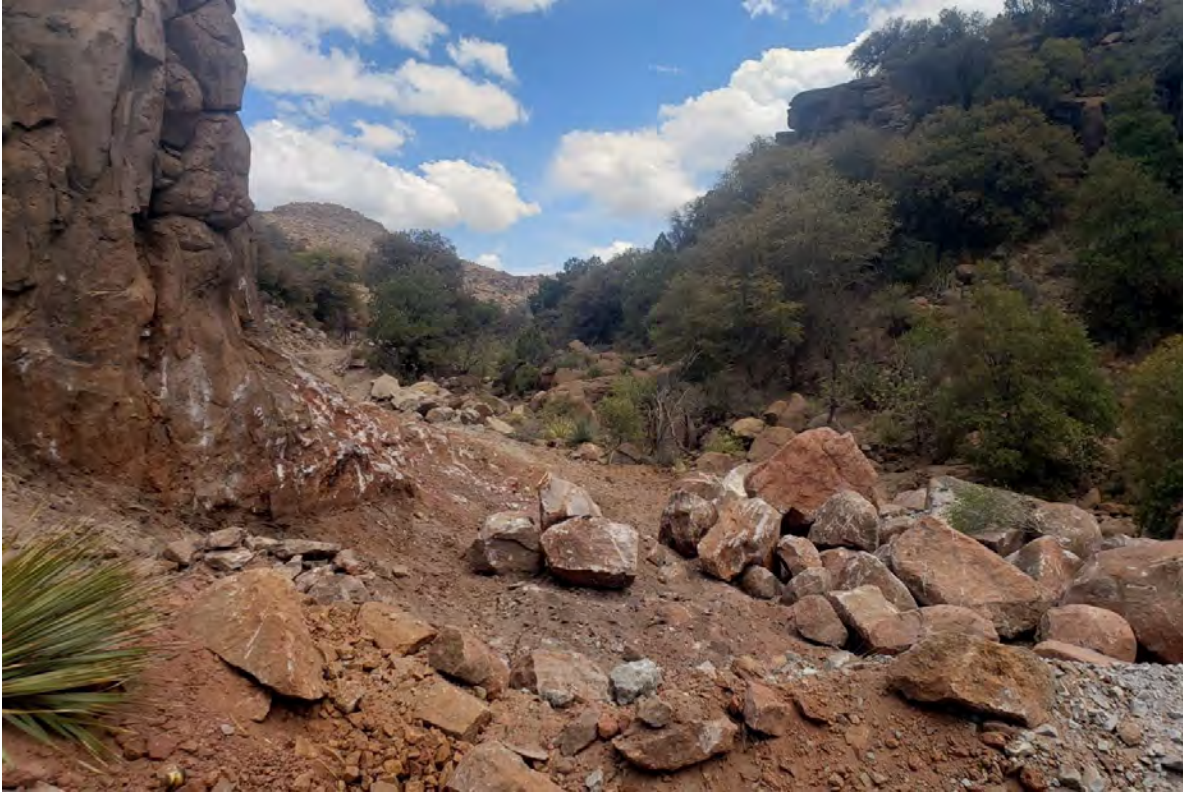
**Photo 1:** Shared Services continued removing material from the former road near Shaft 3 at the confluence with Lucky Bill Canyon.

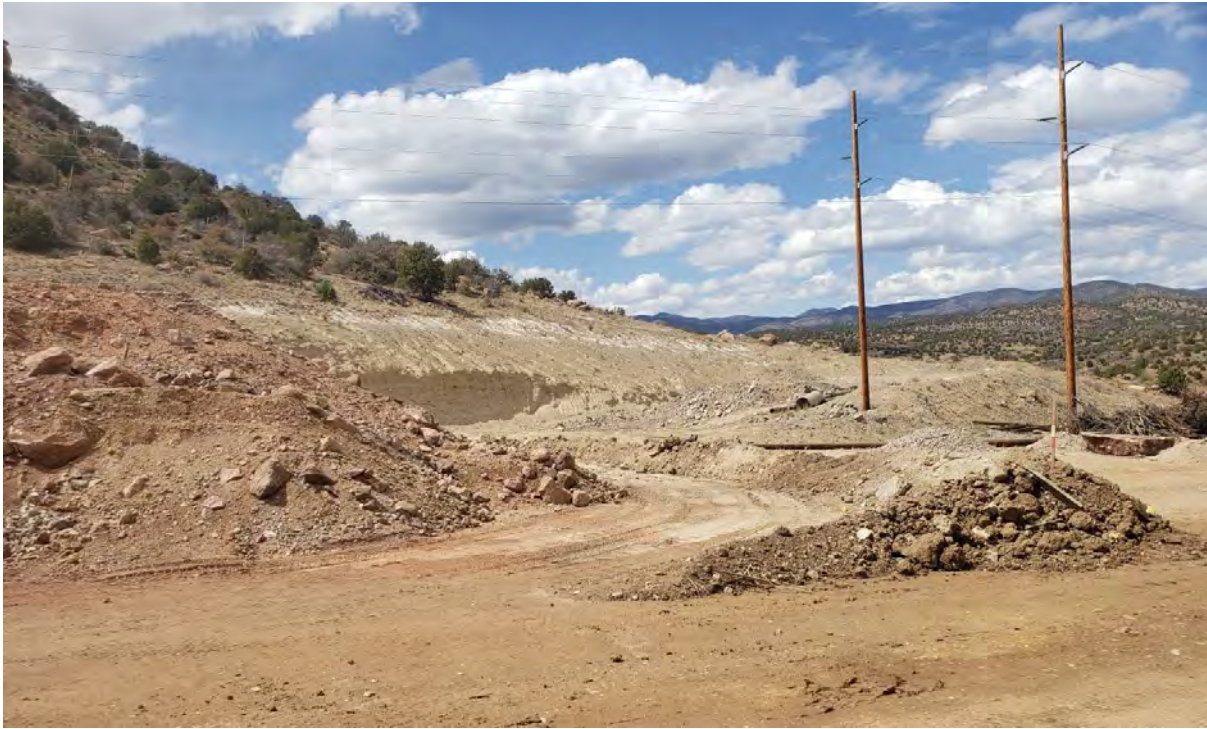
**Photo 3:** Shared Services built an outer berm (right) for better containment of the original stockpile.

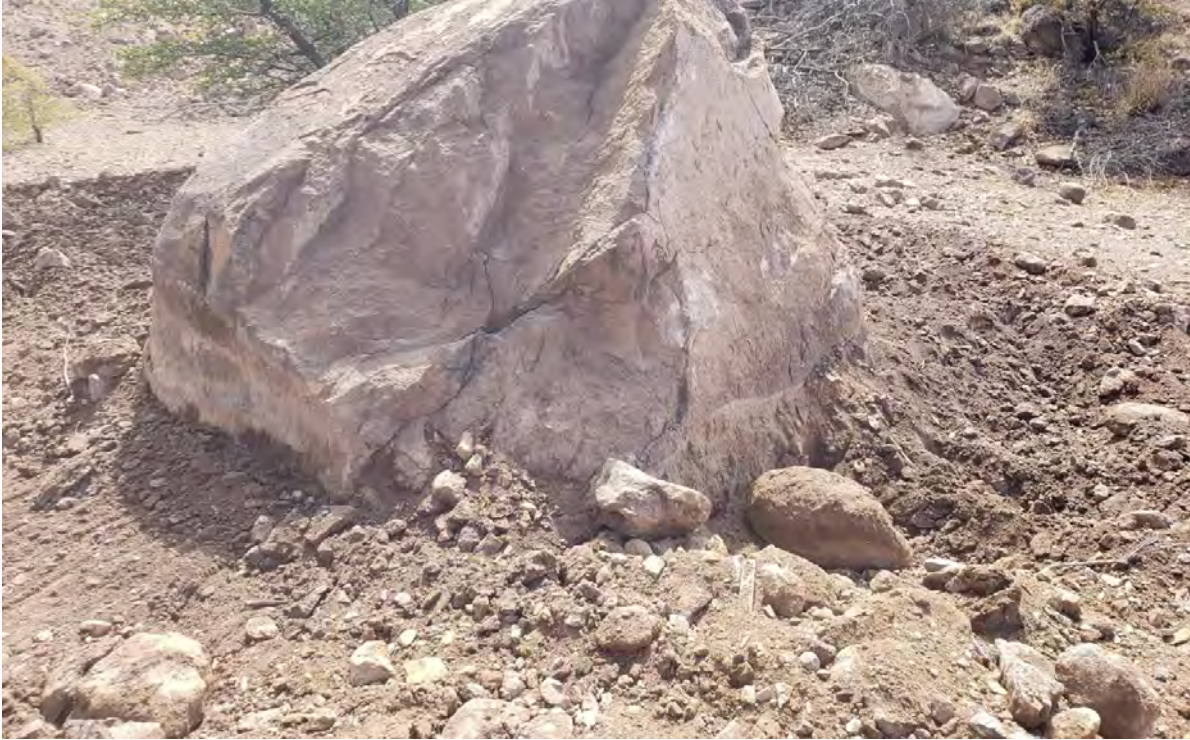
**Photo 1:** Shared Services removed 1 load of reddish material from the creek bed that had deposited around this large boulder.

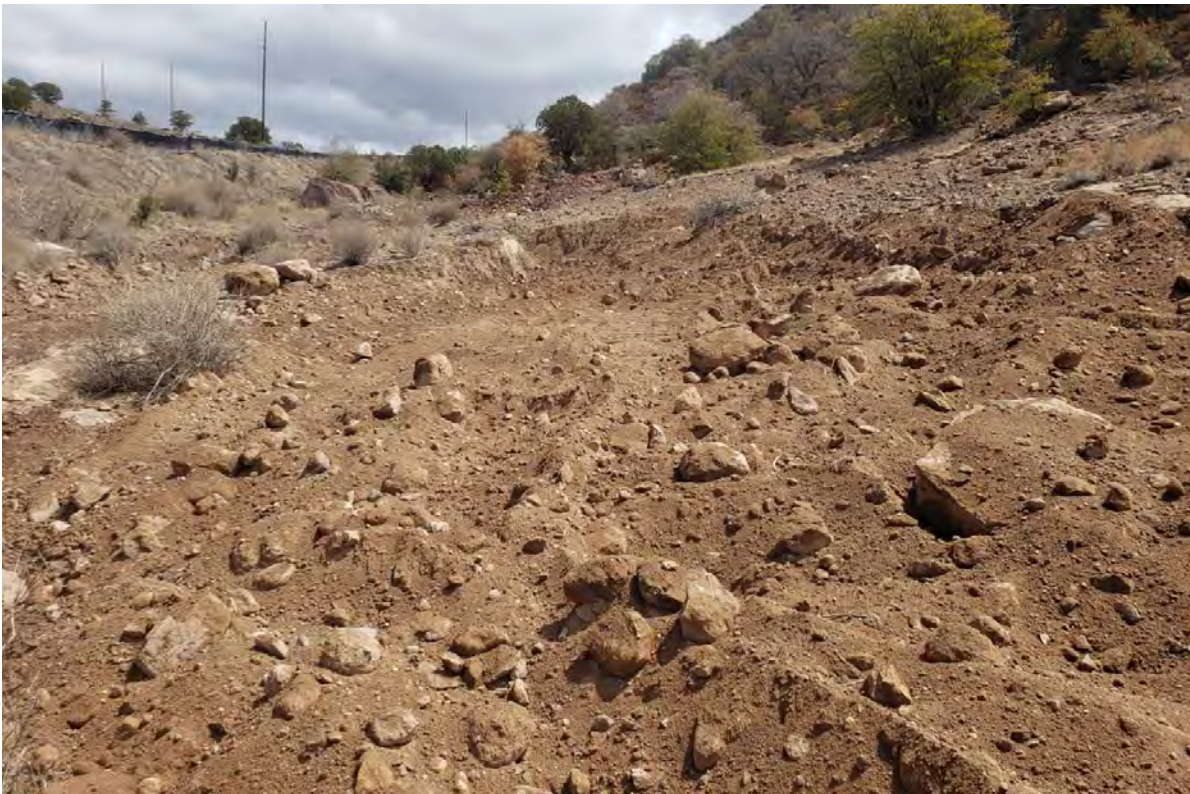
**Photo 2:** Shared Services removed reddish material from the creek below Shaft 2.

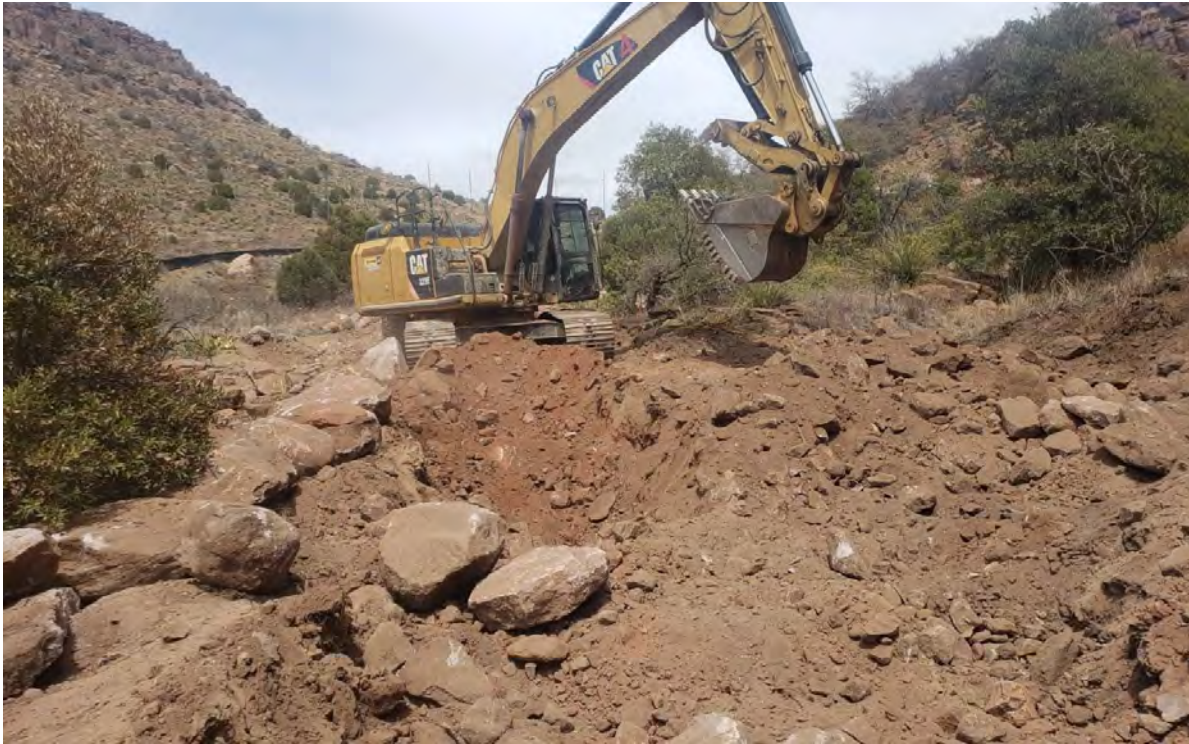
**Photo 3:** While removing surface material from small flagged locations along access road, Shared Services encountered unexpectedly thick layers of reddish material.

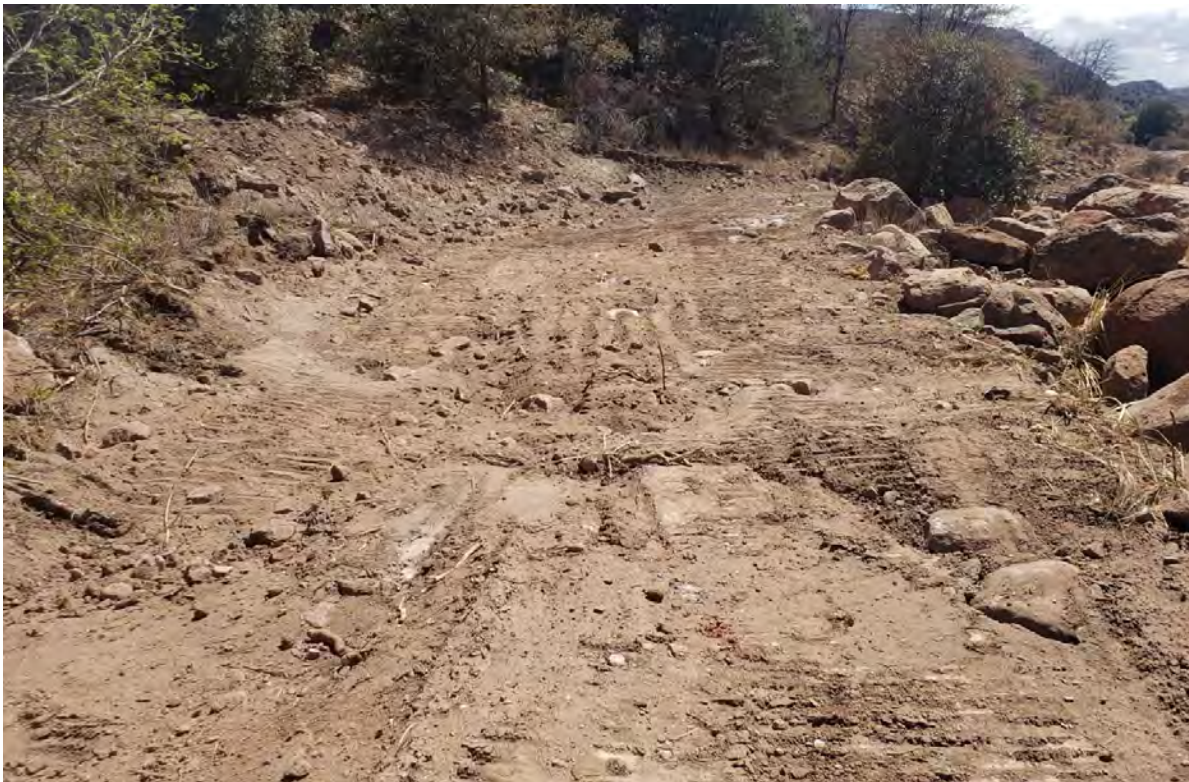
**Photo 4:** Shared Services rebuilt the access road after removing ~2 feet of reddish material.

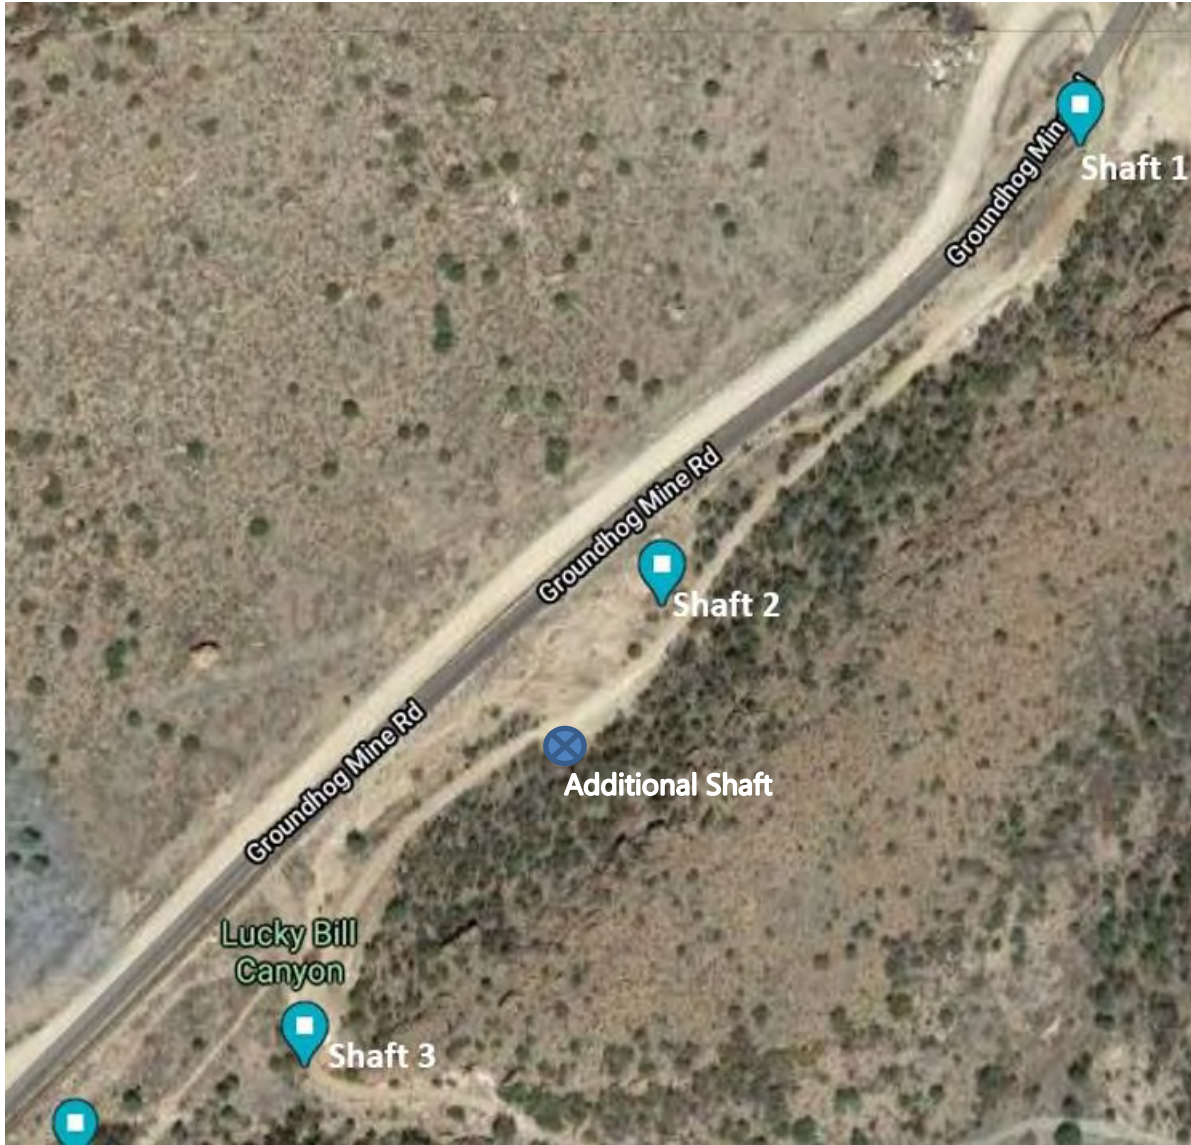
**Figure 2: Northern Area.** An additional shaft location was identified (above) where removal and mounding will be required.

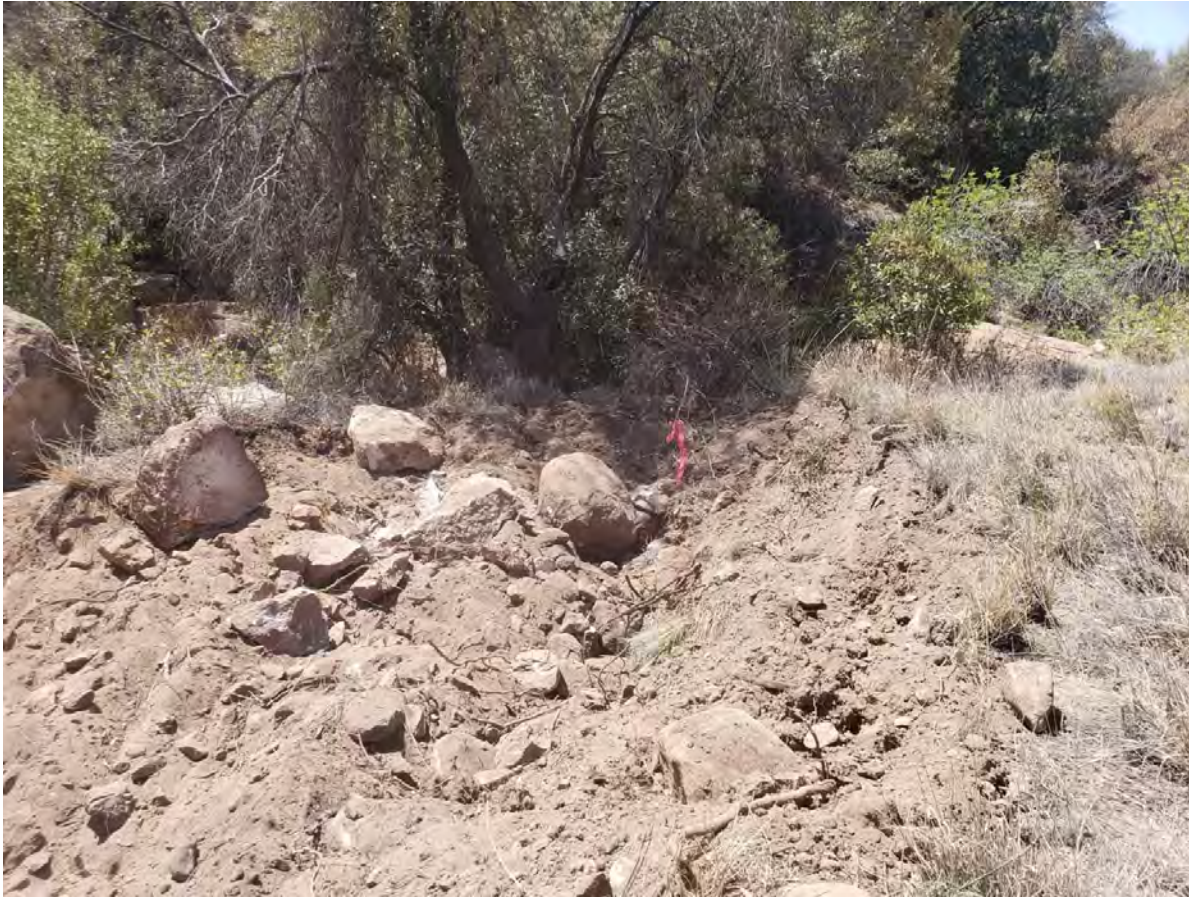
- Excavator focused removal effort most of day at Shaft 3 and 2 areas below it. Surface areas that Pam and York flagged last week for removal below Shaft 3 turned out to be relatively shallow lenses of red material.
- Water truck used throughout day for dust control on roads and stockpiles.
- Dozer and loader used for stockpile consolidation.

**Photo 3:** Flagged areas below Shaft 3 had relatively shallow lenses of red material.

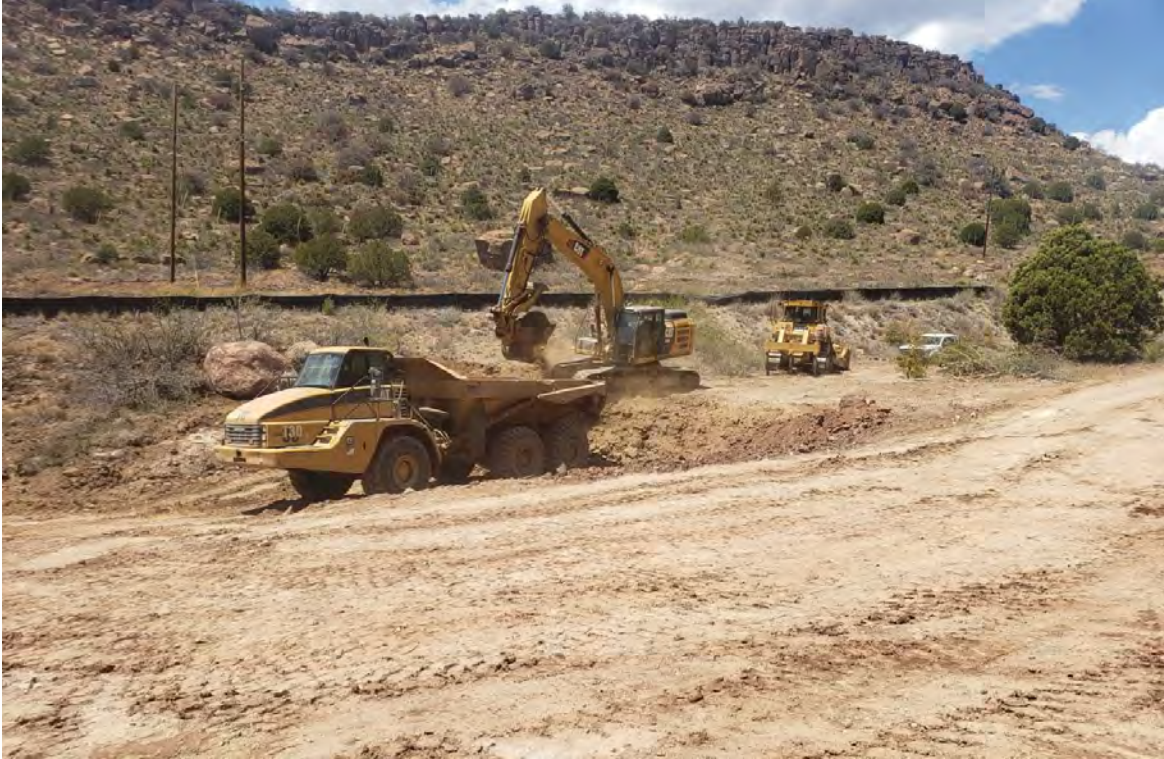
**Photo 1:** Shared Services began removing 8'-thick layer of yellowish material from platform in creek bed near entrance to Lucky Bill Canyon.

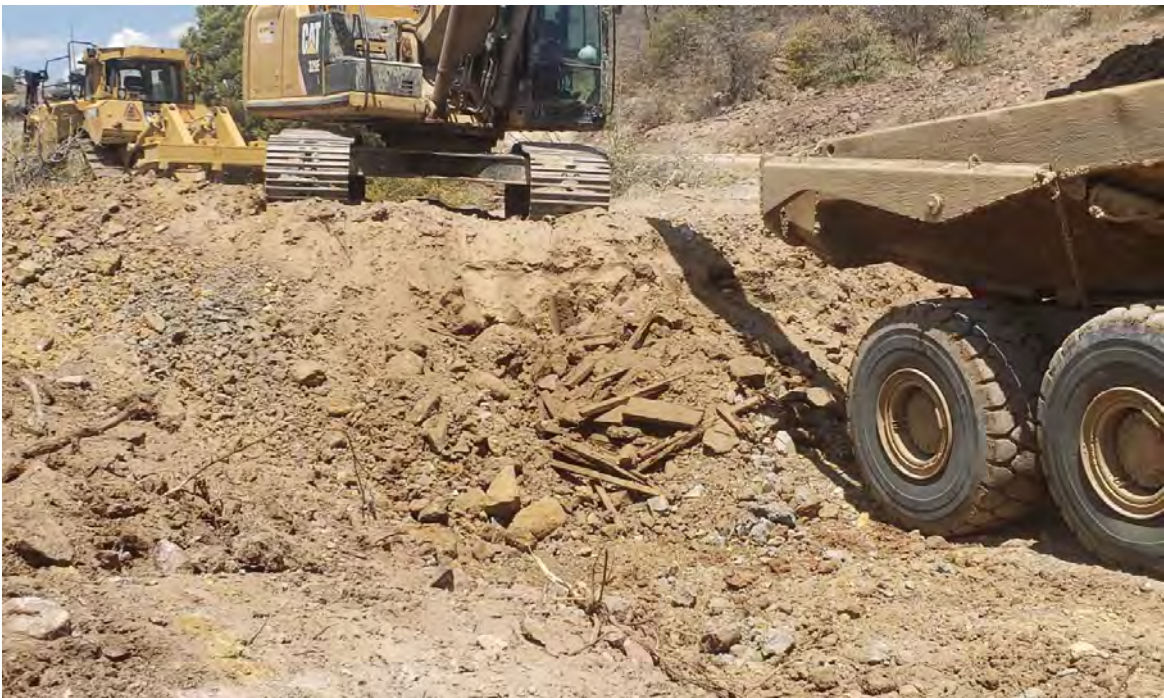
**Photo 2:** Crew encountered lumber amid yellowish waste material at location shown in Photo 1.

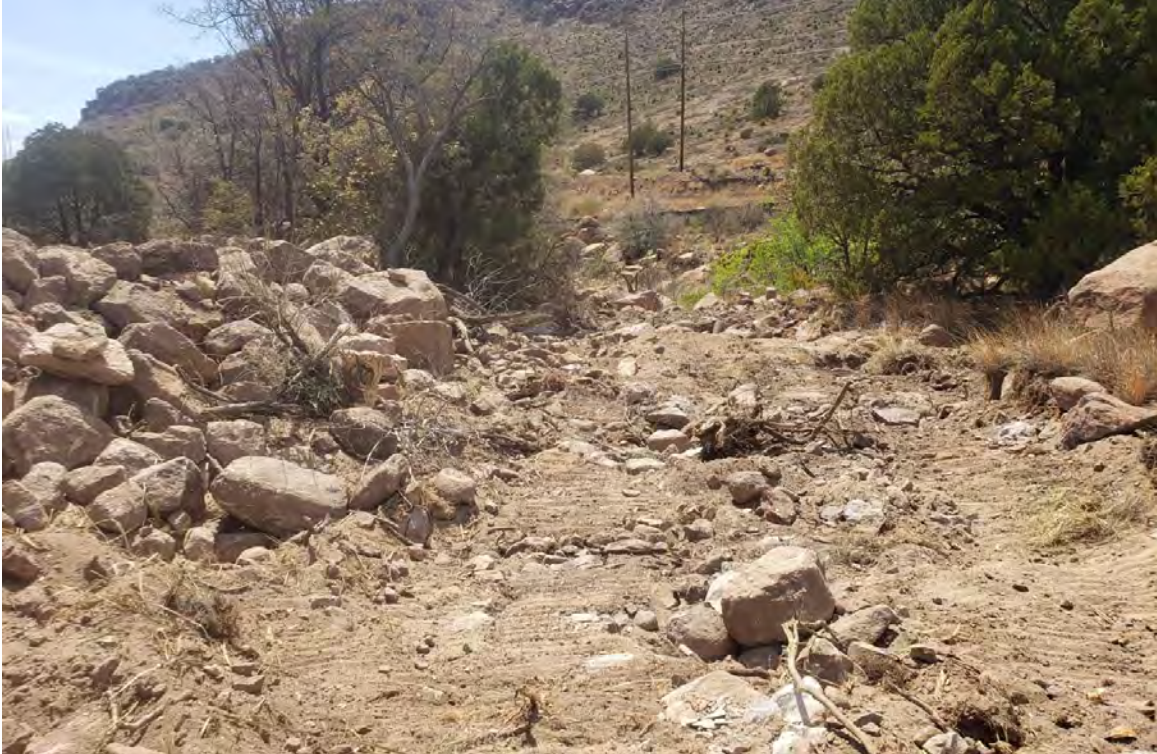
**Photo 3:** Crew re-established original creek channel from Lucky Bill into Bayard – using boulders (left – above) to reinforce bank.

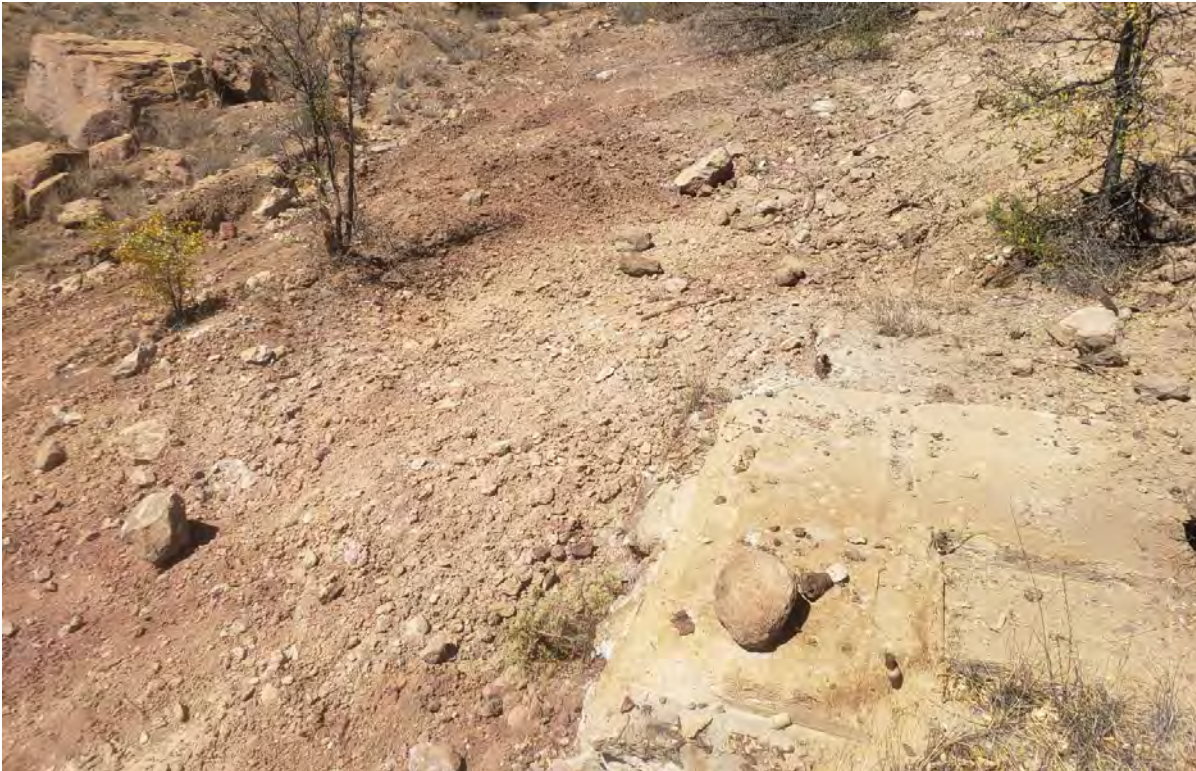
**Photo 2:** Crew removed red material near Shaft 2. Could not remove concrete without breaking it.

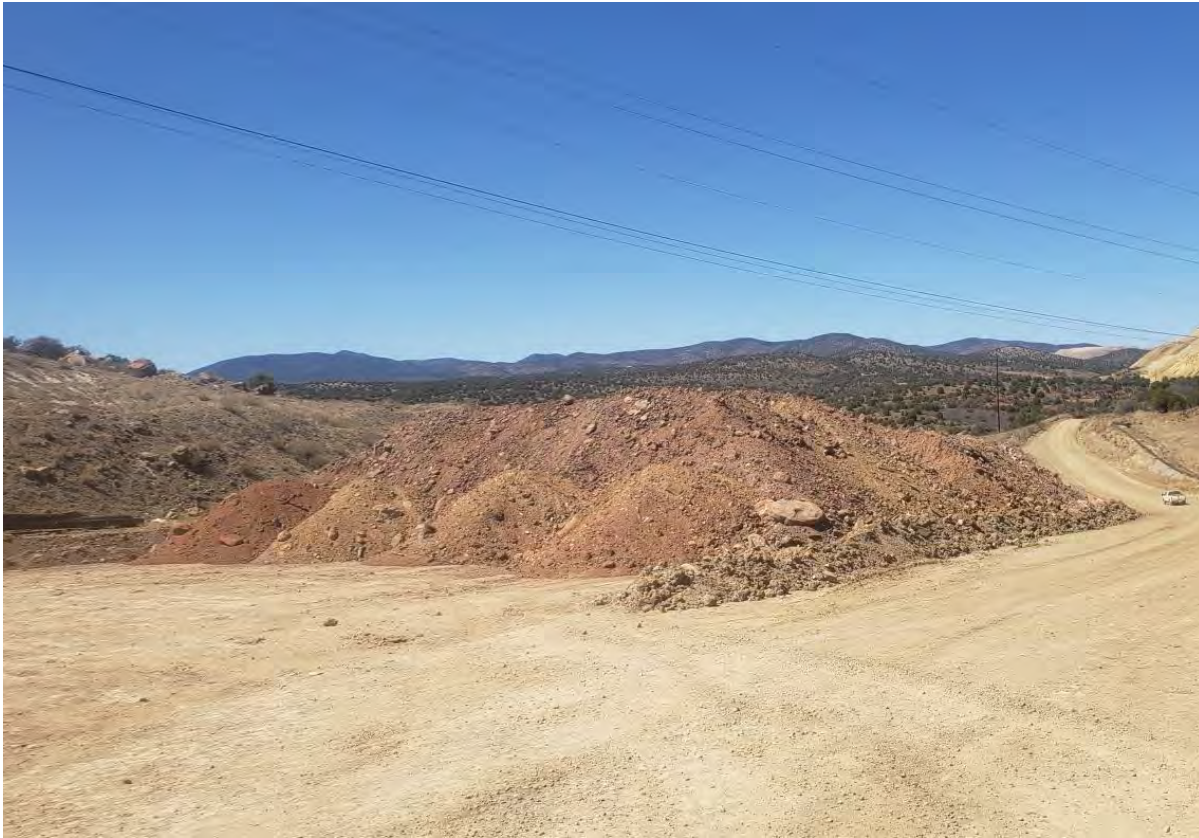
**Photo 3:** Second stockpile boundary will need to be expanded in the next day or 2 to accommodate additional removal material.

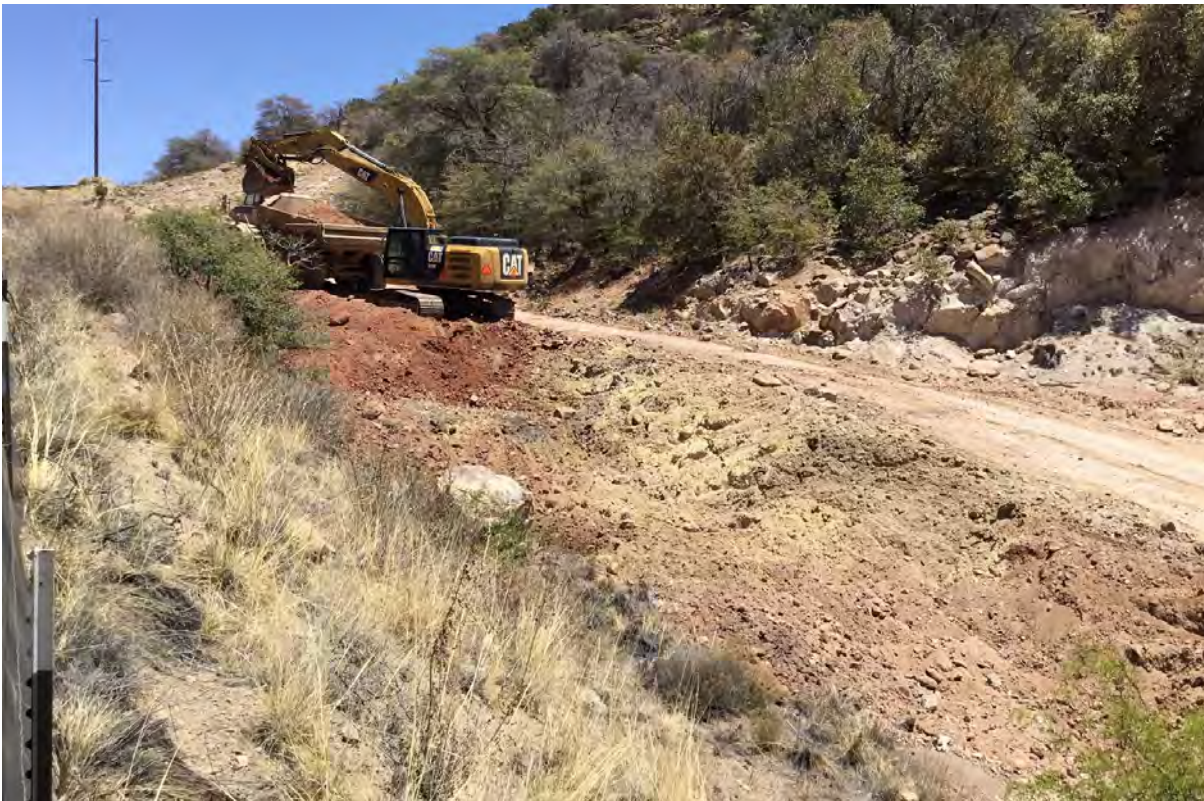
**Photo 2:** Crew removed red material near Shaft 1. Yellow material will be removed also.

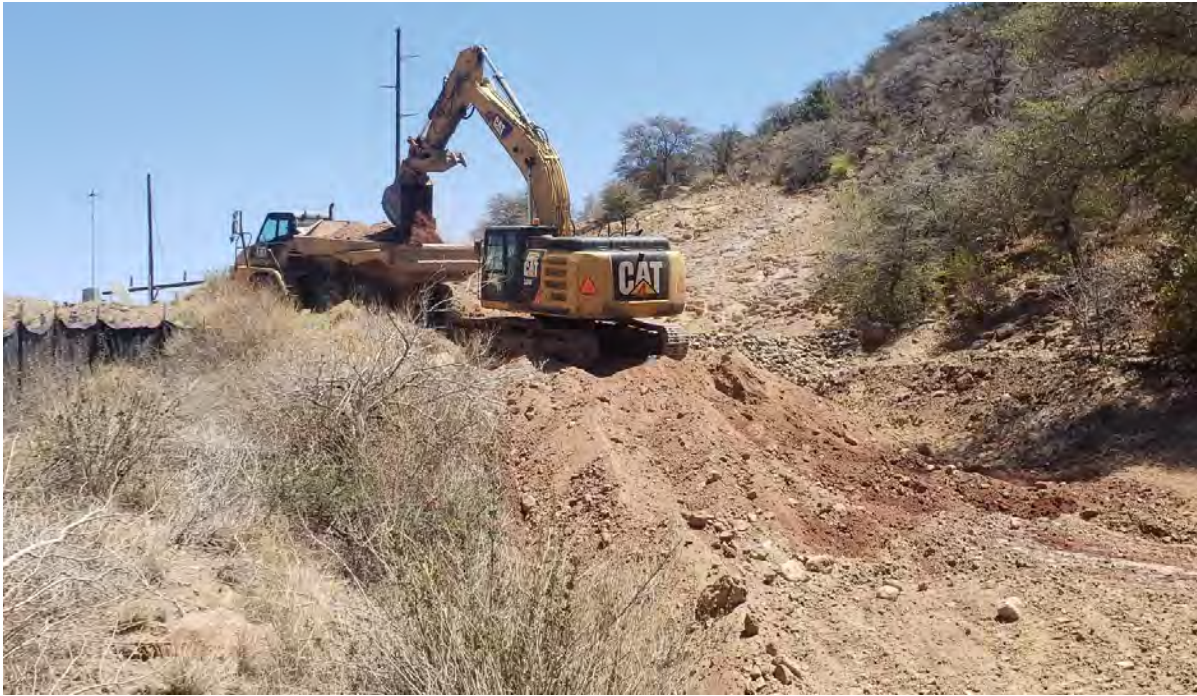
**Photo 1:** Over past 3 work days, Shared Services removed nearly all remaining red material at Shaft 1 east, west, and beneath access road.

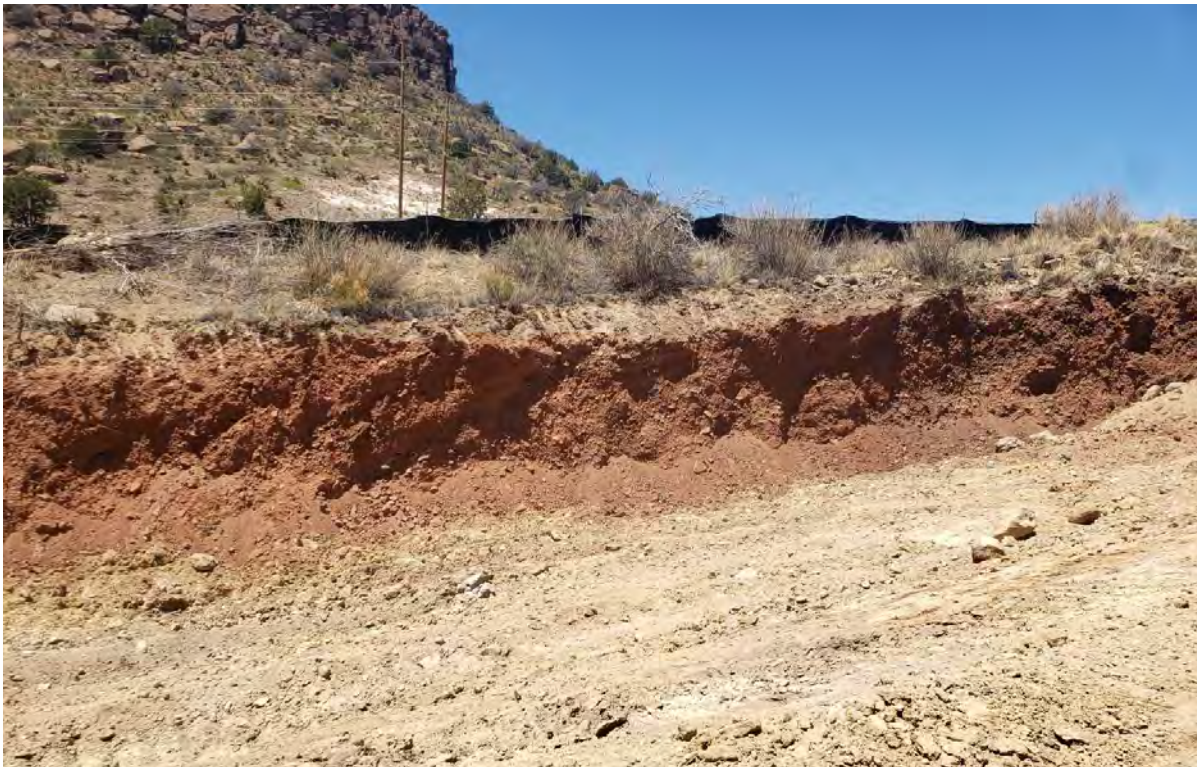
**Photo 2:** Crew did not remove red material along pipeline corridor near Shaft 1 out of concern for undermining. Checking with Elmo Gomez to determine how much further excavation can safely go.

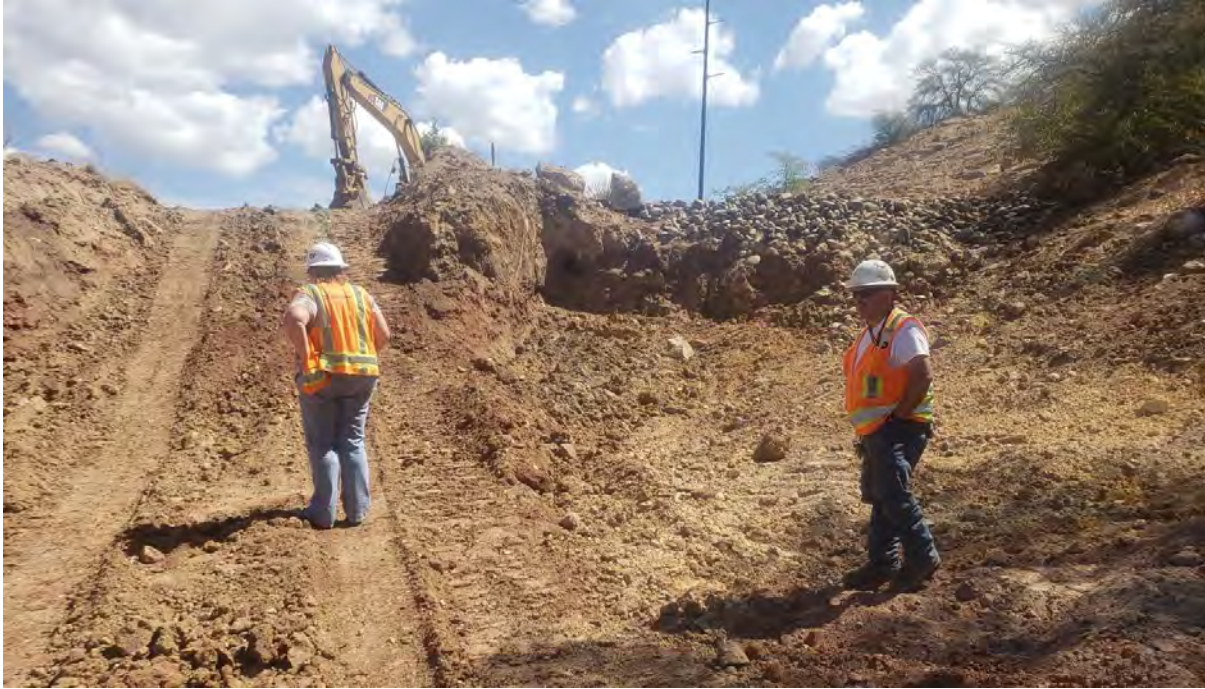
**Photo 1:** Chino, Shared Services, and DBS&A walked northern half of work area and compiled final punch-list for excavation activities.

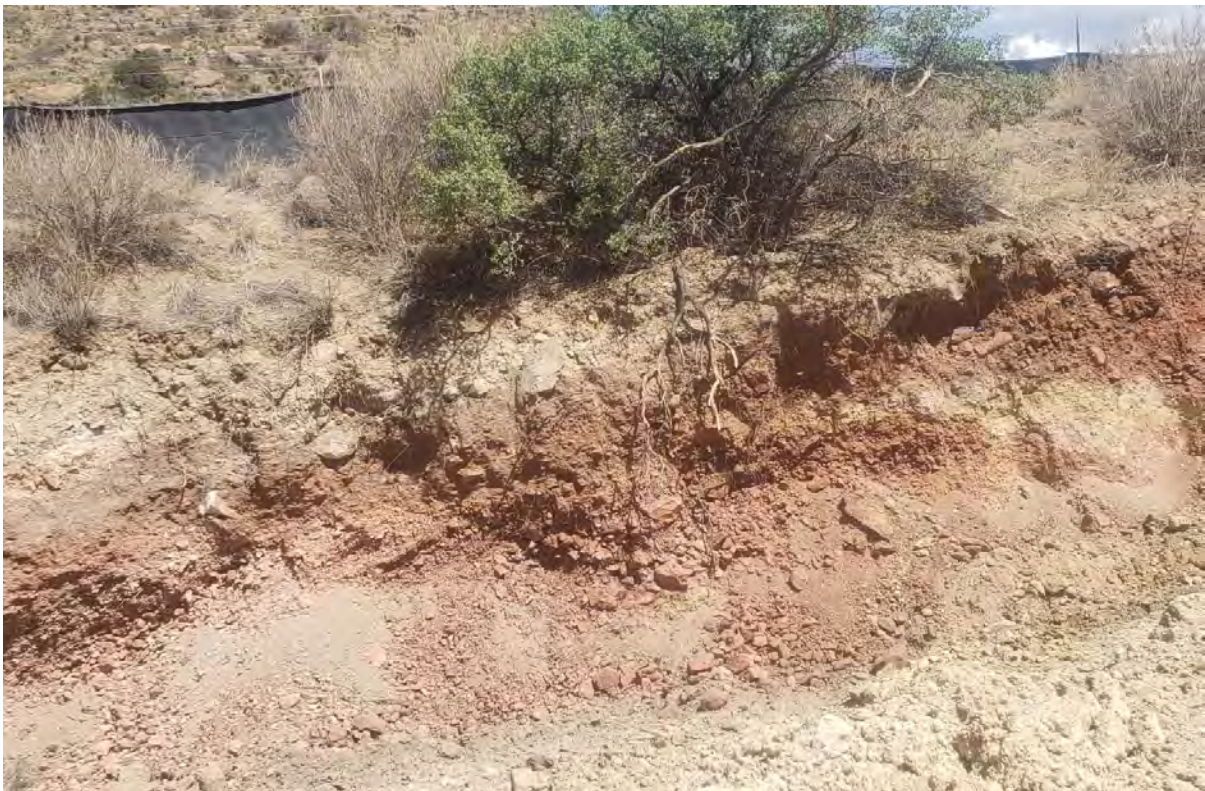
**Photo 2:** Wall adjacent to pipeline corridor where reddish material (native and stockpiled) remains will be capped with clean, import material.

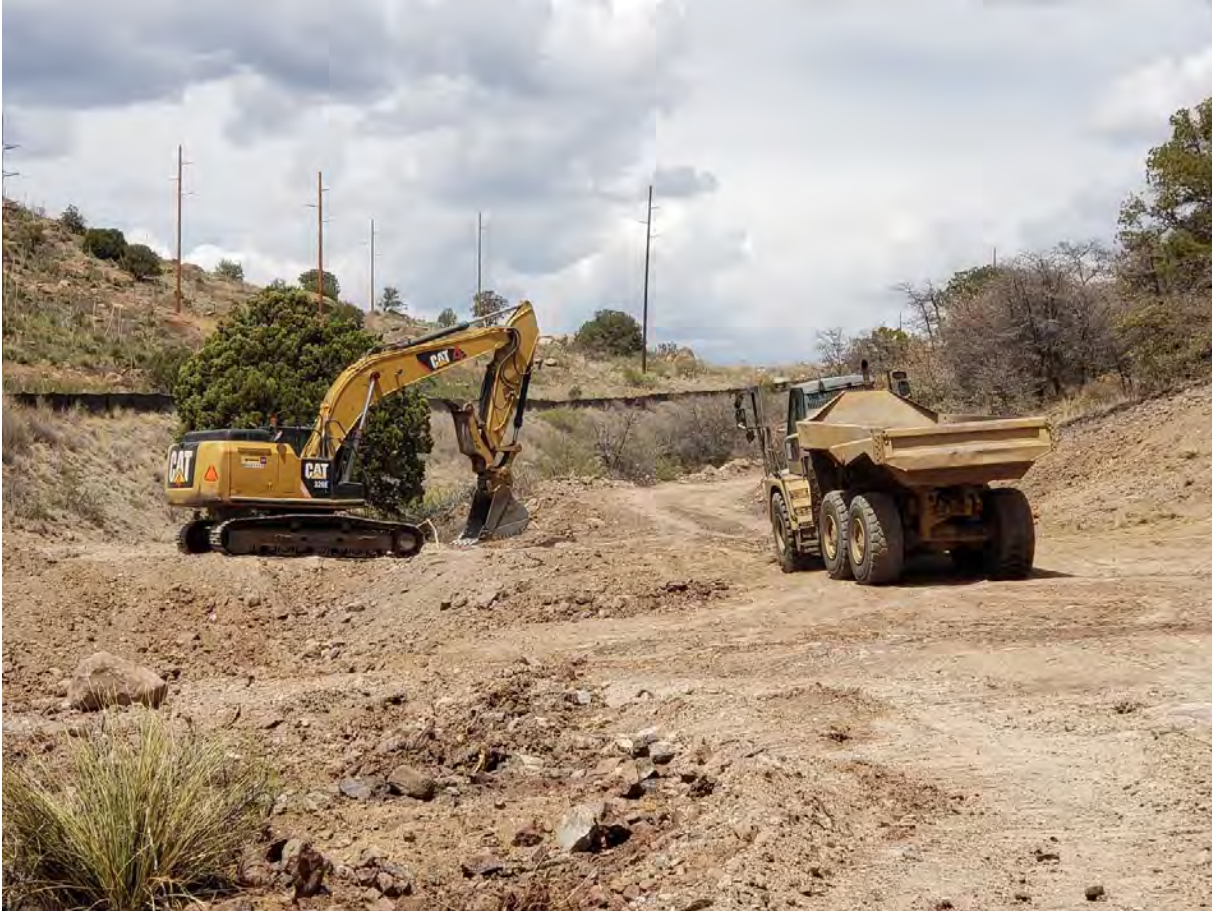
**Photo 3:** After completion of excavation at north end of jobsite, Shared Service returned to Lucky Bill confluence and removed reddish material from numerous small areas flagged for punch-list.

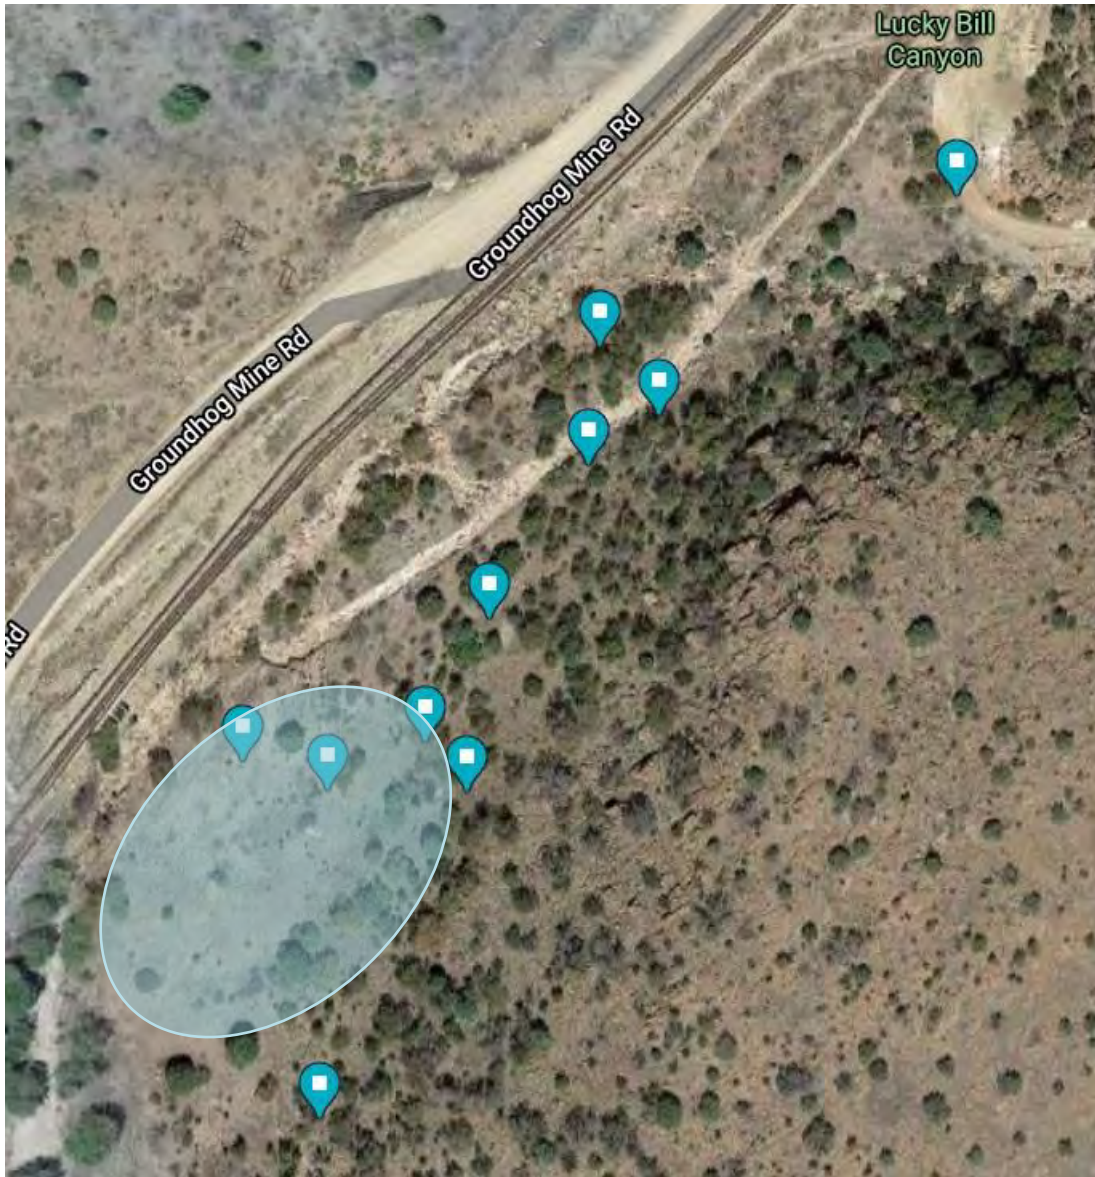
**Figure 3: Central Area Backfill Map:**  
Shared Services also started backfill at a large central removal area (blue oval) today.

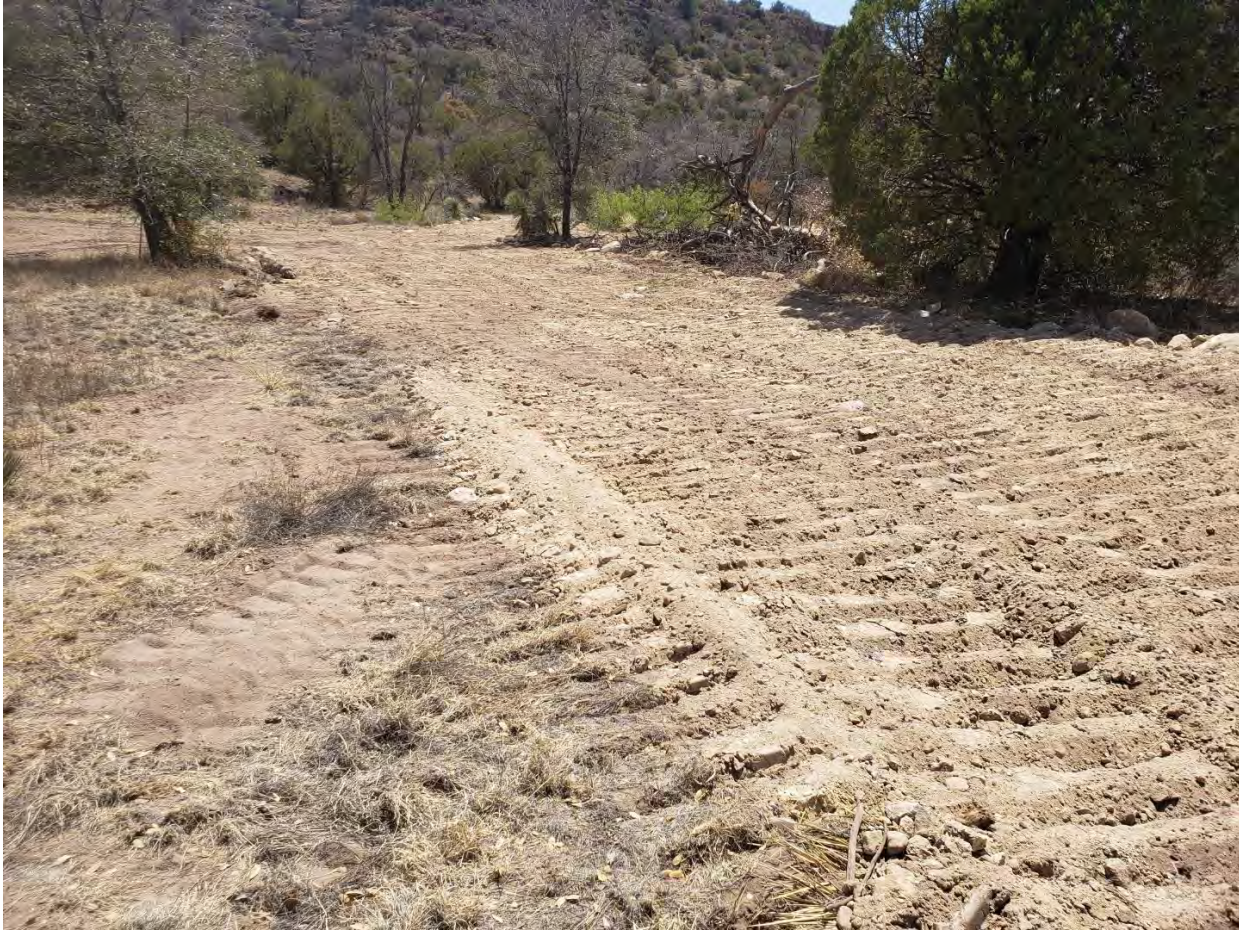
**Photo 3:** Backfill and final grading was completed quickly at the south end of the site.

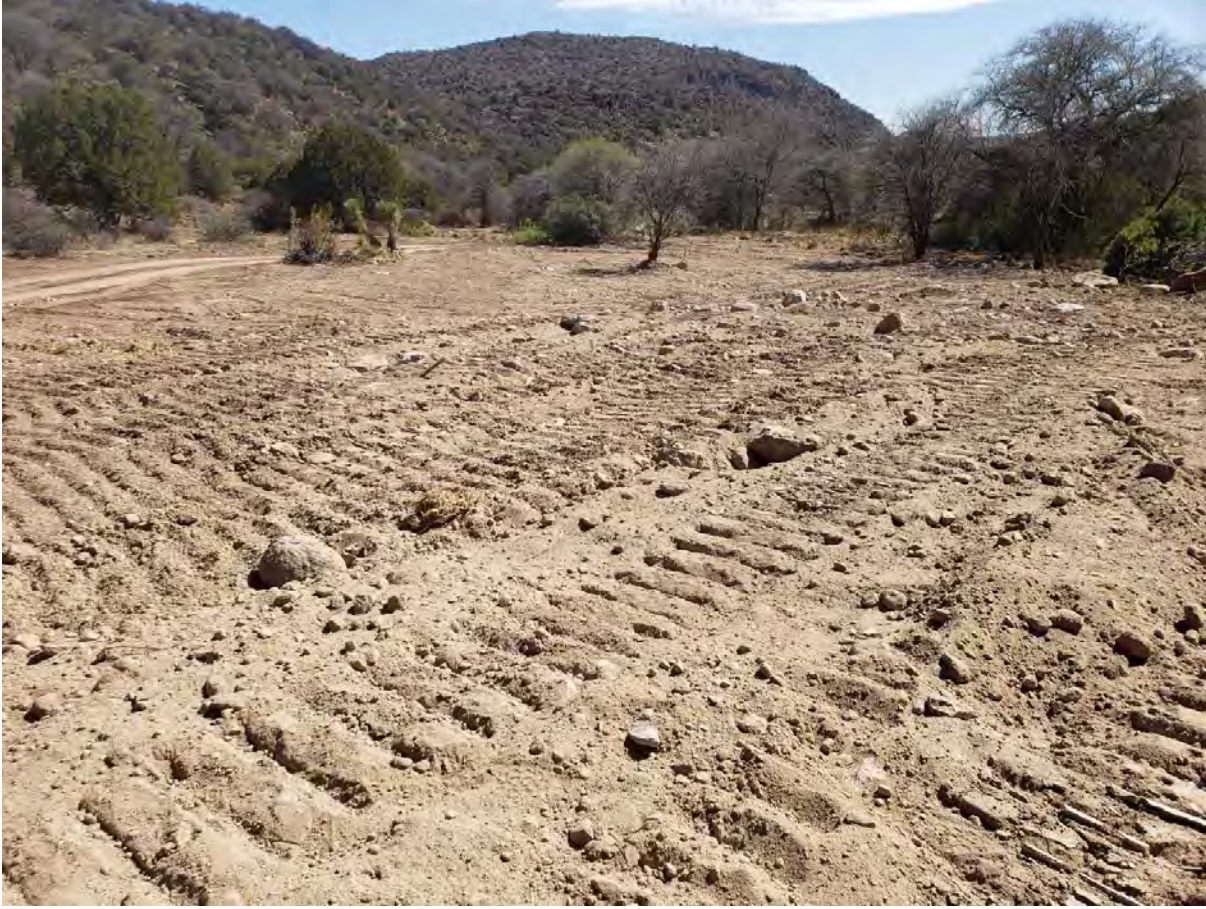
**Photo 3:** Large areas in the central portion of the site were backfilled and graded.
