# **BAYARD CANYON SUPPLEMENTAL INTERIM REMOVAL ACTION COMPLETION REPORT**

Hanover Whitewater Creek Investigation Unit  
Vanadium, New Mexico

July 2022

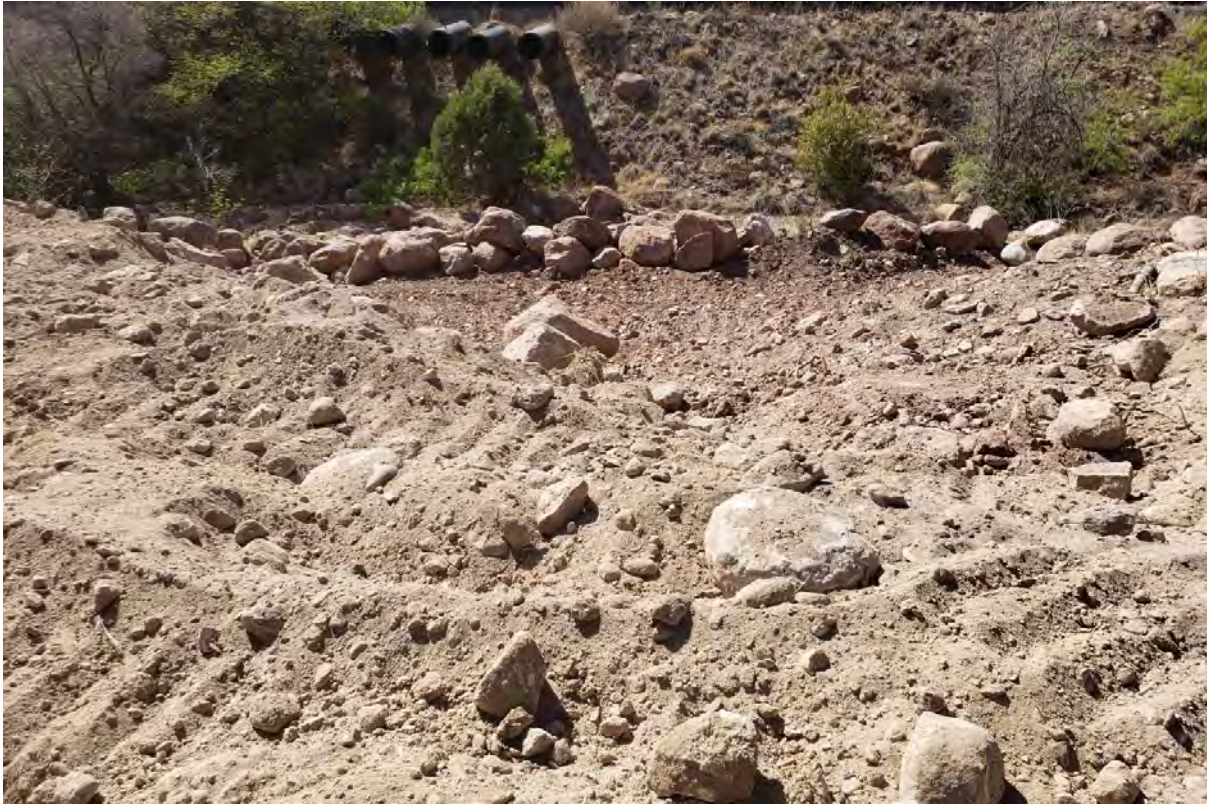
**Photo 1:** Partially-backfilled areas along creek bank at central portion of jobsite.

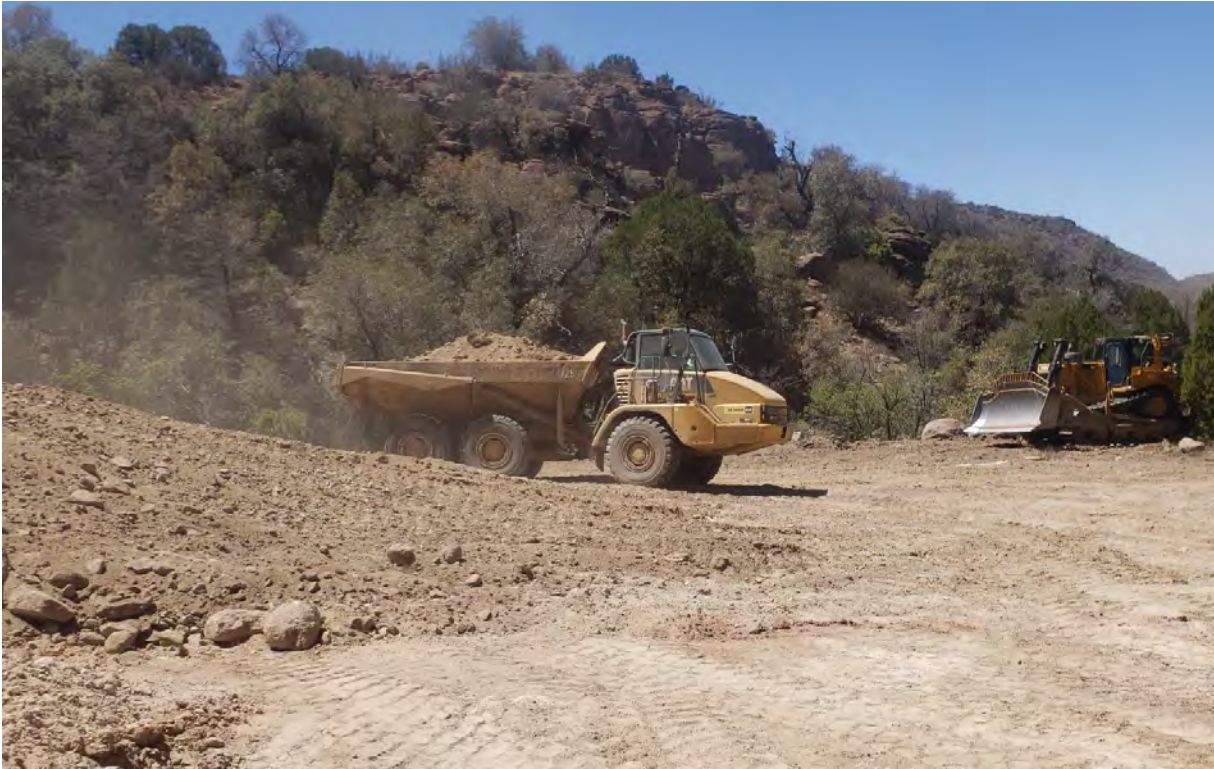
**Photo 1:** Crew backfilled area and rebuilt road leading into Lucky Bill Canyon.

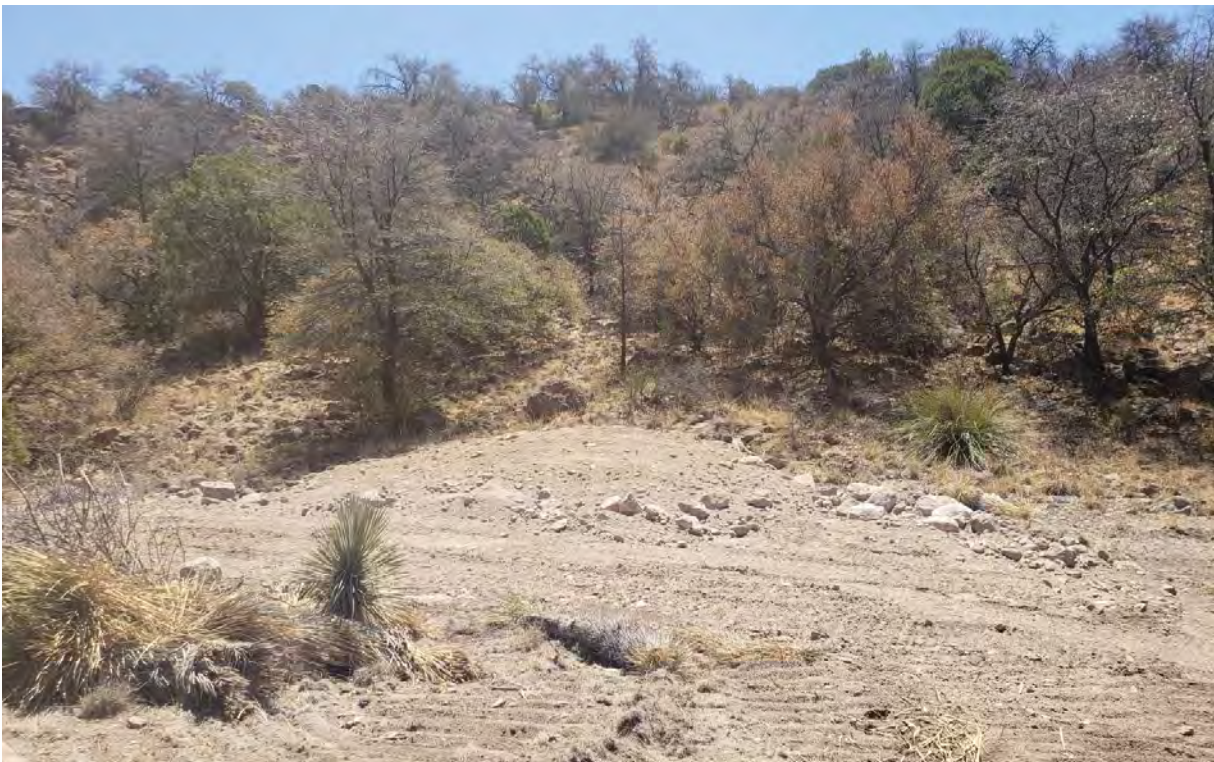
**Photo 2:** Crew mounded cover material in areas where former mine workings potentially persist.

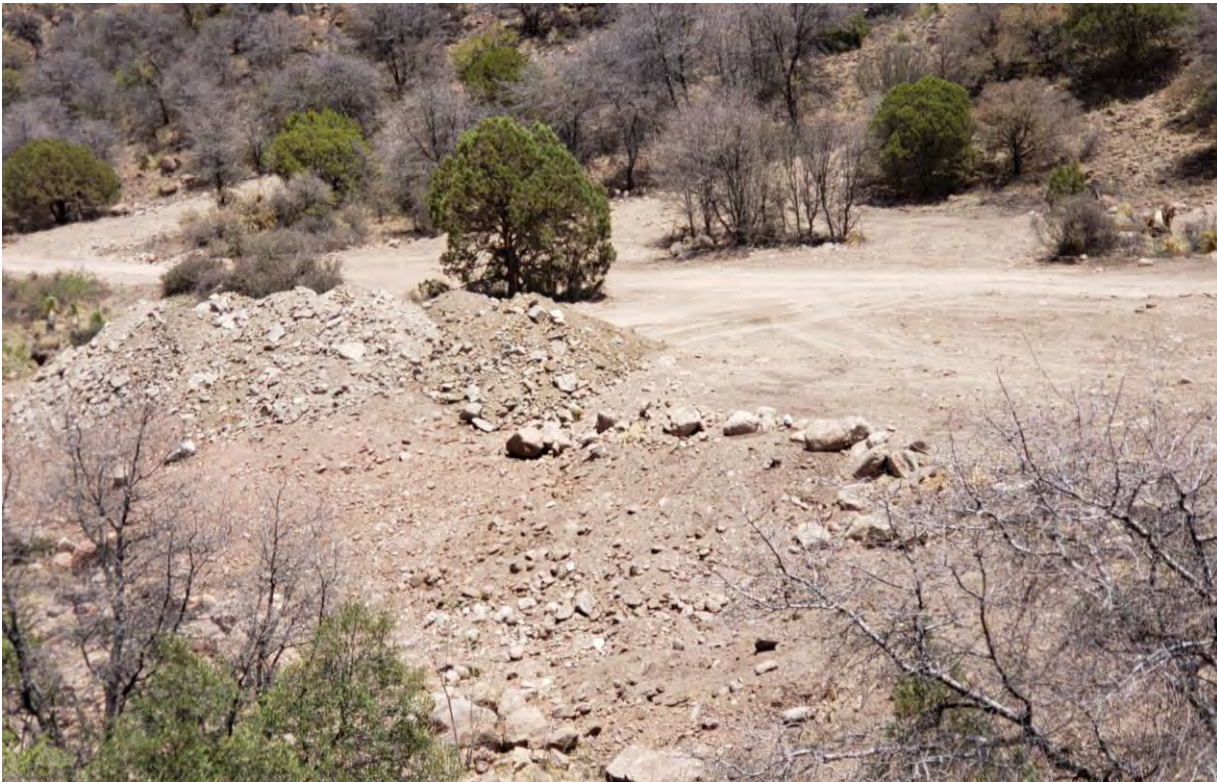
**Photo 2:** Crew mounded rocky cover material from Groundhog borrow area at creek bank.

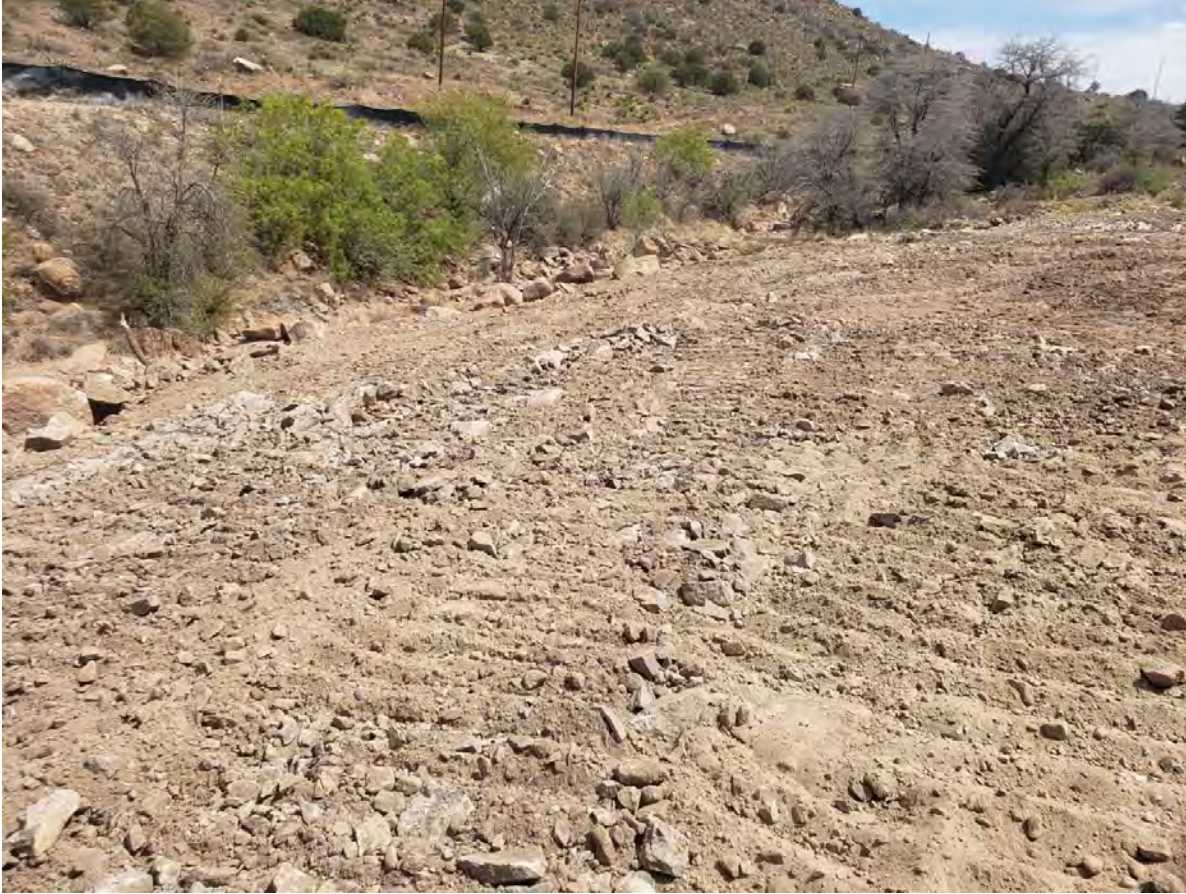
**Photo 3:** A well-graded slope was achieved using cover material on the creek bank that was excavated during removal. Large boulders at the toe (left) serve as armoring.

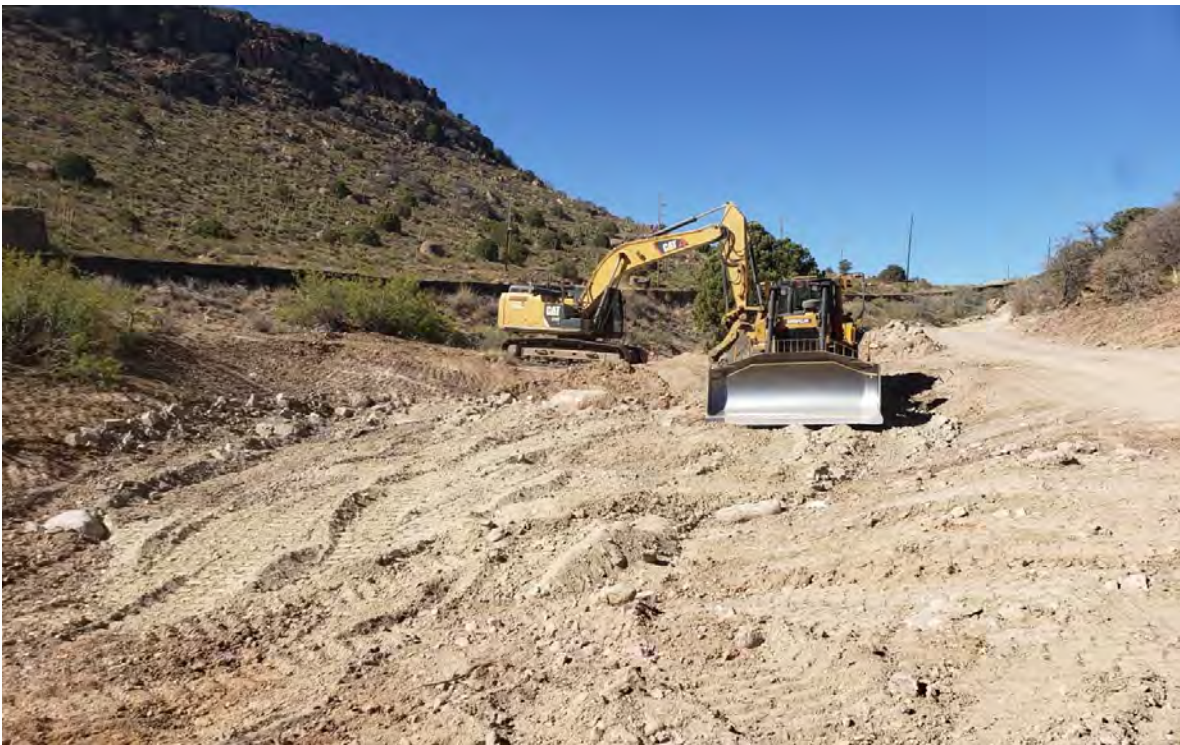
**Photo 2:** Crew nearly finished filling hole from deep excavation along creek above Lucky Bill.

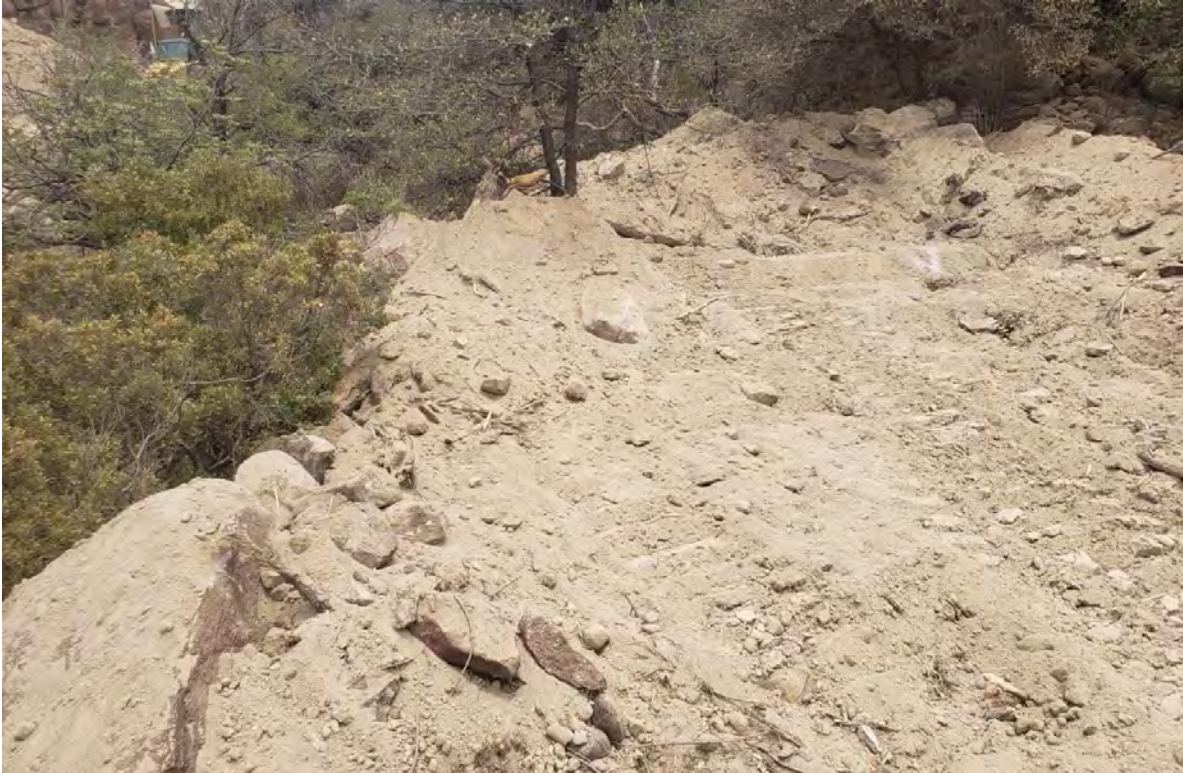
**Photo 3:** Material was added to reinforce creek bank.

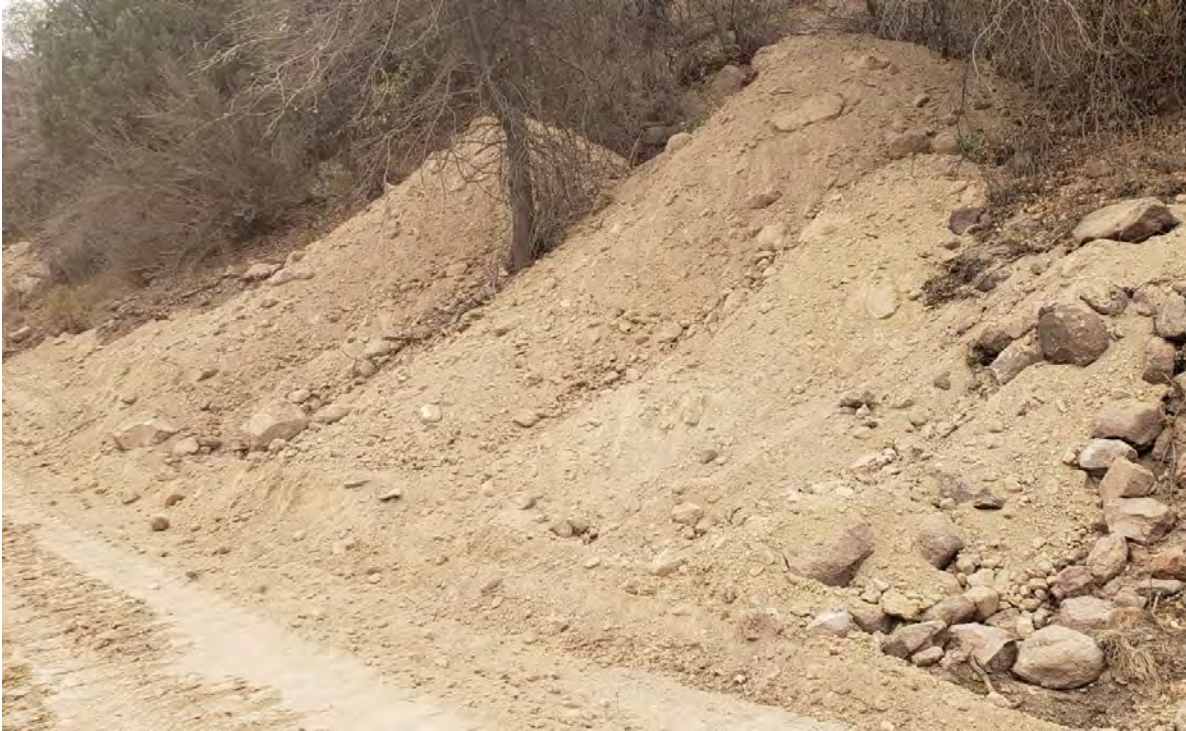
**Photo 1:** Shared Services placed cover material with mounds over former workings along access road below Lucky Bill.

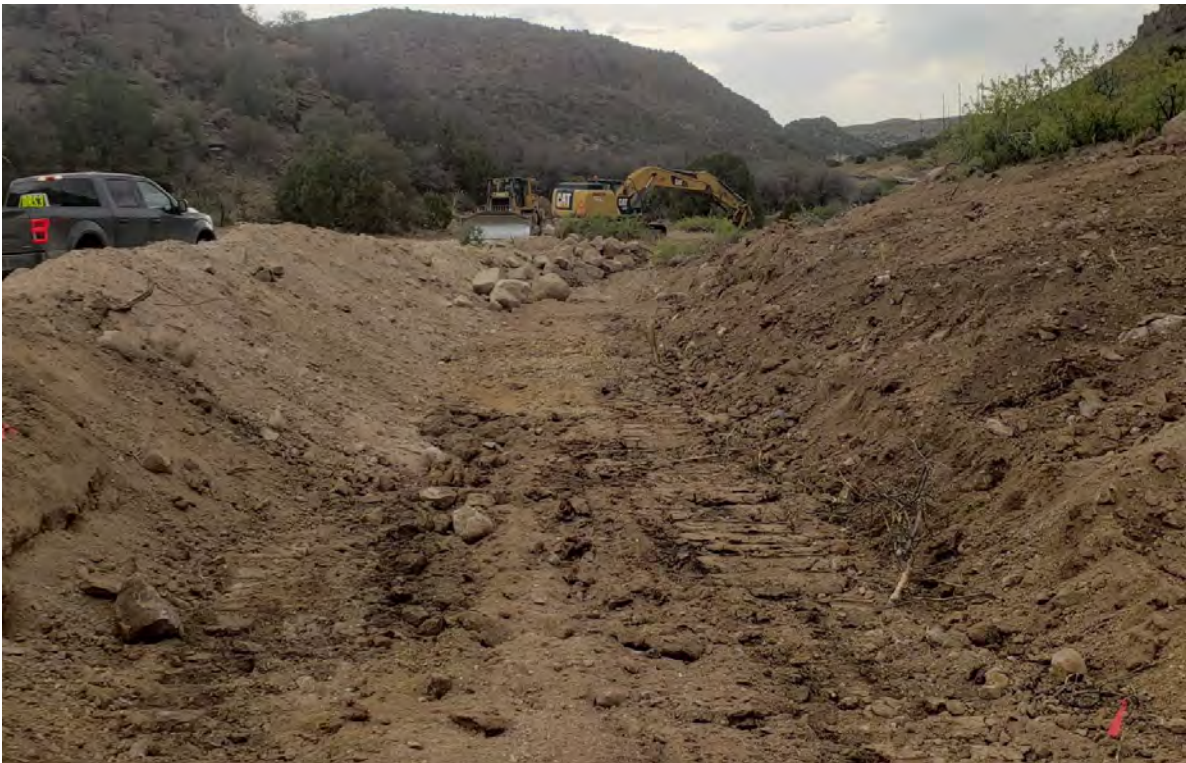
**Photo 2:** Crew re-cut a channel in the creek bed above Lucky Bill.

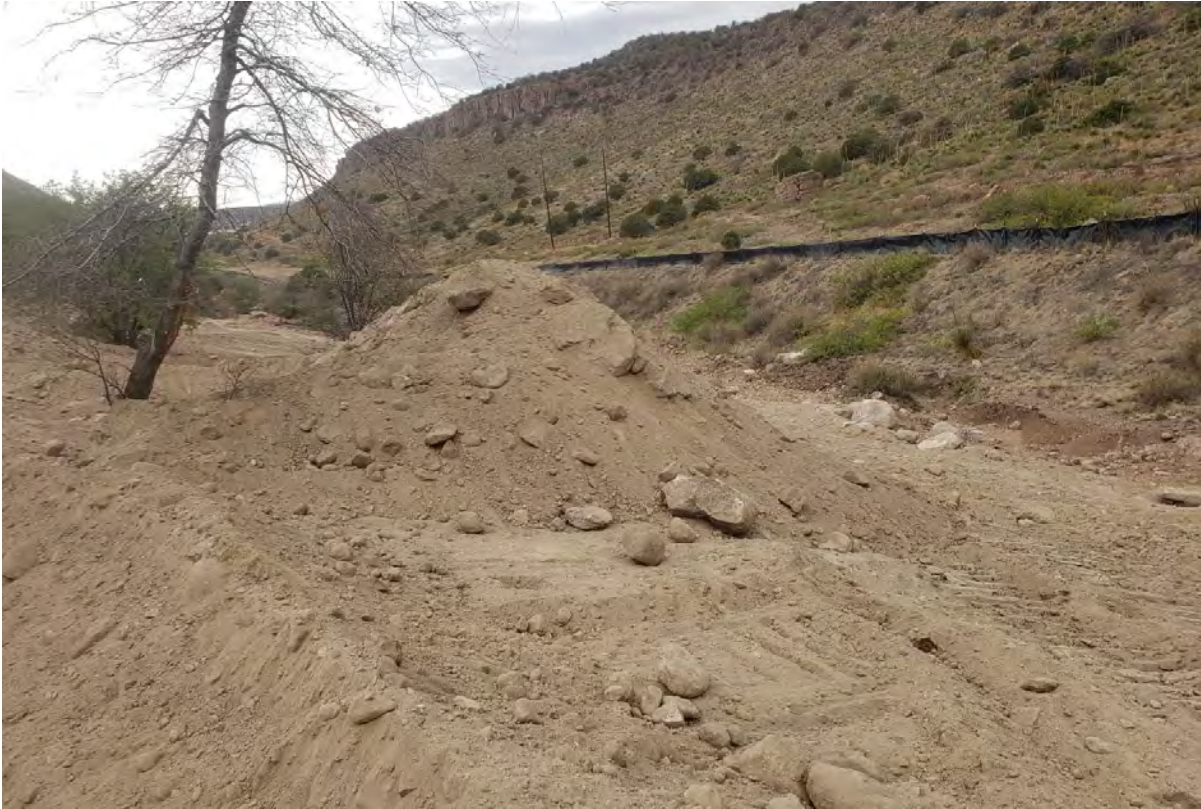
**Photo 3:** Cover and a mound were placed over Shaft 2.

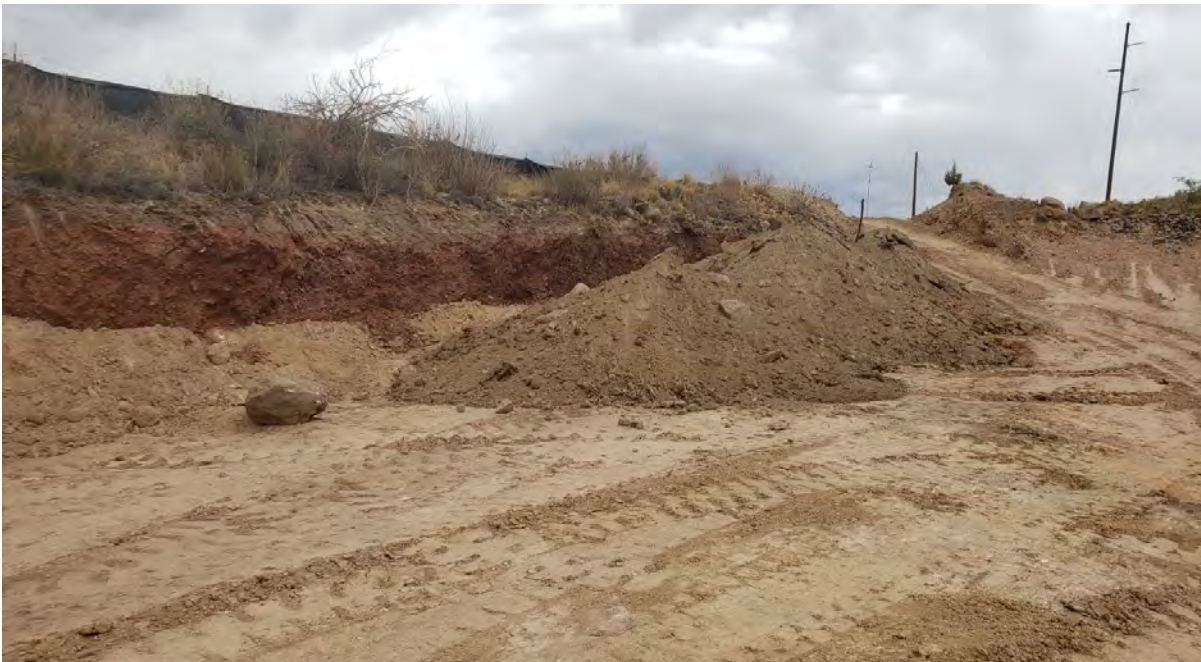
**Photo 4:** Substantial progress was made backfilling along red wall at north end of jobsite.

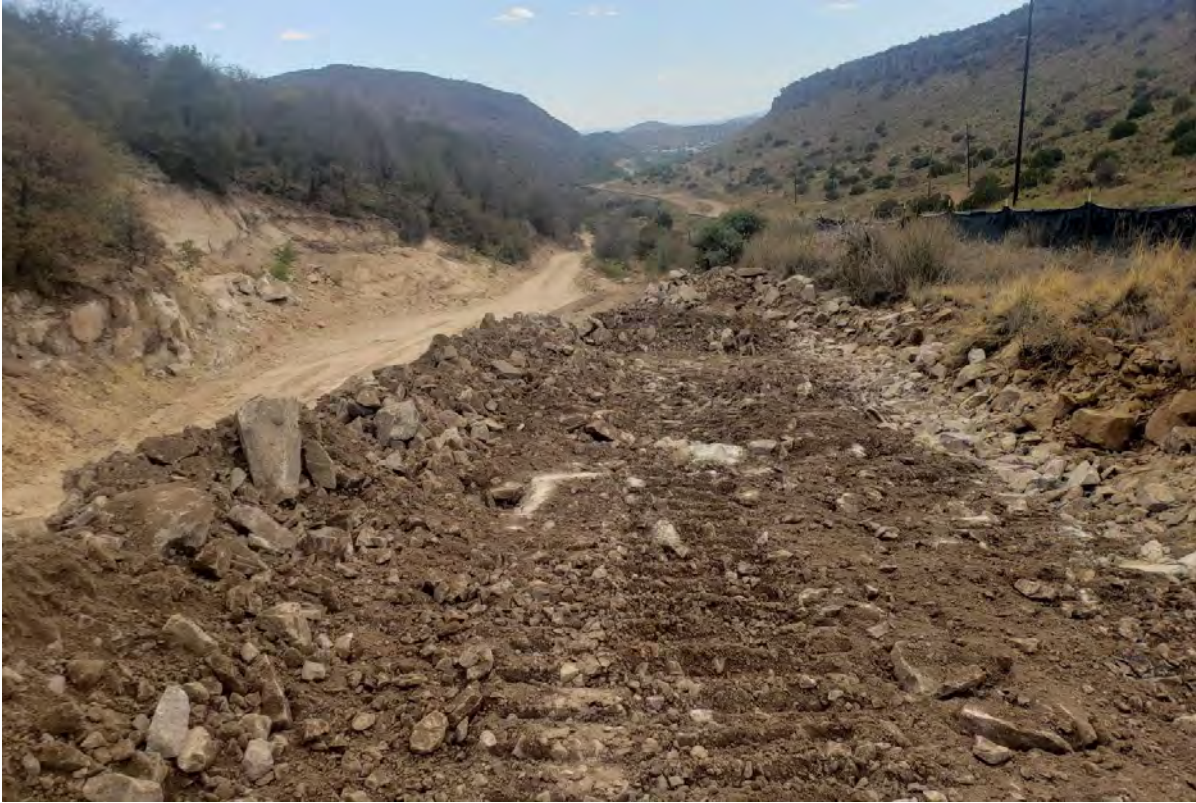
**Photo 1:** Shared Services hauled 53 loads of cover material to ramp at north end into site.

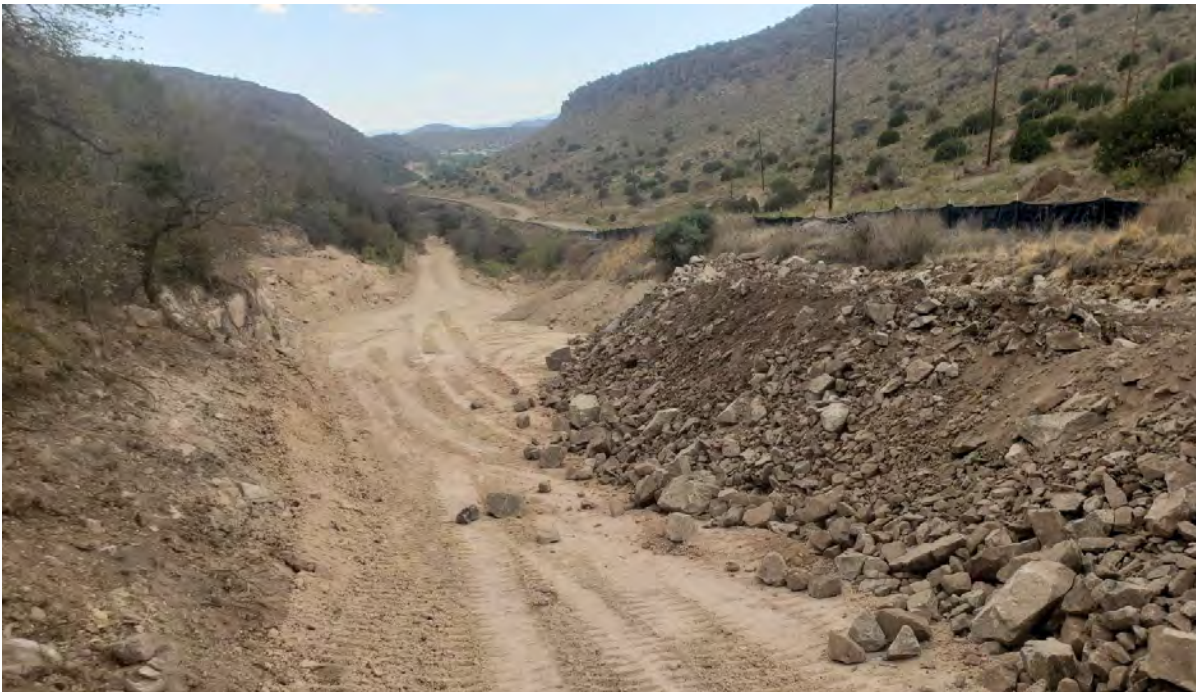
**Photo 2:** With new grading plan at north end of site, the road (right) will ramp in along east bank and creek will flow along former road (left).

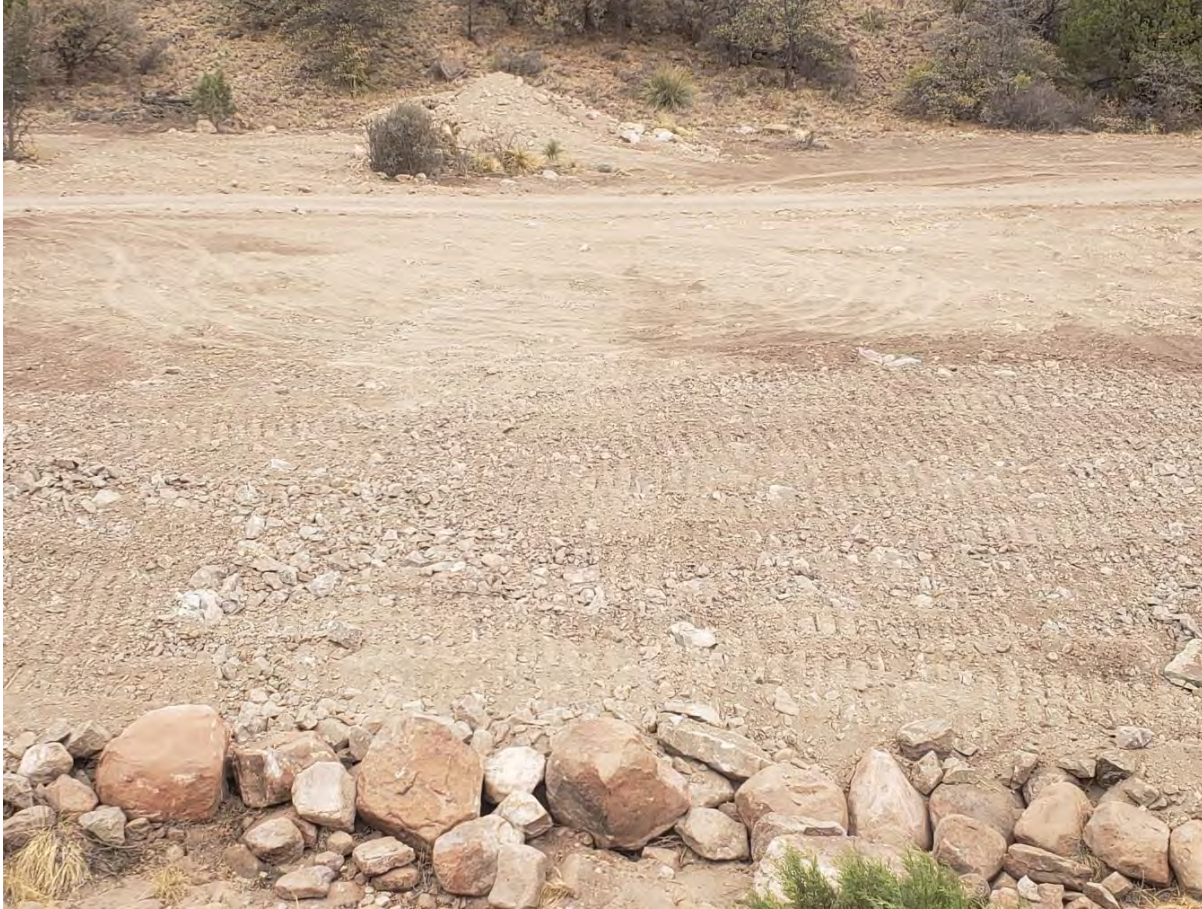
**Photo 3:** Boulders and rocky cover material armoring creek bank where deep cut was excavated

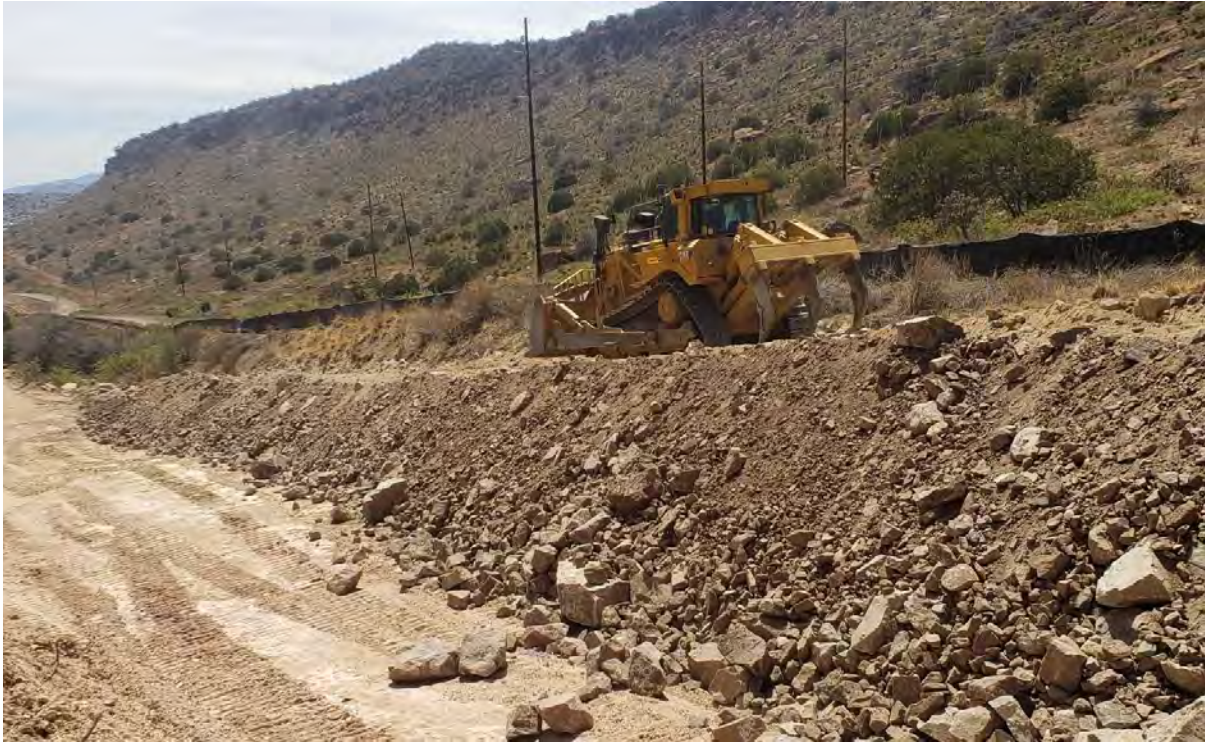
**Photo 1:** Shared Services continued working on ramp at north end of work area. Dozer spread layer of fine material on top of rocky material that makes up most of ramp.

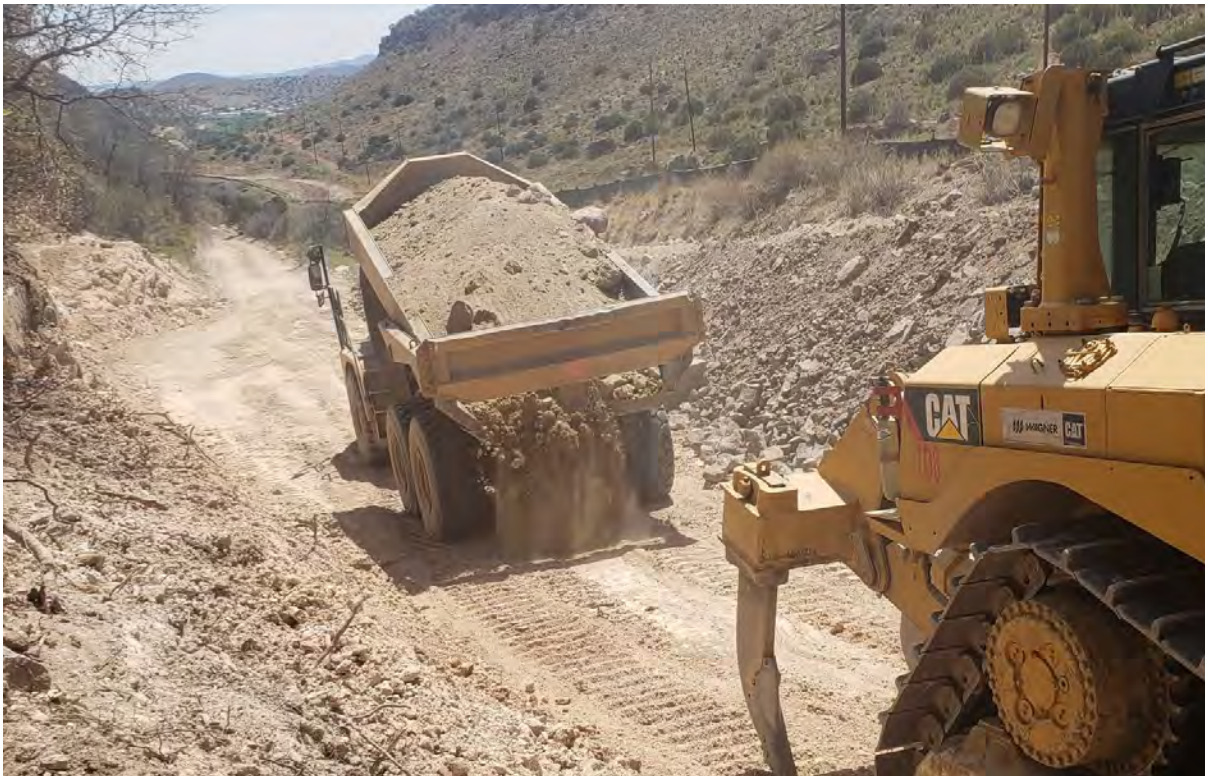
**Photo 2:** Crew imported cover material for placement on east bank (left) at north end of site.

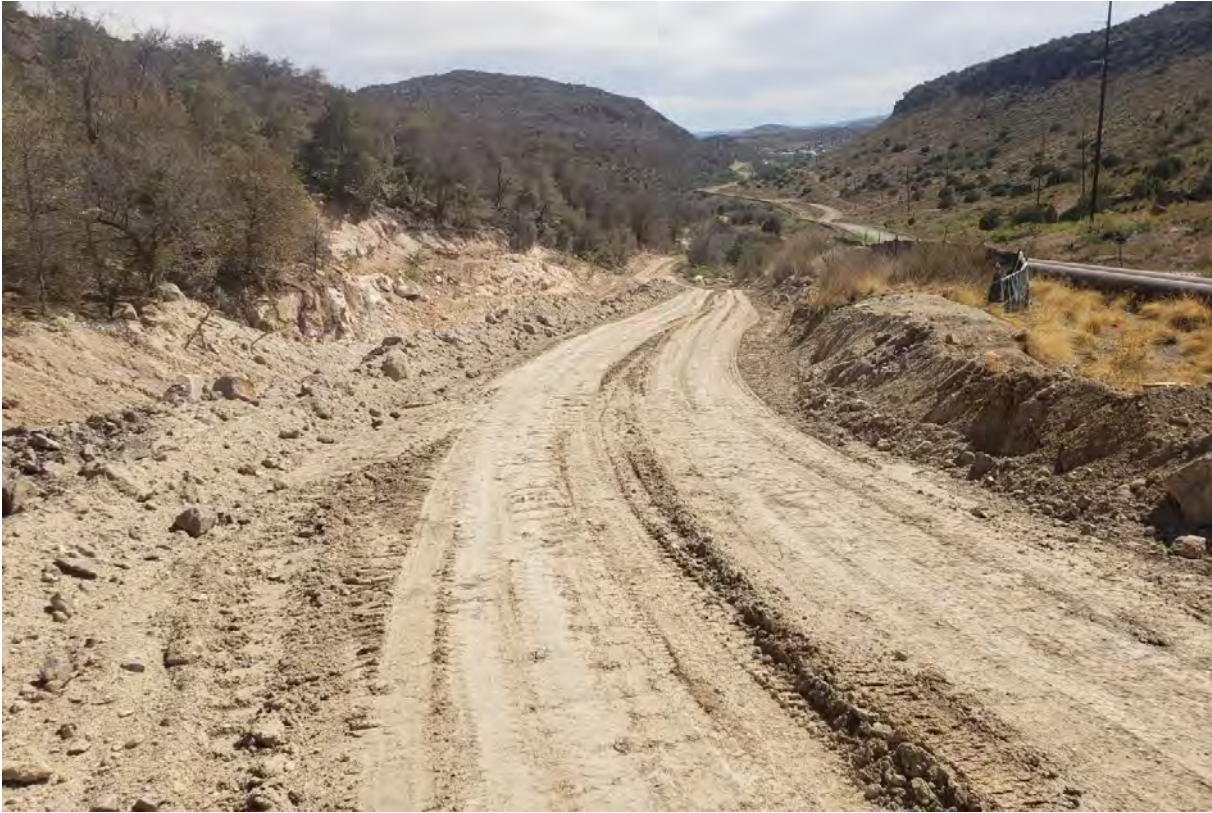
**Photo 1:** Shared Services finished reconstruction of ramp at north end of work area.

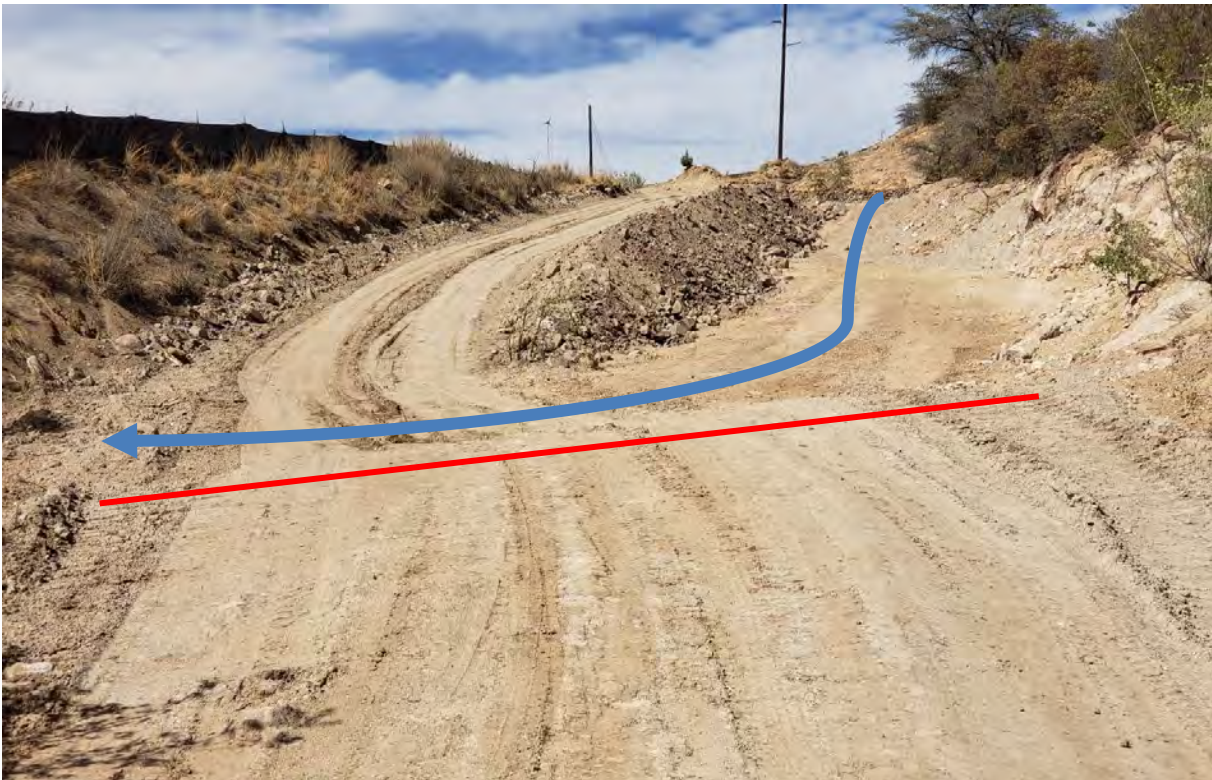
**Photo 2:** A newly-constructed berm (red line) will help keep creek flow from following access road.

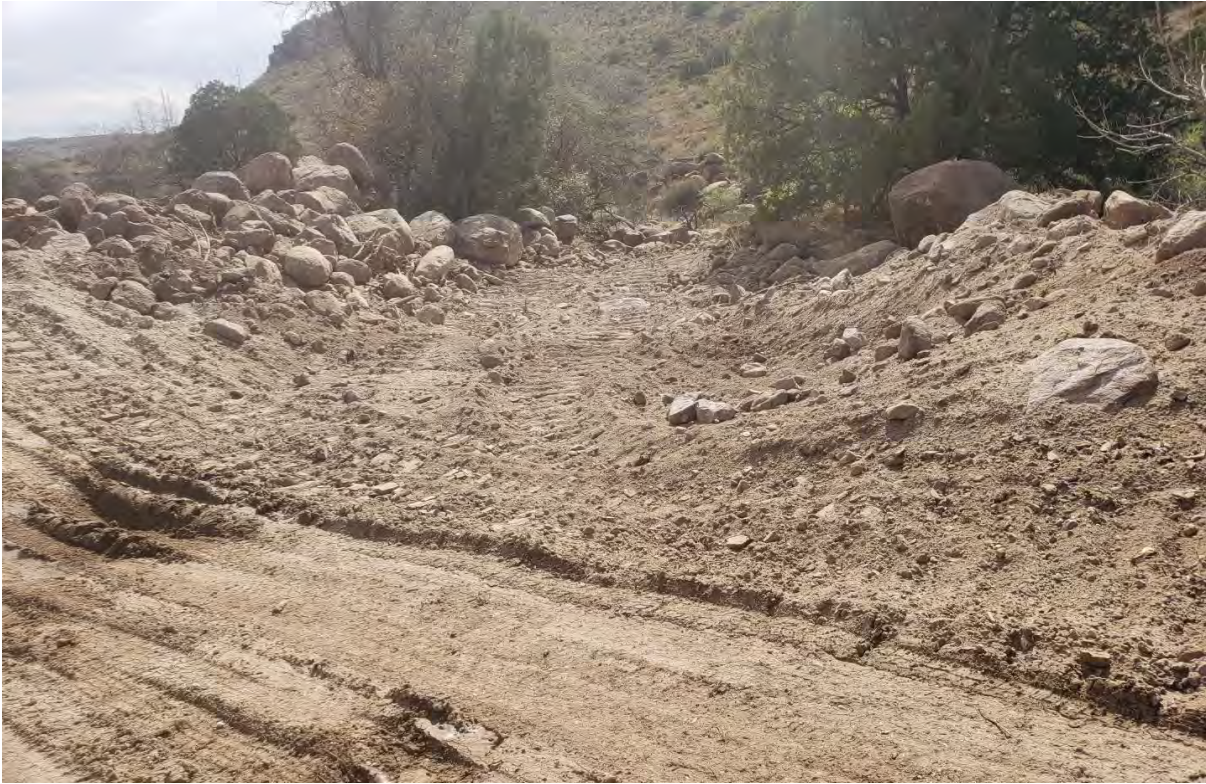
**Photo 3:** Boulders and sediment were removed from channel from Lucky Bill to Bayard Canyon creek

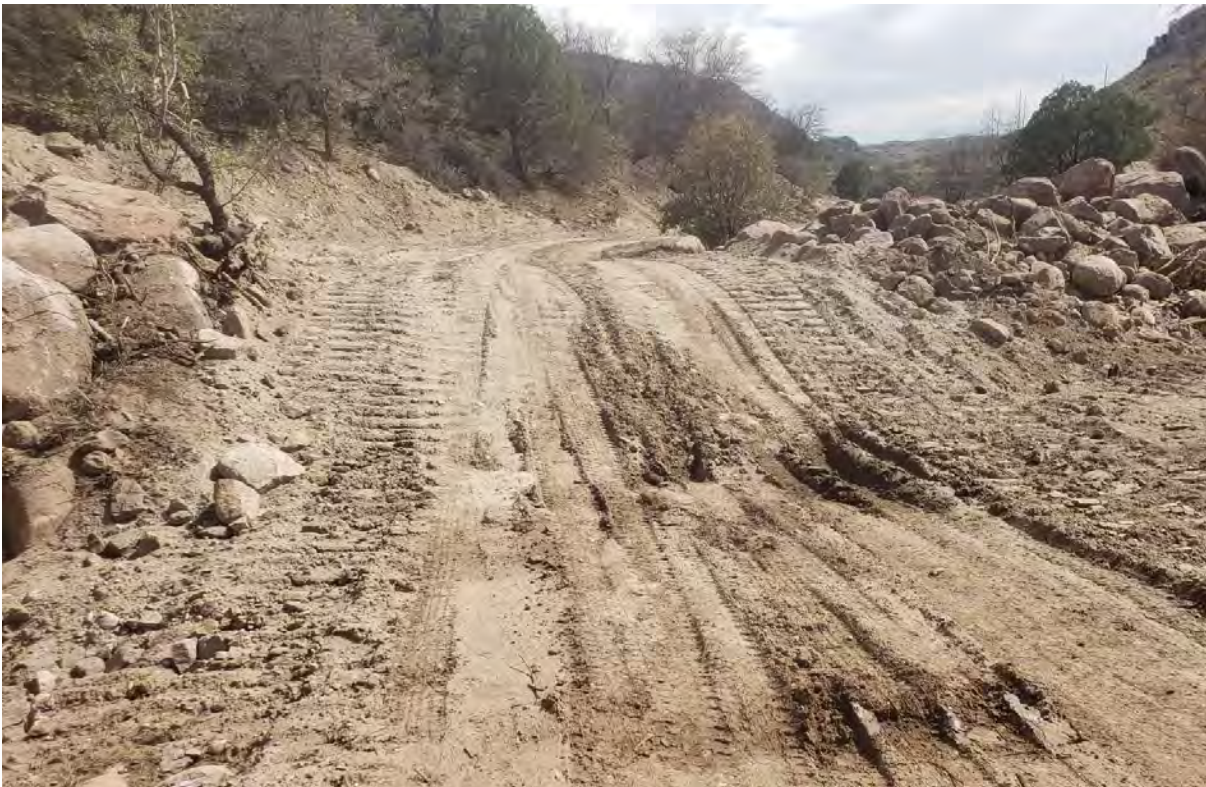
**Photo 4:** A new berm on the access road will enable seeding crew entry and keep creek in channel.

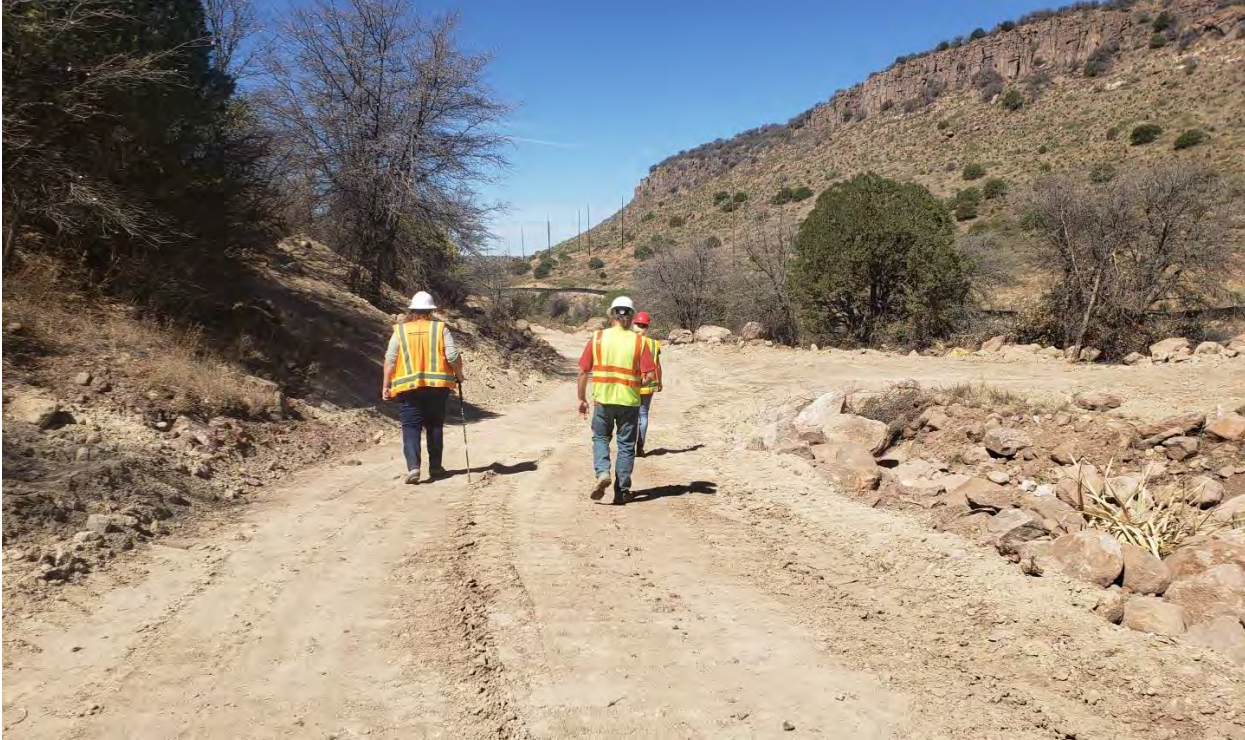
**Photo 1:** Chino ENV and NMED completed final walk-through of work areas.

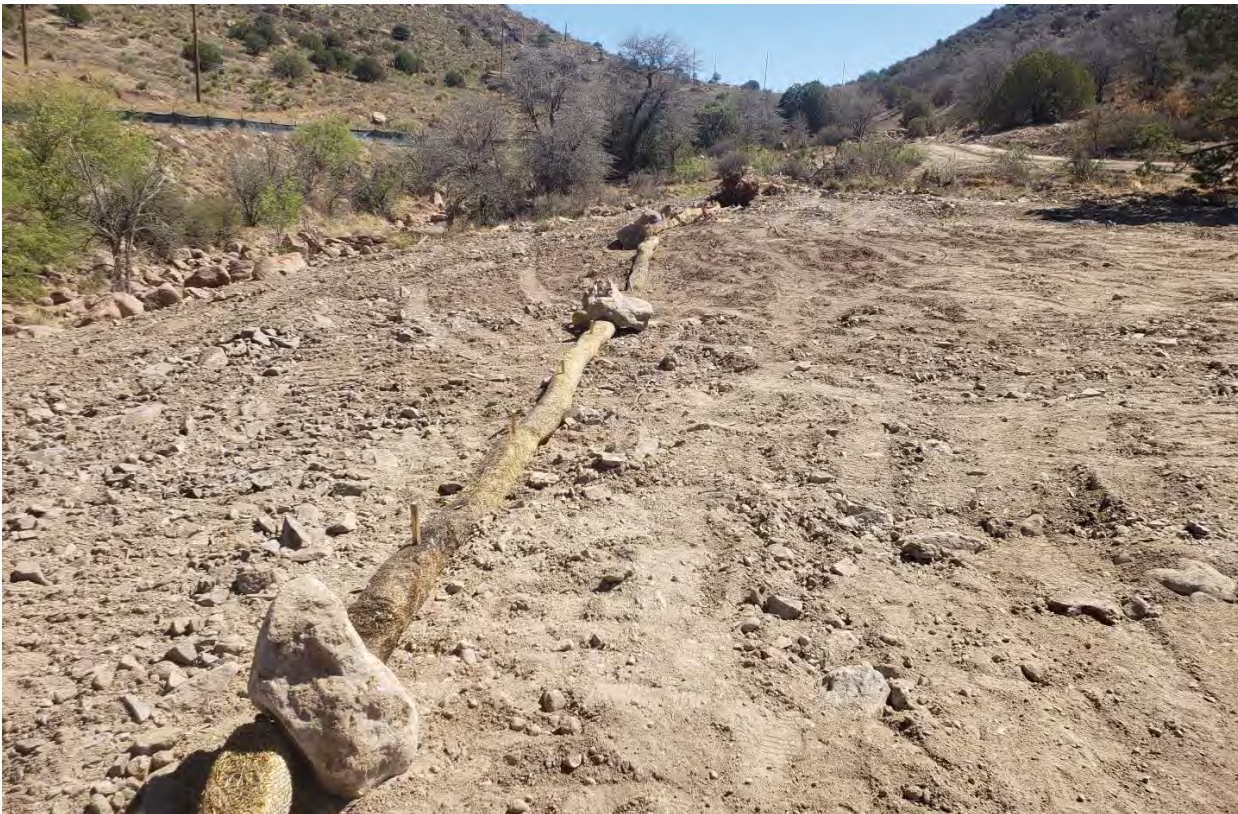
**Photo 2:** Straw wattles installed along creek bank – boulders and stakes used to secure.

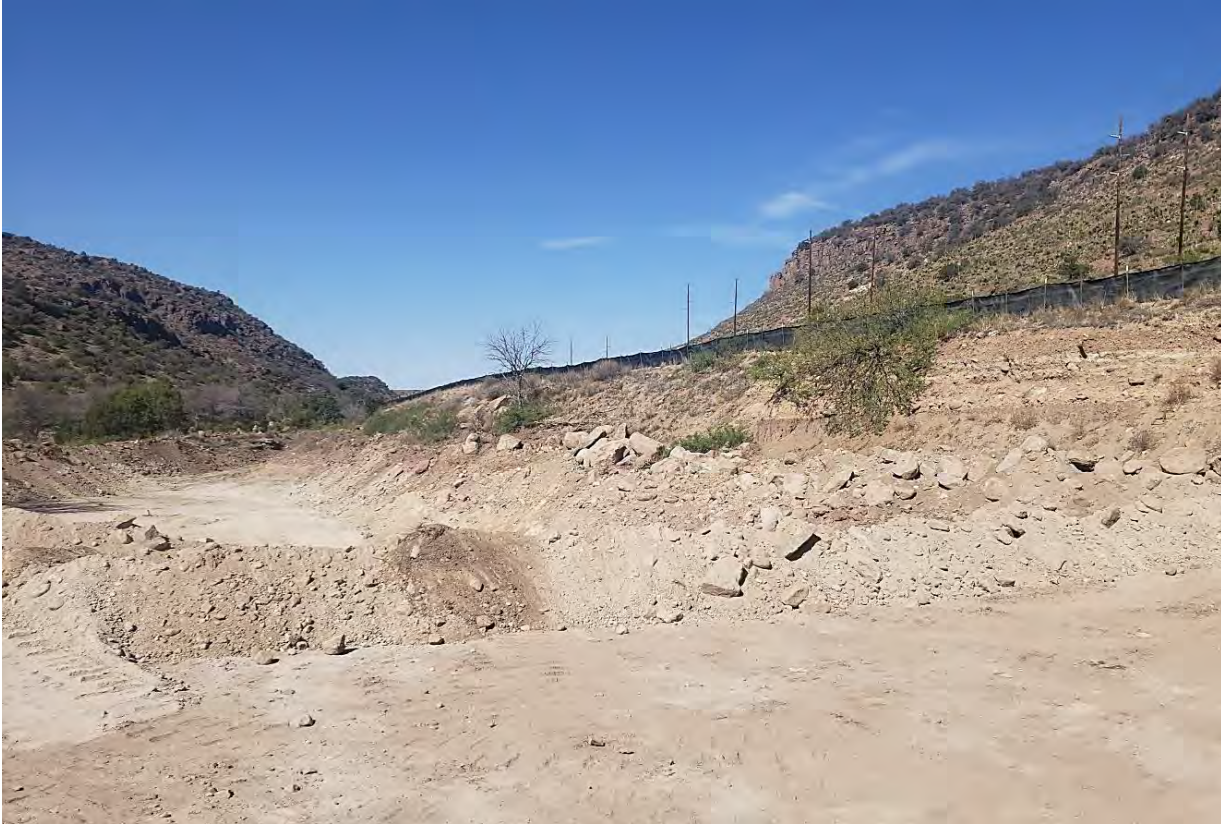
**Photo 3:** A stout berm along edges of the southern borrow area to prevent stormwater entry.

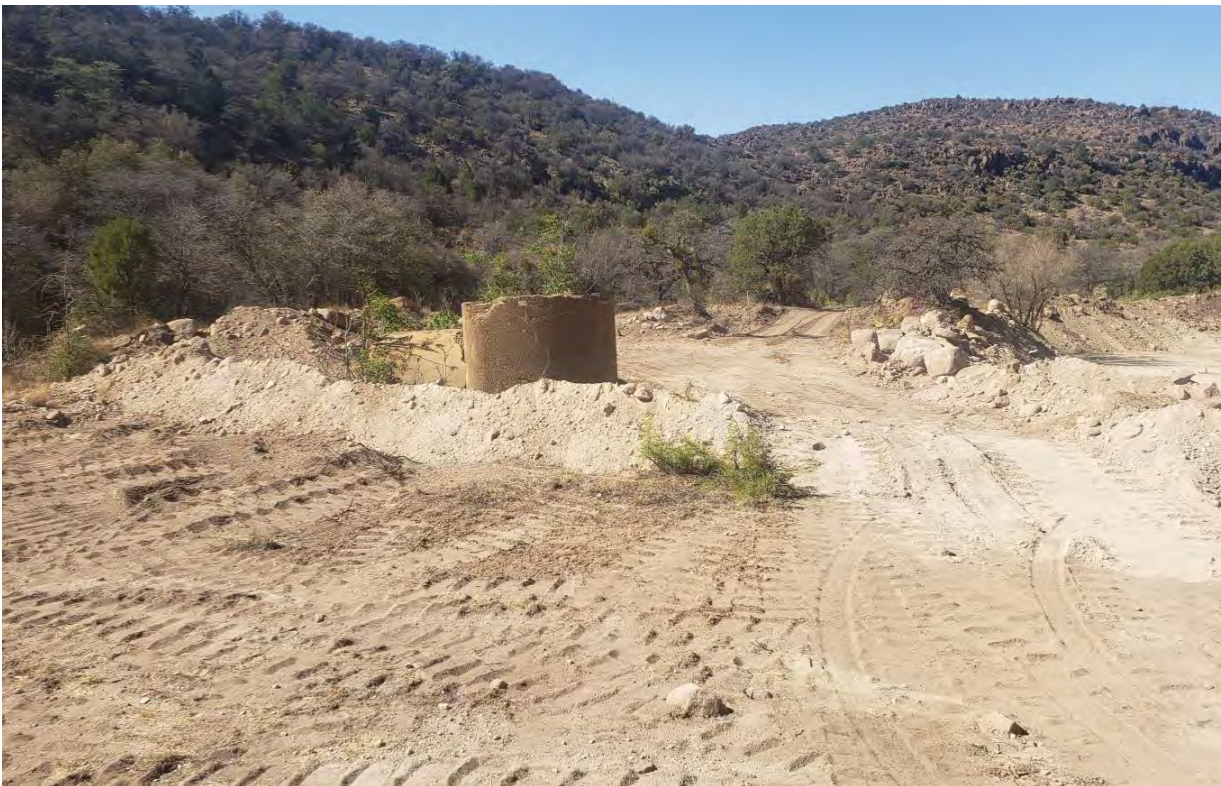
**Photo 4:** Berms at southern borrow area also prevent stormwater from following access road.
