# **BAYARD CANYON SUPPLEMENTAL INTERIM REMOVAL ACTION COMPLETION REPORT**

Hanover Whitewater Creek Investigation Unit  
Vanadium, New Mexico

July 2022

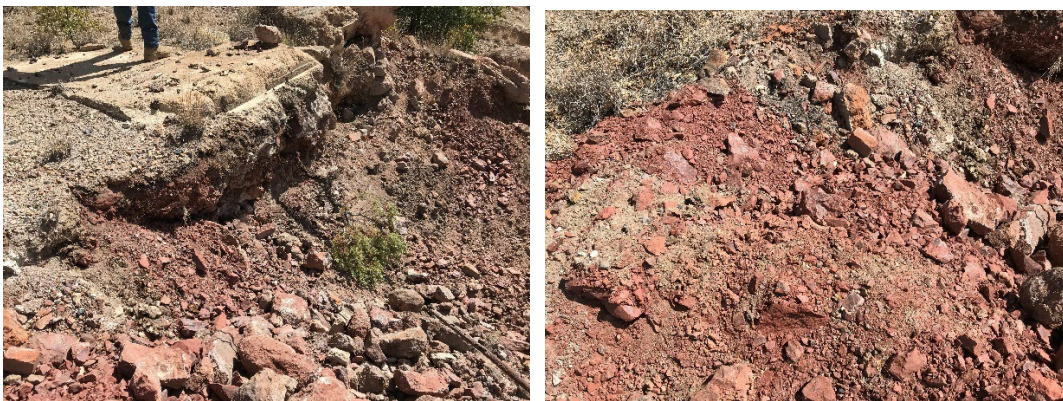
- Shaft 2 – An area approximately 14,666 ft<sup>2</sup> in size and an average depth of 0.5 feet (approximately 272 yd<sup>3</sup>) was removed in the vicinity of this shaft. See **Exhibit 6a** of site prior to stockpile removal. An outcropping of jasperoid vein was noted following removal of debris and stockpile. See **Exhibit 6b** of jasperoid vein outcrop following removal and prior to soil cover placement.

**Exhibit 6b – Photographs showing exposed outcrop of jasperoid vein following stockpile removal.**

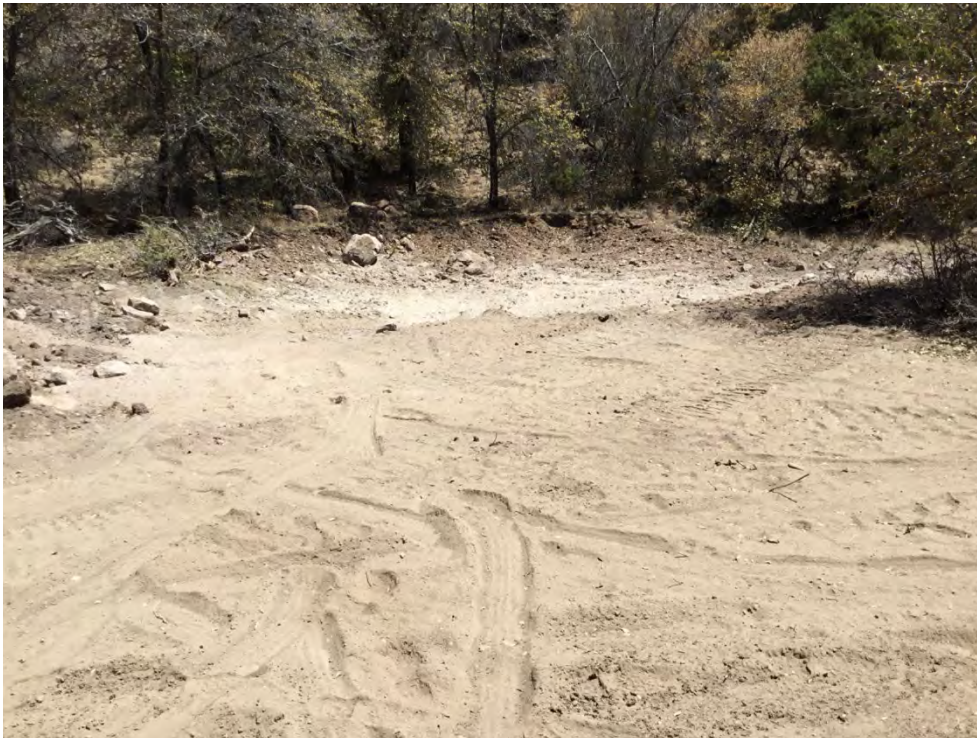
**Photograph: 8**

**Description:**  
BC6b

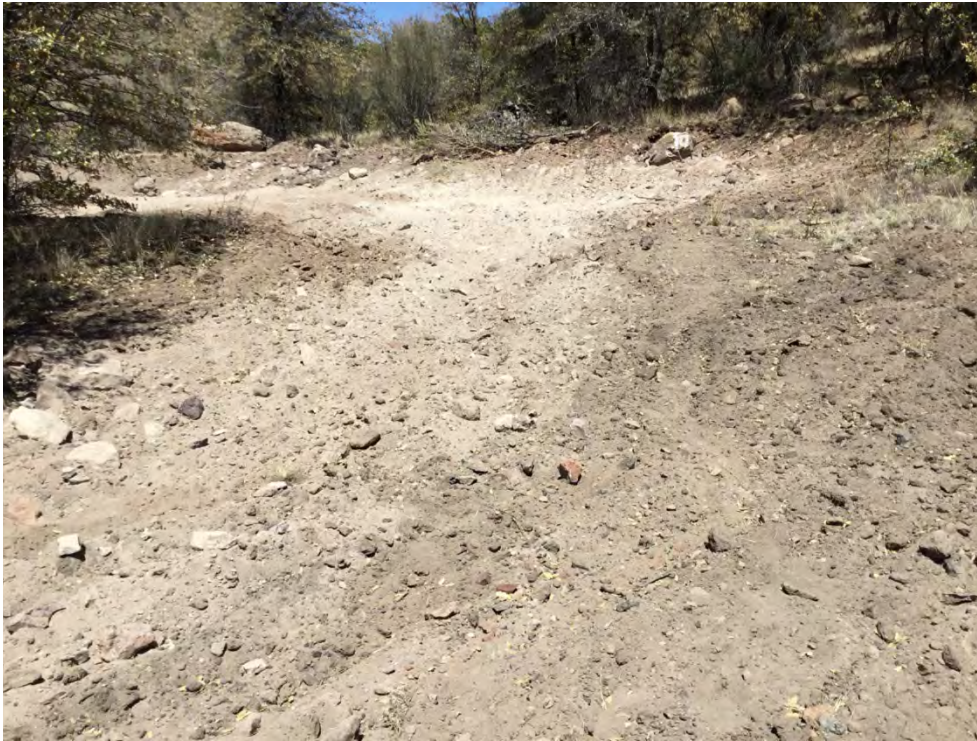
**Photograph: 9**

**Description:**  
BC6c

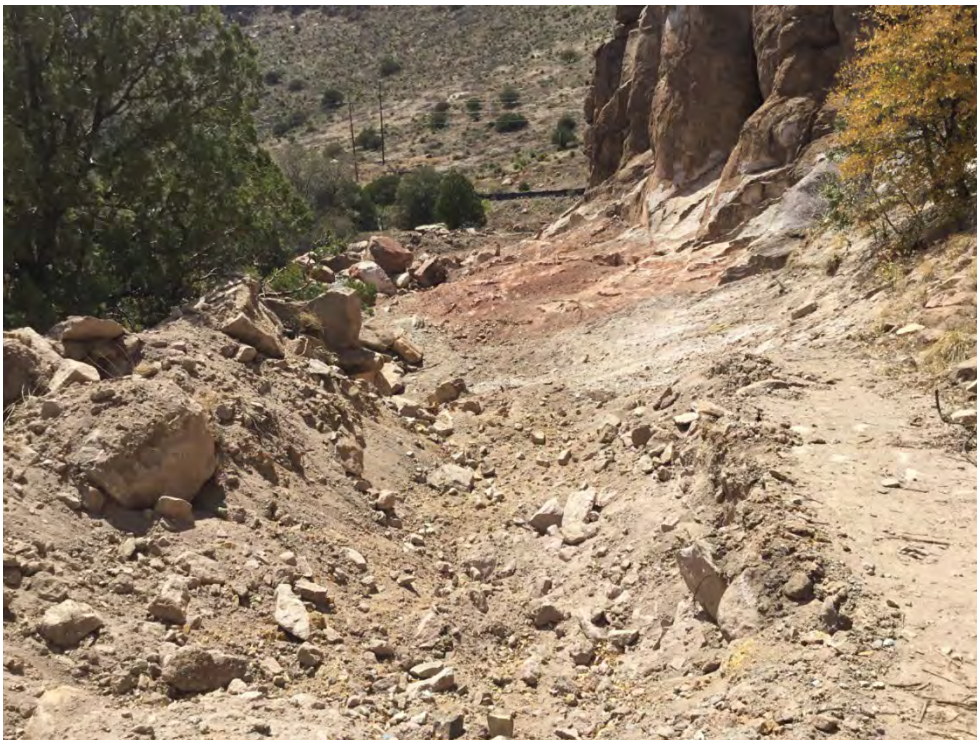
**Photograph: 18**

**Description:**  
BC13a

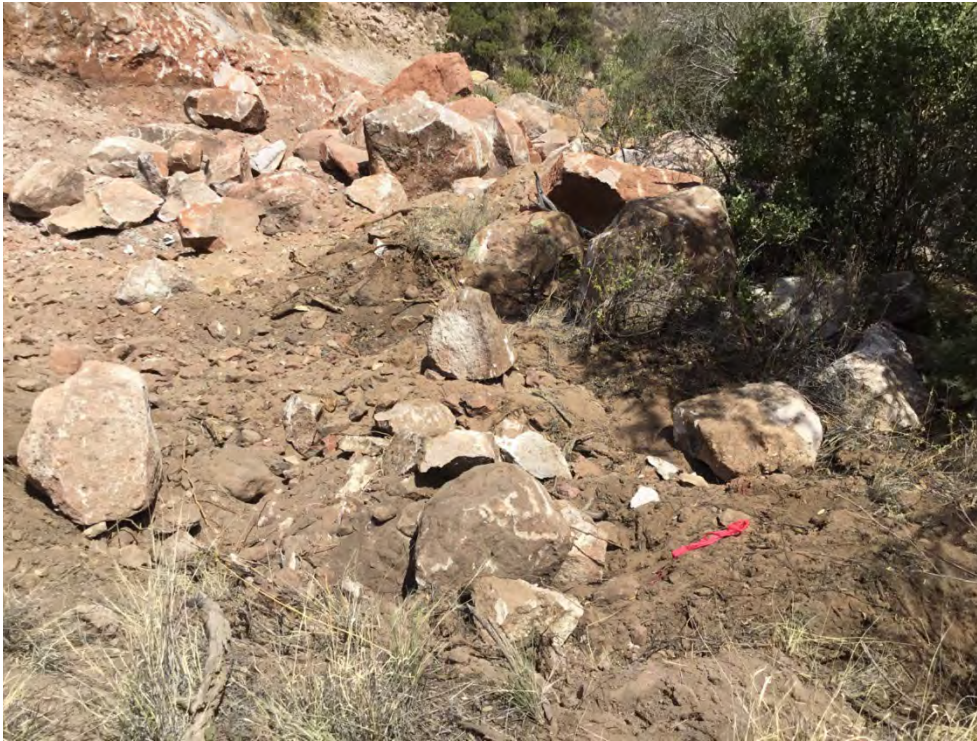
**Photograph: 19**

**Description:**  
BC14

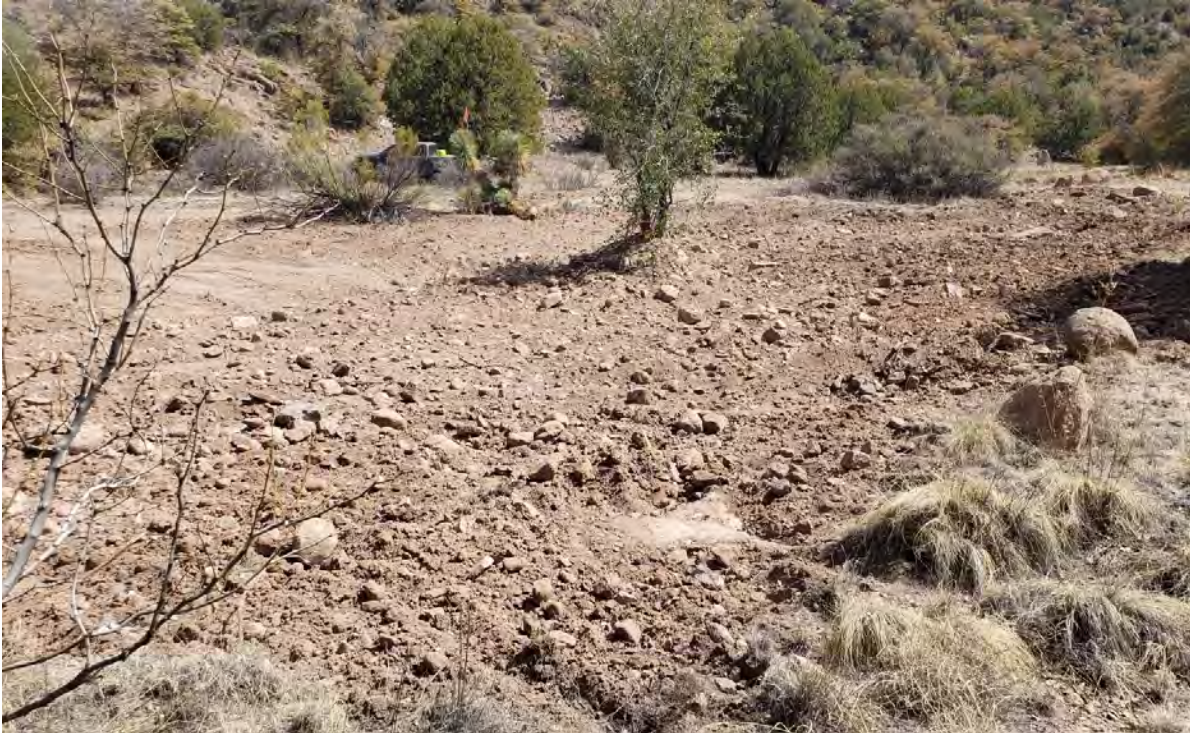
Photo 1: Shared Services expanded boundaries and depth of large, central area.

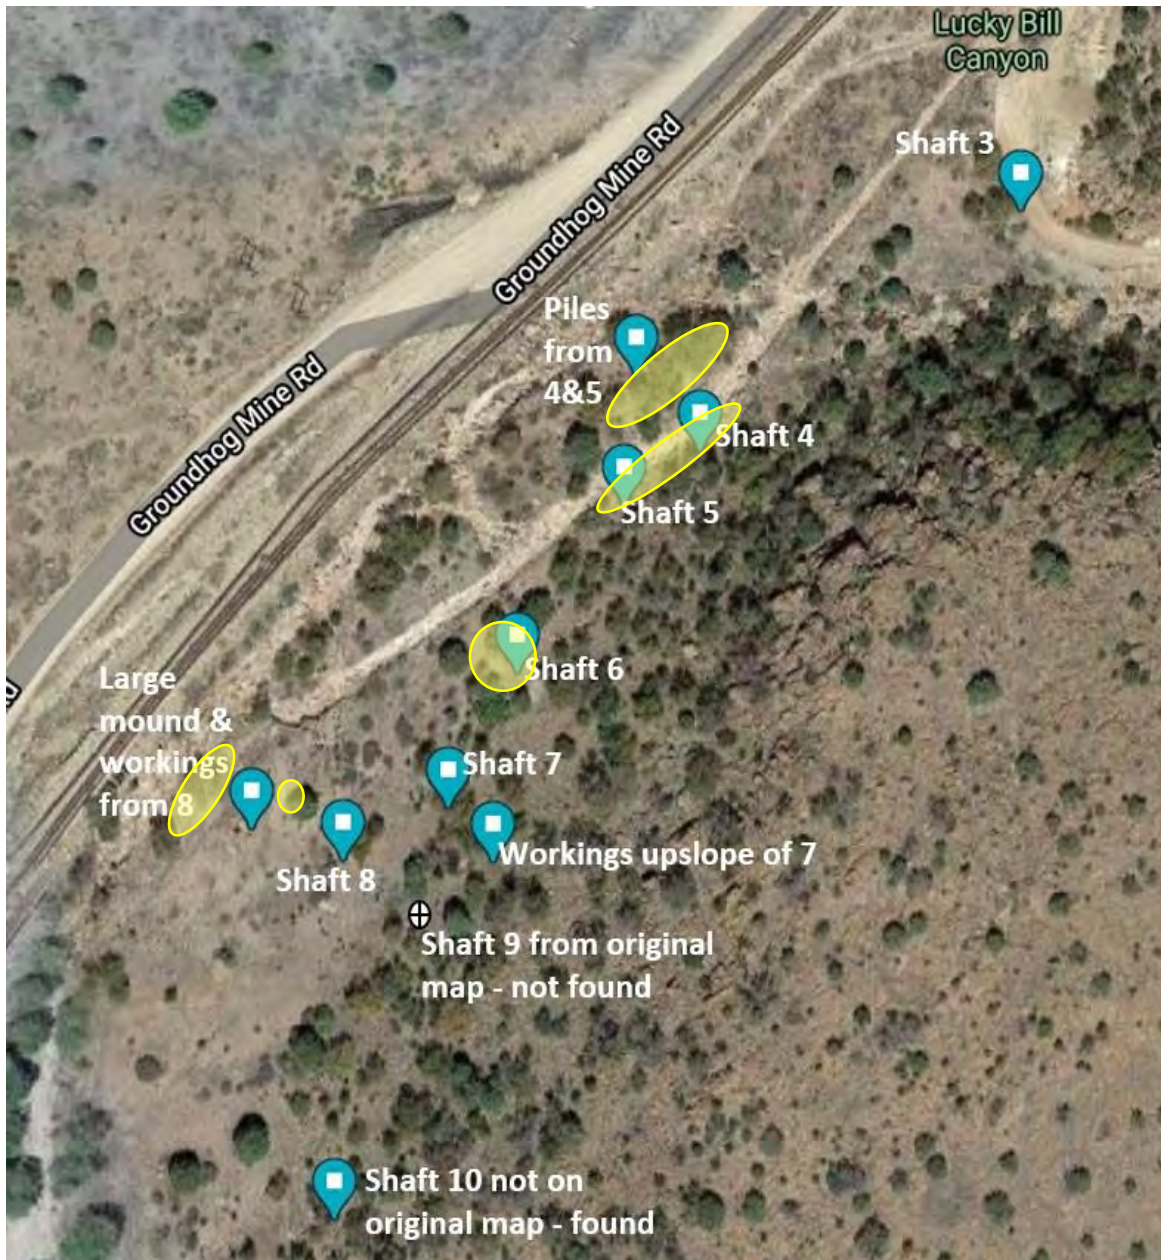
Figure 1: Central portion of site. Shared Services:

- Finished excavation around Shaft 6.
- Used excavator and loader to remove material east of access road around Shafts 4 and 5.
- Removed reddish material from multiple small stockpiles across from Shafts 4 and 5.
- Removed small area near Shaft 8 that had reddish material at surface.
- Returned to area along creek bank west of Shaft 8 and continued moving large area of red material identified by Pam as requiring additional excavation.

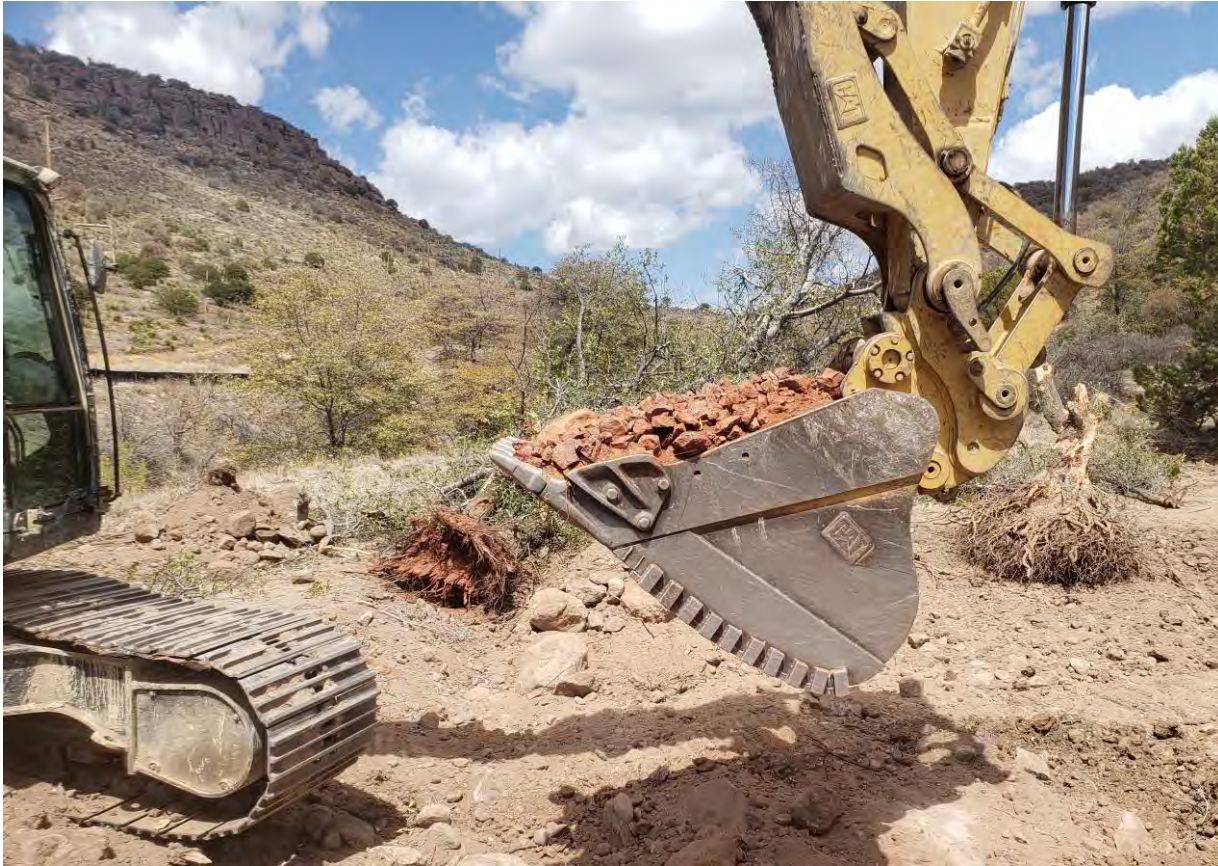
Photo 3: Red material from the creek bank west of Shaft 8 was removed.

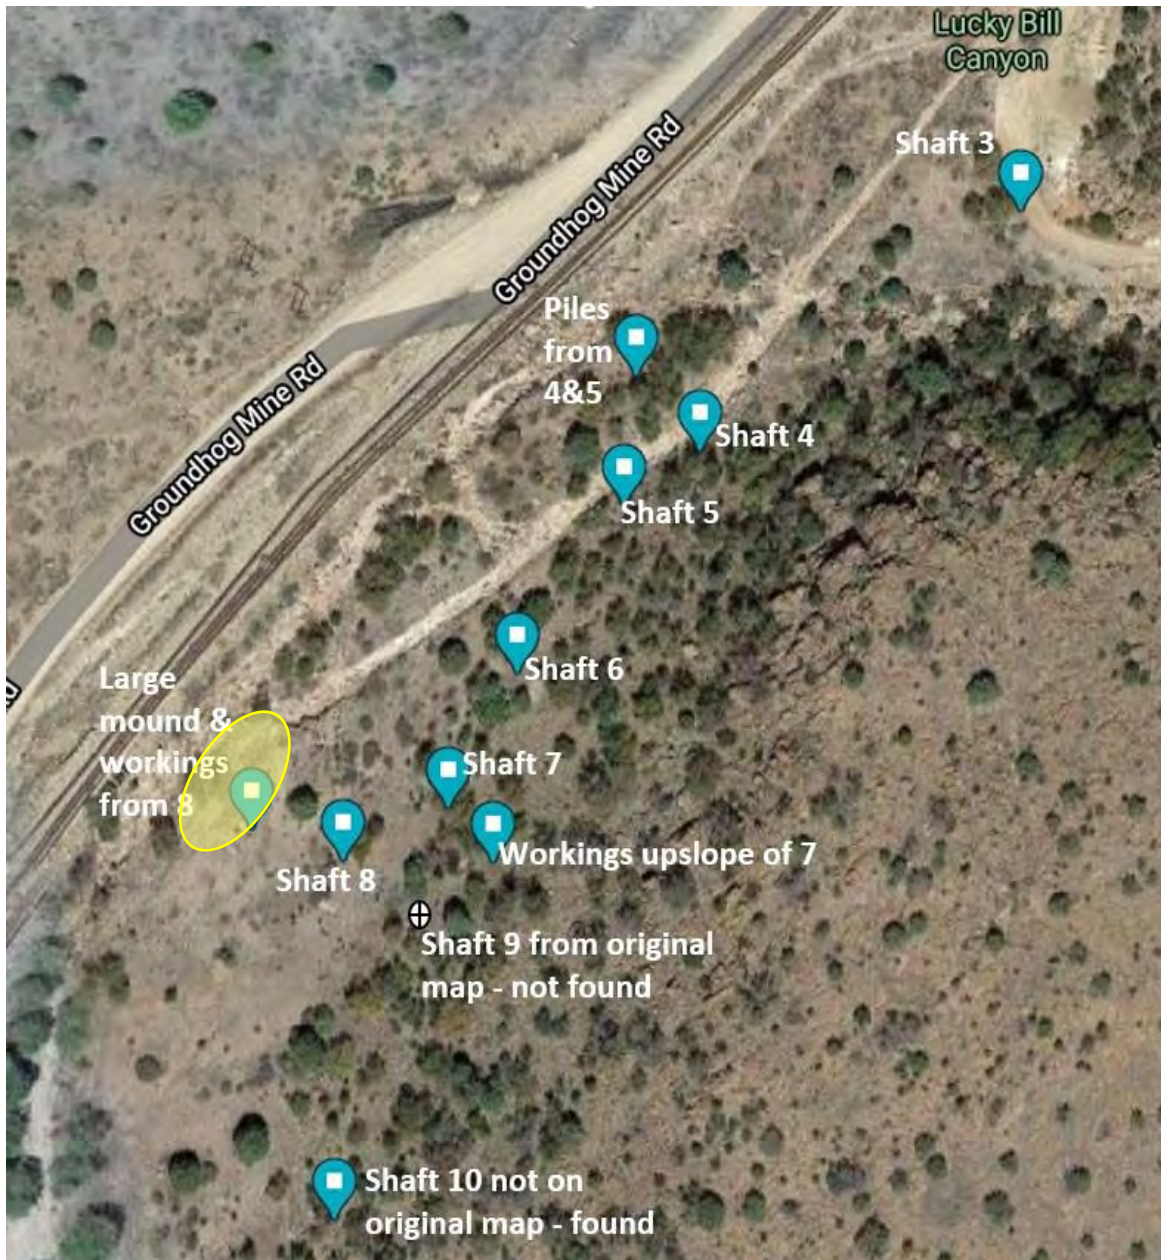
Figure 1: Central portion of site. Shared Services:

- Continued removing red material from area along creek bank west of Shaft 8.

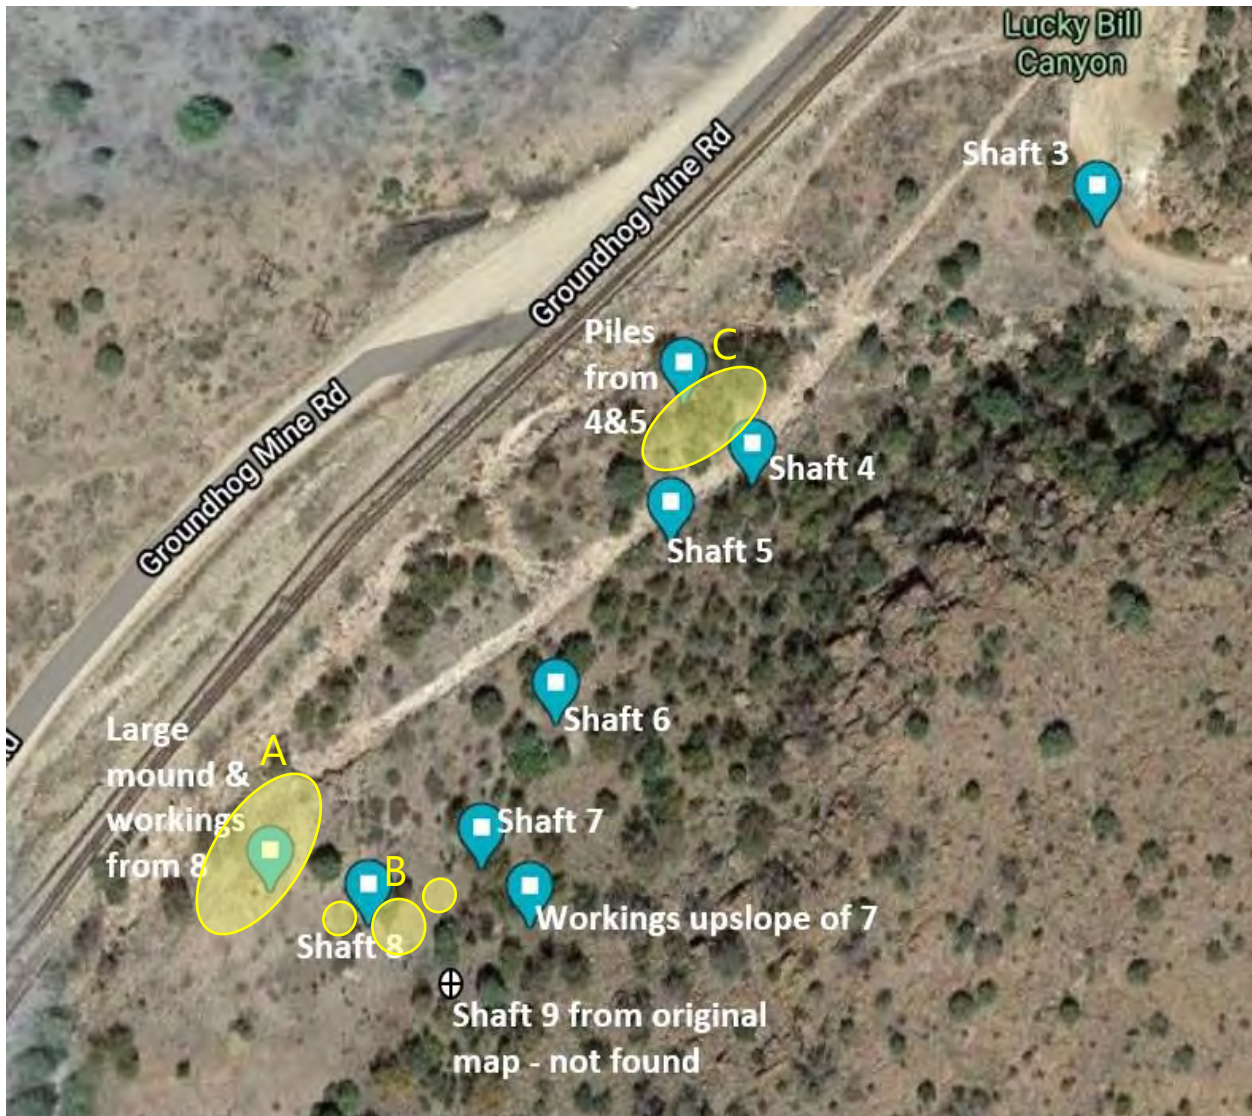
**Figure 1: Central Area.** Today, Shared Services:

- A. Completed excavation of red material along creek bed west of Shaft 8. Red material tapered off after substantial excavation to east and north from initial location. Graded a ~4:1 slope toward creek and placed existing boulders at toe for stabilization of eventual backfill.
- B. Removed reddish material from ground surface in several small areas flagged by Pam and York previous day.
- C. Removed stockpiles of reddish material located NE of Shafts 4 & 5.

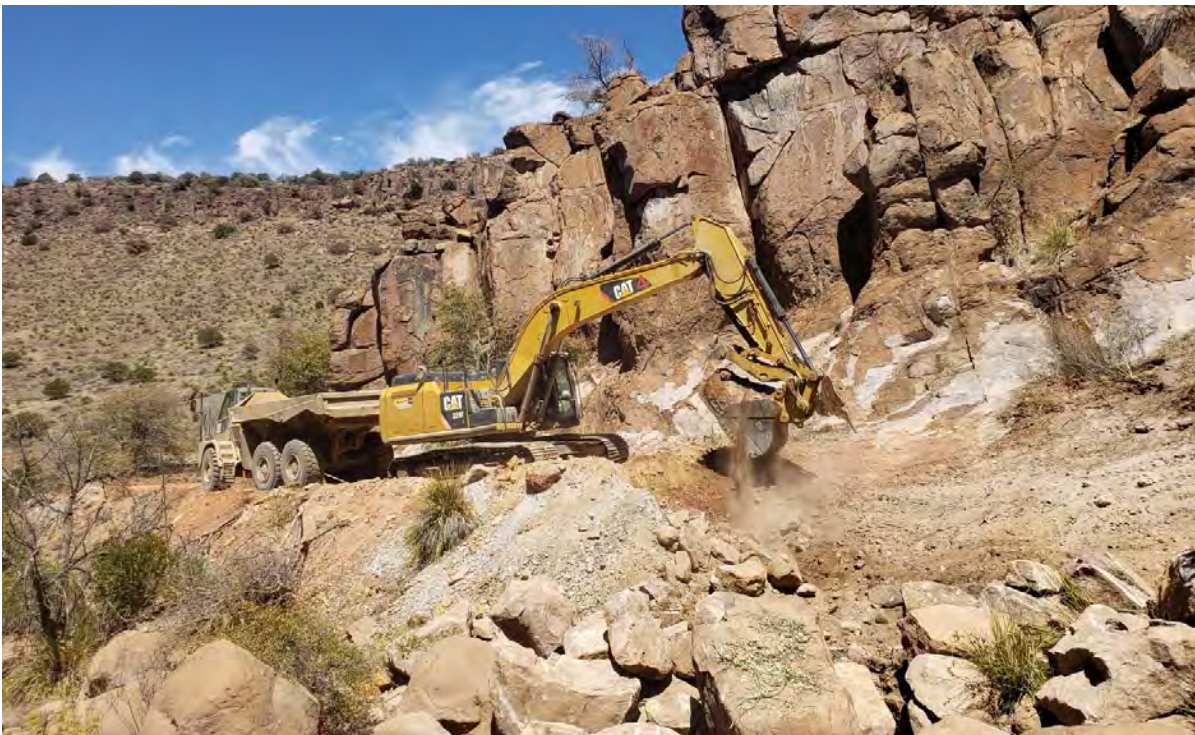
**Photo 2:** Primary focus of day was removing material at Lucky Bill confluence.

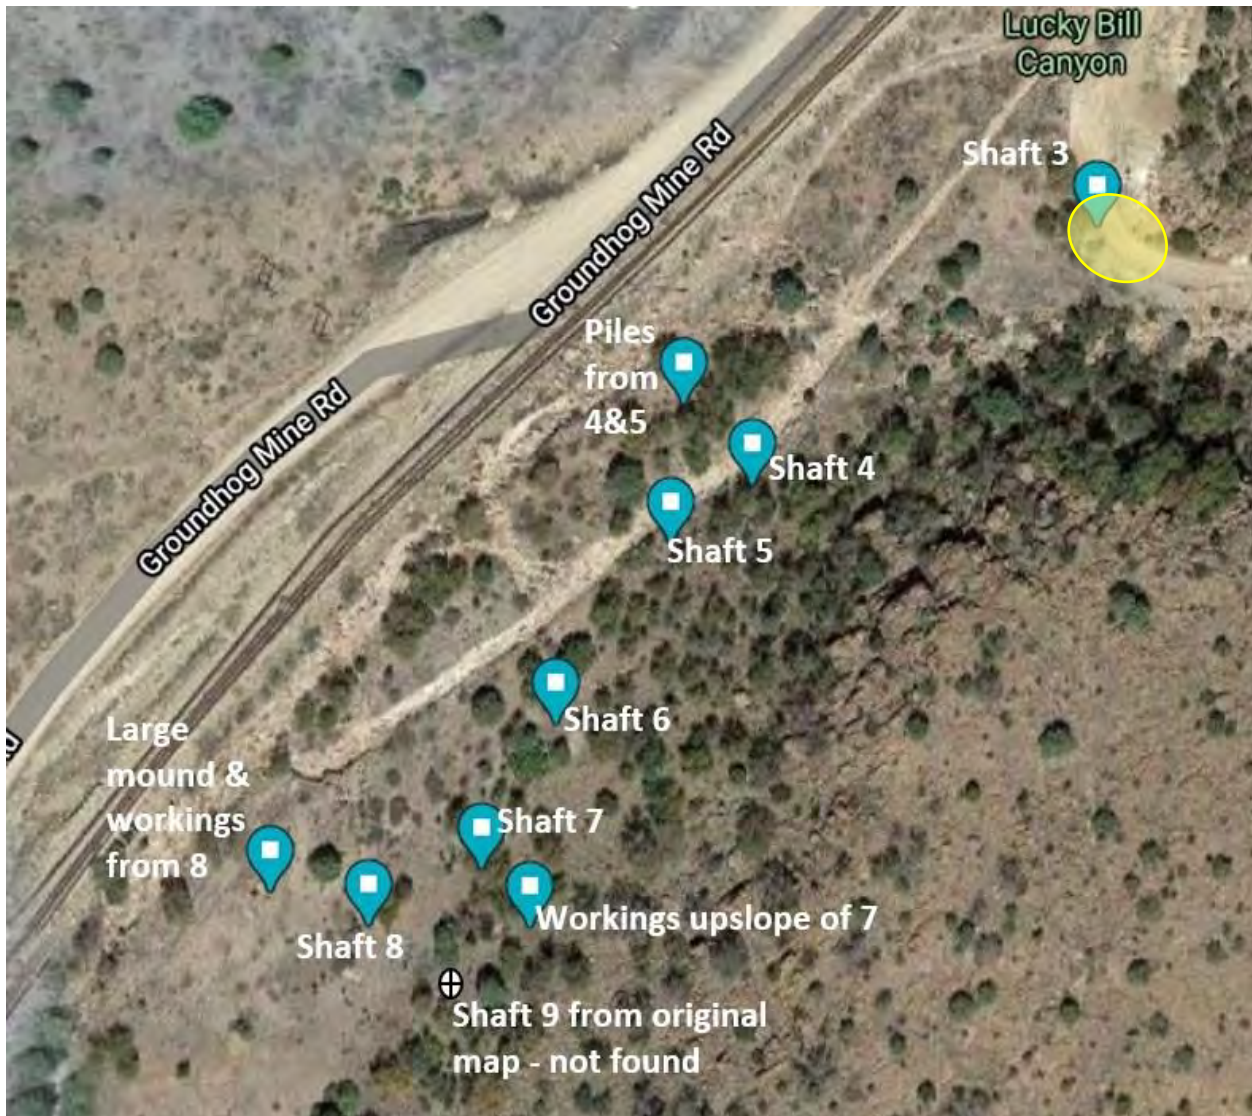
**Figure 1: Central Area.** Today, Shared Services:

- Worked 2/3 of a day adjacent to Shaft 3 at confluence with Lucky Bill Canyon – removing soil to depths of 10', down to bedrock. Large yellow circle above. Then, most of crew was called to alternate work site at Chino for final 3.5 hours of day.
- Used loader to build an outer containment berm around the first stockpile of removal material. The stockpile's footprint encroached on the original containment berm, making a breach possible with rain in the forecast.
- Used water truck for dust control on haul roads and stockpiles.

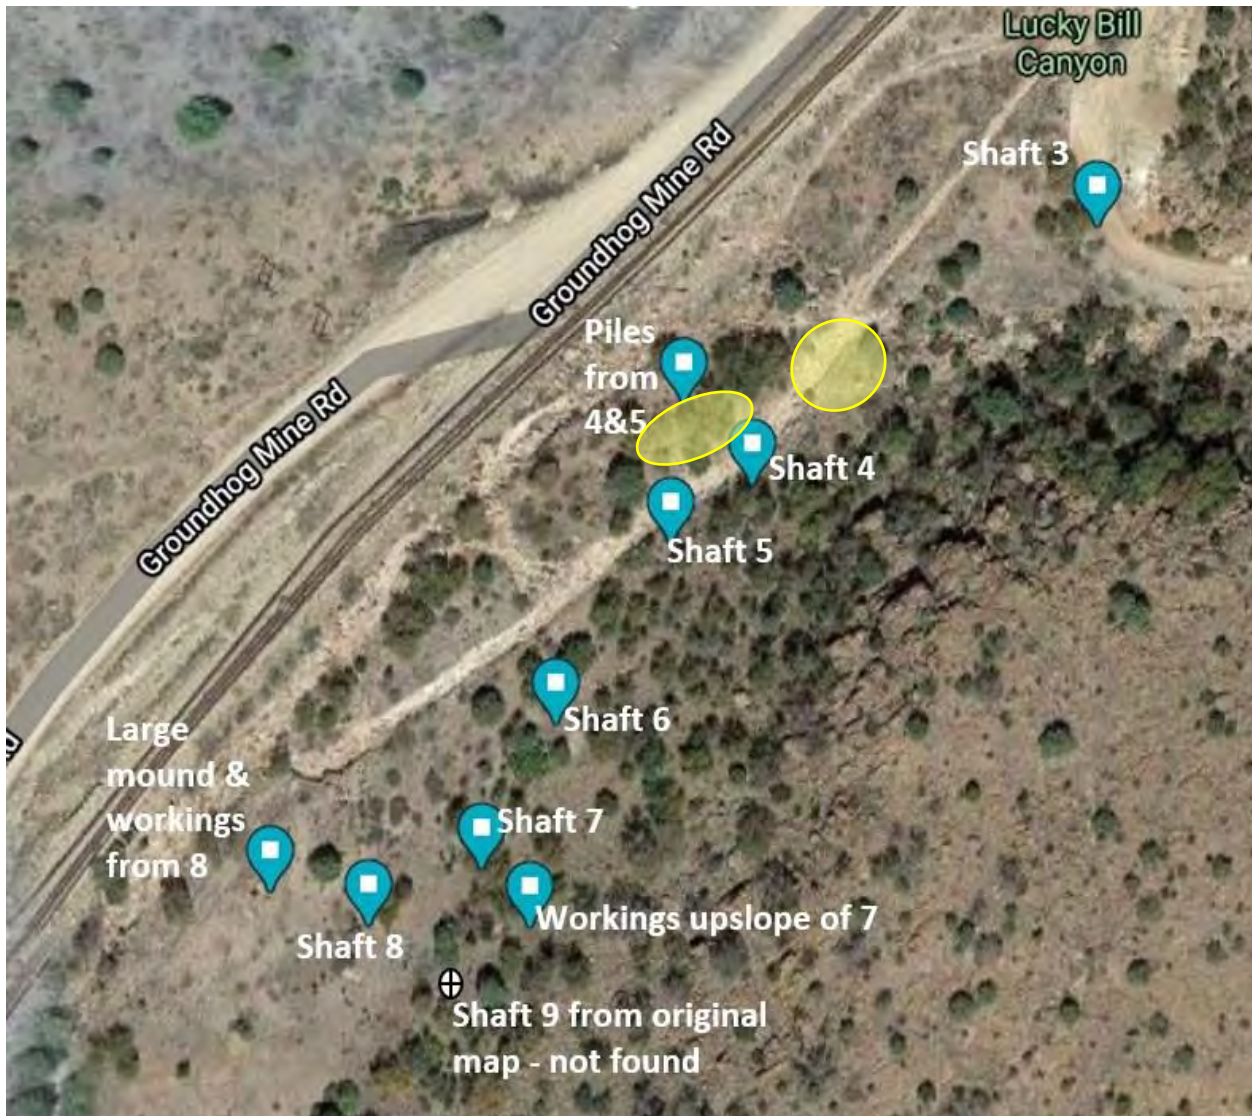
**Figure 1: Central Area.** Thursday, Shared Services:

- Had only 2 workers: 1 excavator and 1 haul truck onsite.
- Returned to location of former piles NW of Shafts 4 & 5 to remove additional material flagged by York. Removed an additional 1' of material. (Southernmost yellow oval – above.)
- While removing reddish surface material along access road at 5 separate locations flagged by York, excavator uncovered additional reddish material that required deeper excavation than expected. Excavator re-graded road after removing 2-3' of material in some areas. (Yellow circle – above.)

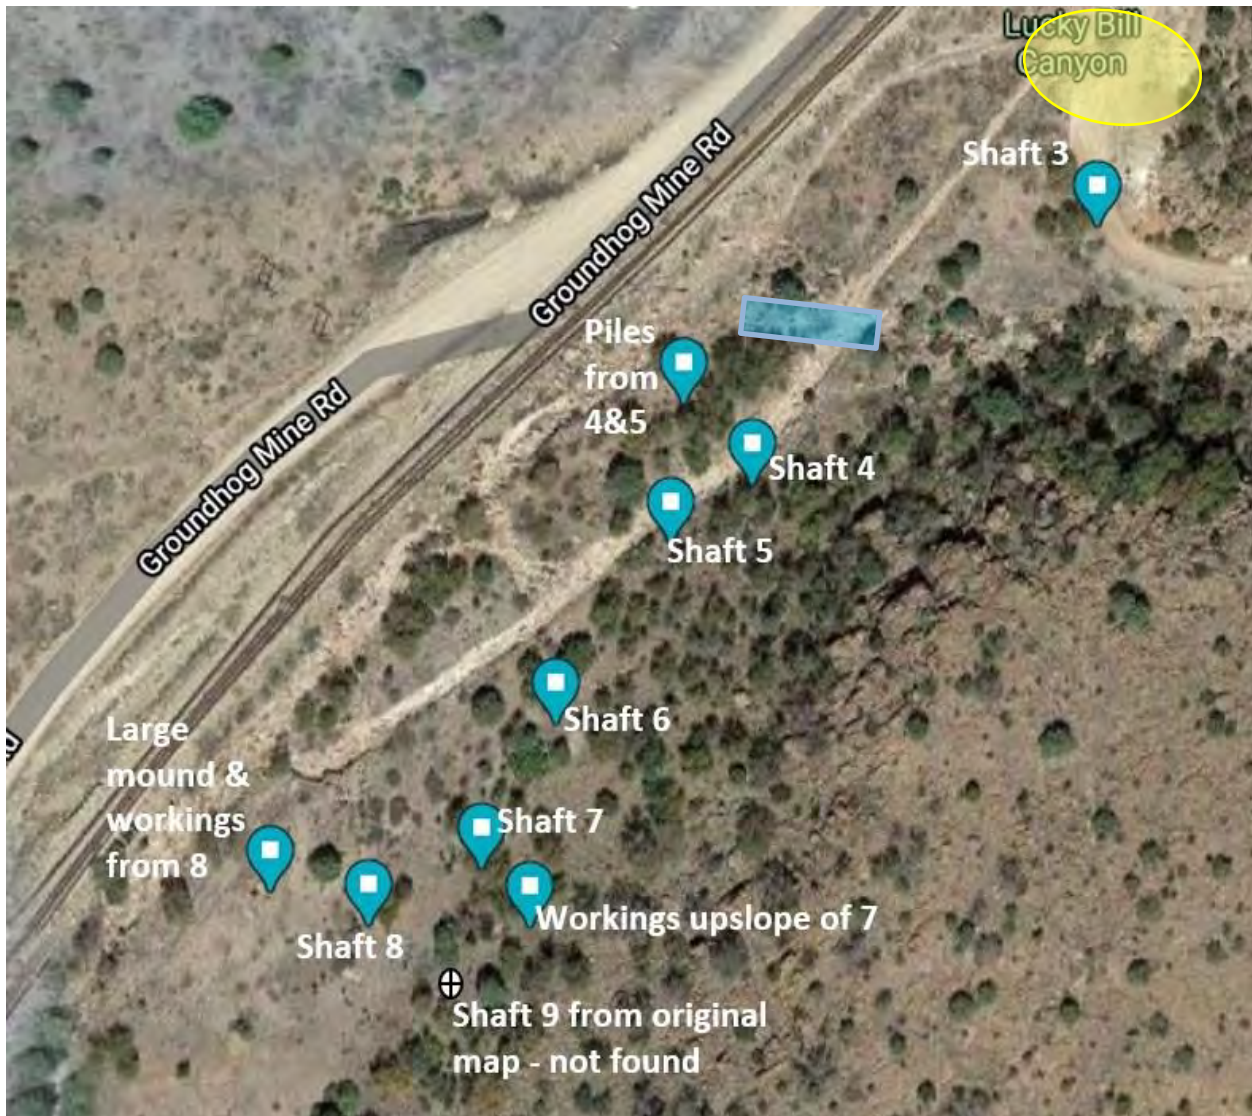
**Figure 1: Central Area.** Thursday, Shared Services:

- Removal effort focused mostly on working platform adjacent and northwest of Shaft 3 – yellow oval above. Crew used dozer to push piles of reddish material, that were loaded into 2 haul trucks with loader.

- After Pam arrived with NMED, crew used excavator to remove yellowish material from upper left portion of yellow oval – above. Target material was found in creek bed at thickness of up to 8’.

- Excavator cleared material from slope on right side of yellow oval – above.
- Excavator also cleared area of original creek bed going east to west from Lucky Bill into Bayard Canyon – see blue rectangle above. Plan is to re-establish creek flow into its original footprint to prevent it following construction access road south. Crew will leave a ramp across re-established creek so seeding crew can access southern end of site in June.

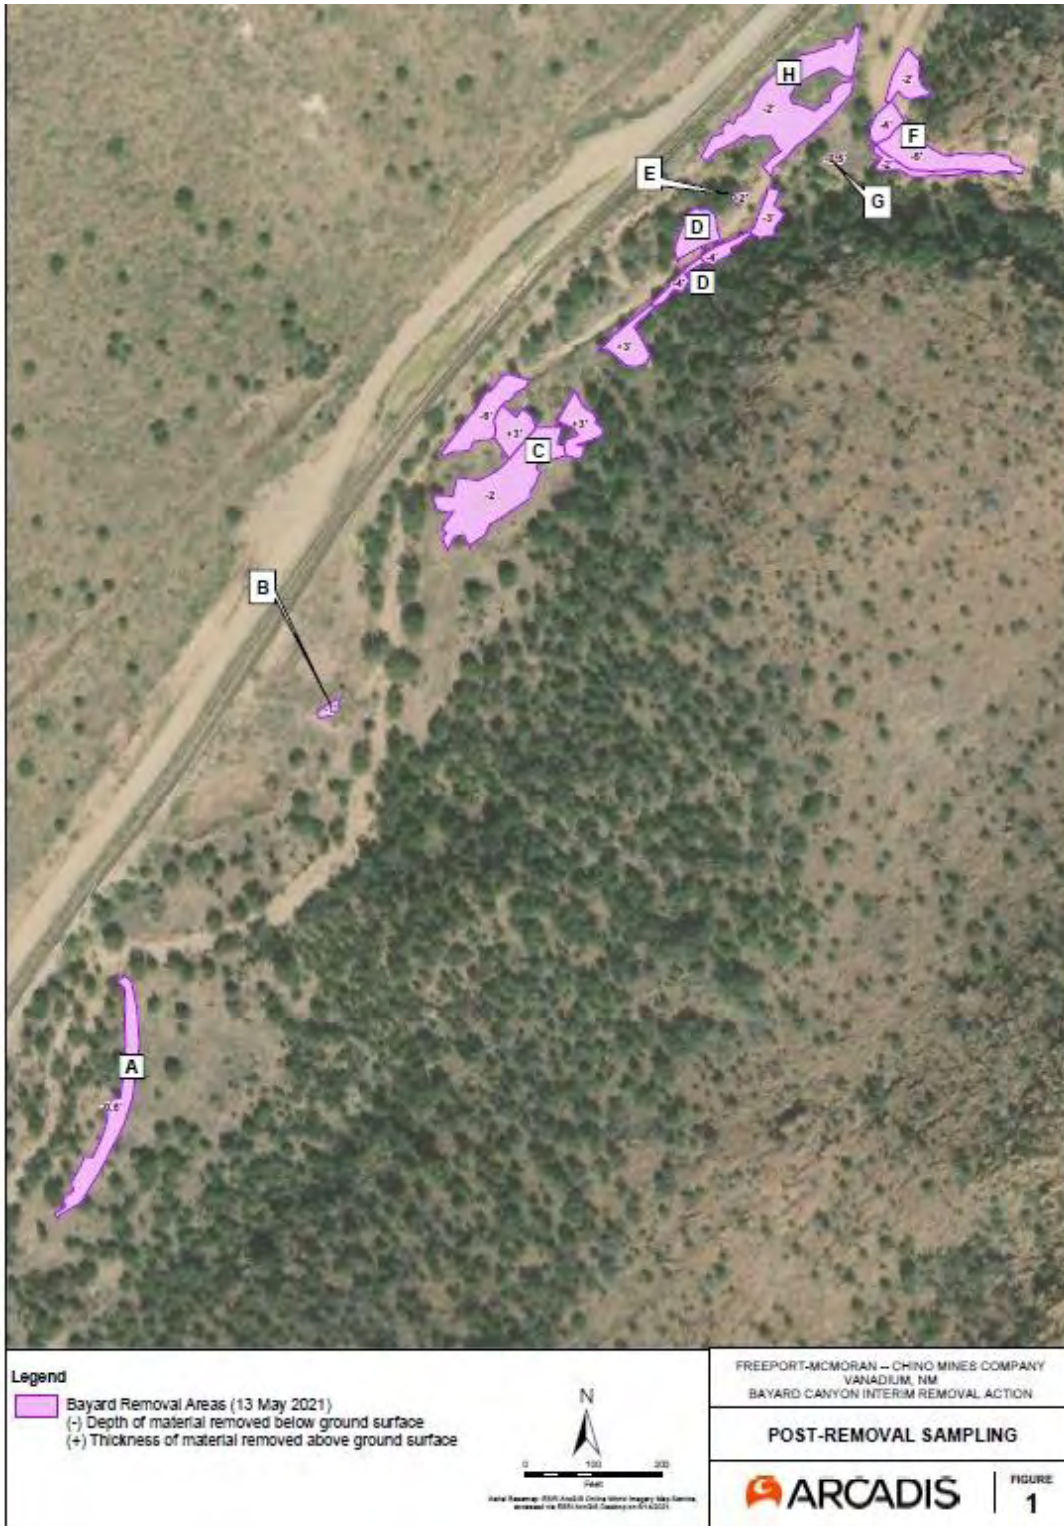
**Figure 2: Post-Removal Sampling Map.**

York collected post-removal samples from Areas D, E, G, & H today. These areas are ready for backfill.

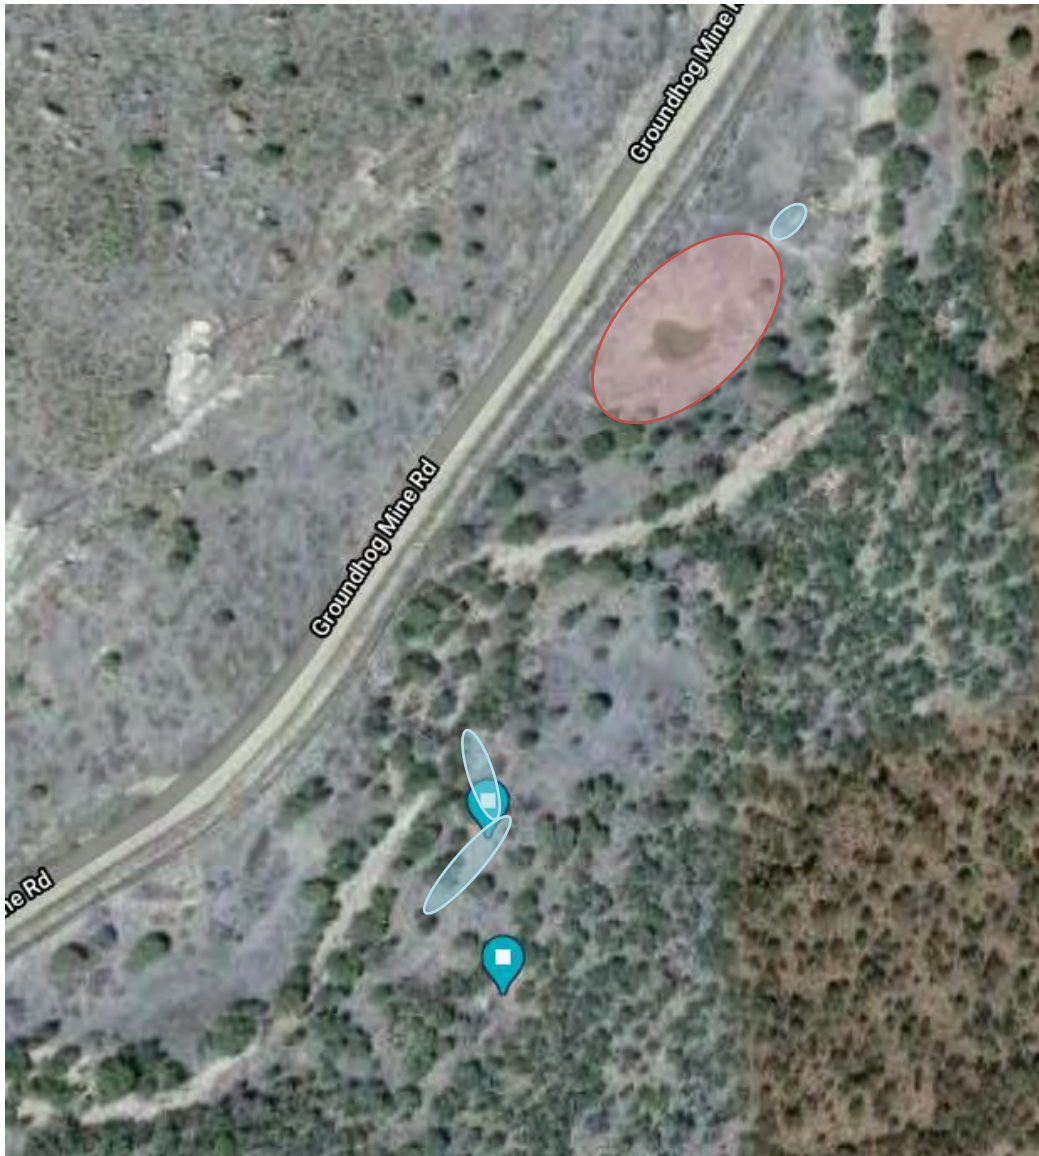
**Figure 2: Southern Area Backfill Map:**

Shared Services started and finished backfill at the 2 southernmost removal areas (blue ovals) today. Borrow area for backfill materials is shown in red oval.

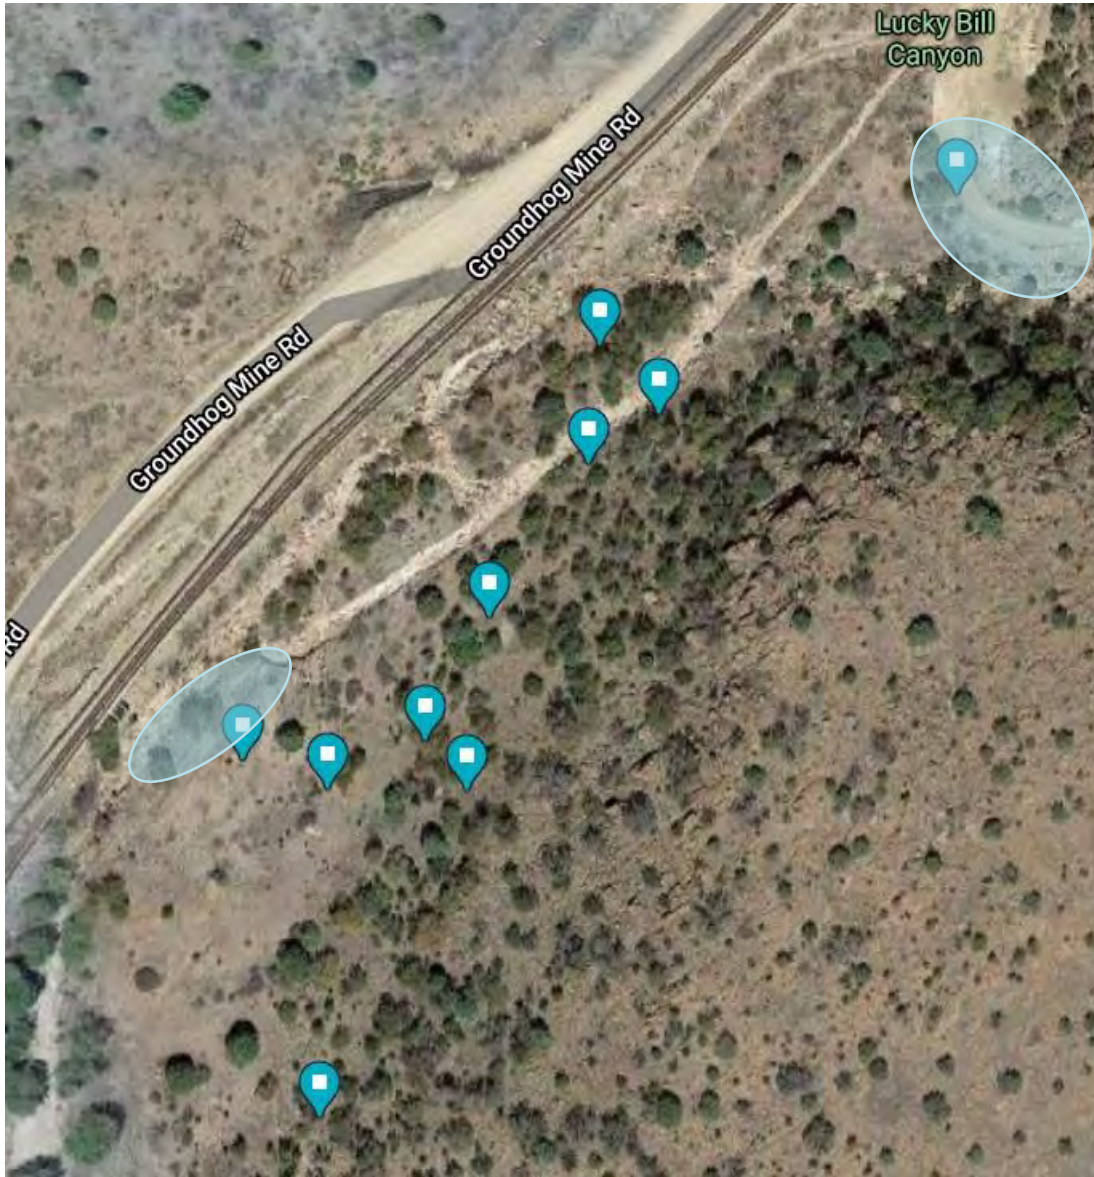
**Figure 1: Central Area Backfill Map:**

- Shared Services continued backfilling and re-building road leading into Lucky Bill Canyon.
- Crew also began backfilling creek bank in area where deep removal occurred. Crew is using cover material from 2<sup>nd</sup> borrow area at Groundhog (vs. material in southern borrow area) because it is rockier and should armor the creek bank better than the other material.
- Crew hauled 2 large boulders from central area to stockpile because boulders were stained red with a crust of red soil.

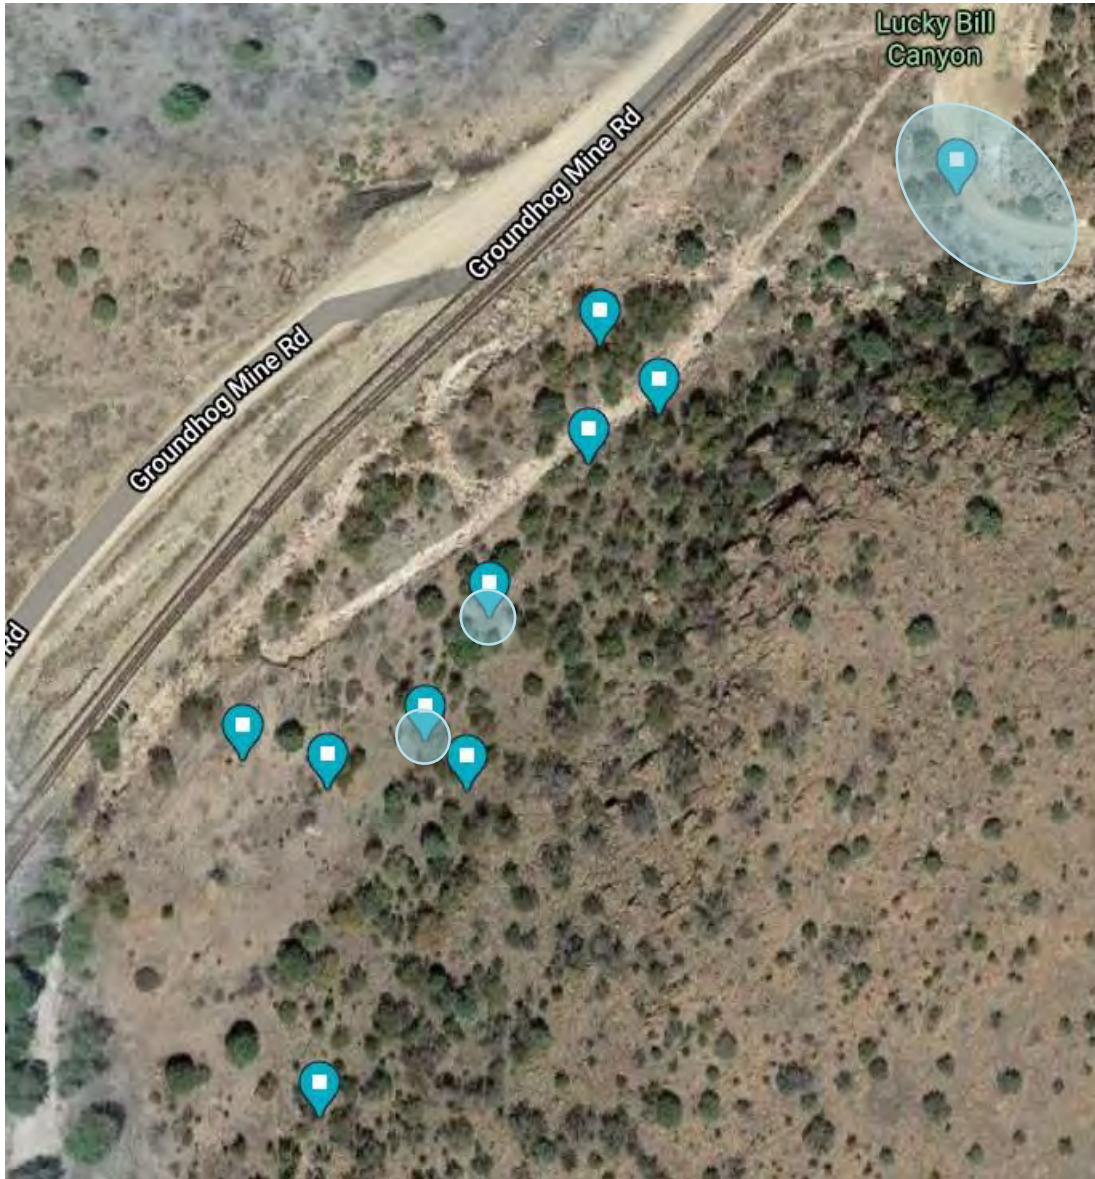
**Figure 1: Central Area Backfill Map:**

- Shared Services continued backfilling and re-building road leading into Lucky Bill Canyon. Road appears to be complete unless it subsides.
- Crew also placed "ant hill" mounds over 2 former mine workings per direction from Pam.

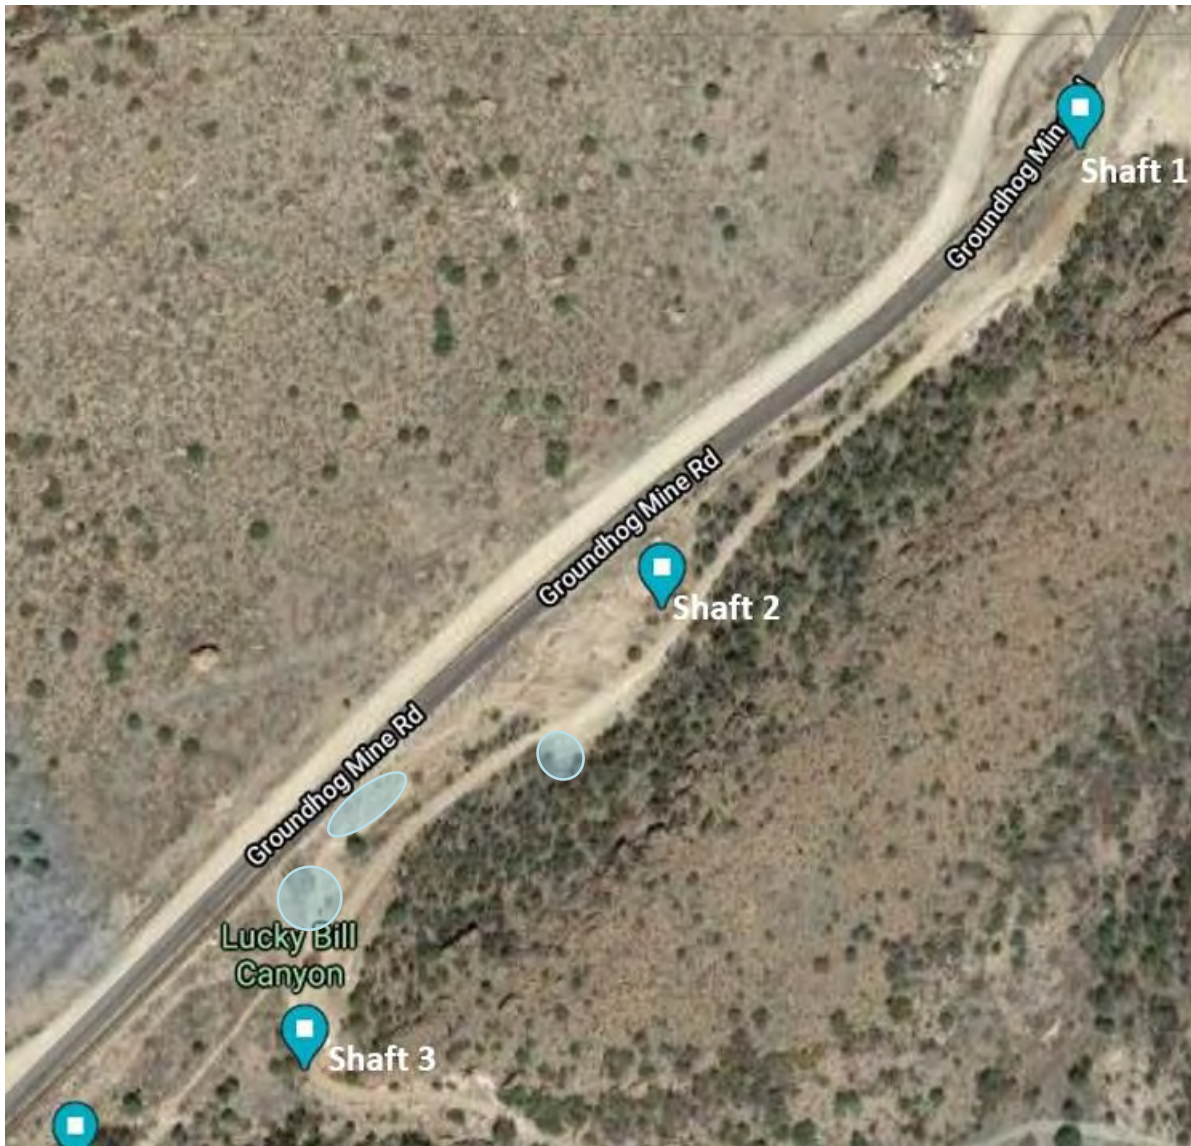
**Figure 2: Northern Area Backfill Map:**

- Shared Services began backfilling above Lucky Bill confluence including partial fill of deep area that formed during soil excavation (bottom circle), shallow areas along creek (oval), and a "new" mine feature south of Shaft 2 where an "ant-hill" mound was placed.
