# **BAYARD CANYON SUPPLEMENTAL INTERIM REMOVAL ACTION COMPLETION REPORT**

Hanover Whitewater Creek Investigation Unit  
Vanadium, New Mexico

July 2022

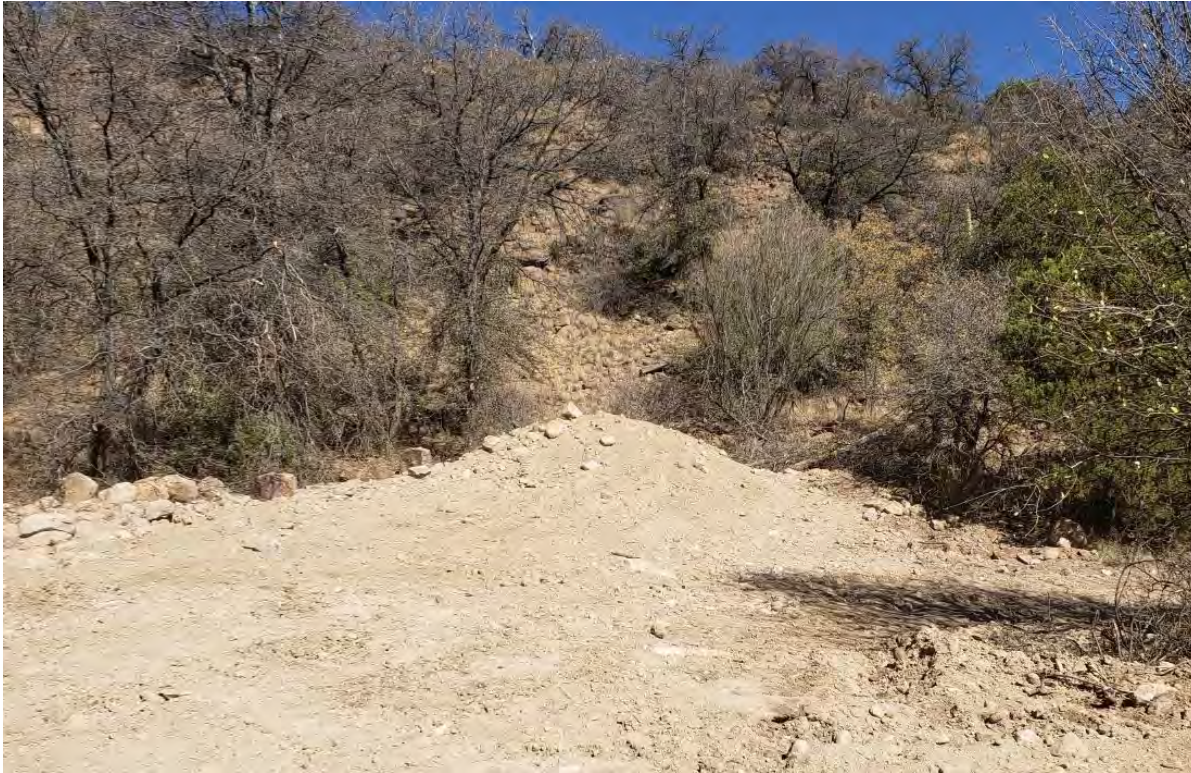
**Photo 3:** "Ant-hill" mounds were constructed above former workings south of Lucky Bill.

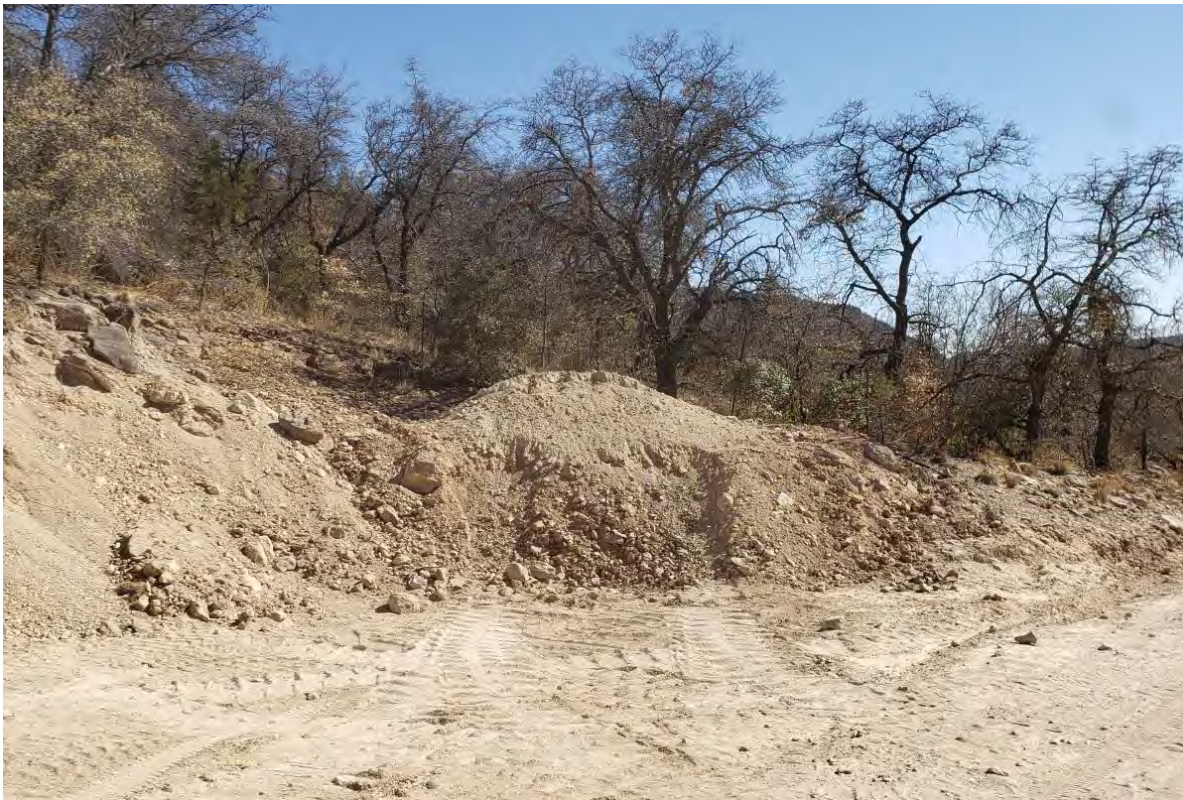
**Photo 4:** "Ant-hill" mound was placed above former working south of Shaft 2.

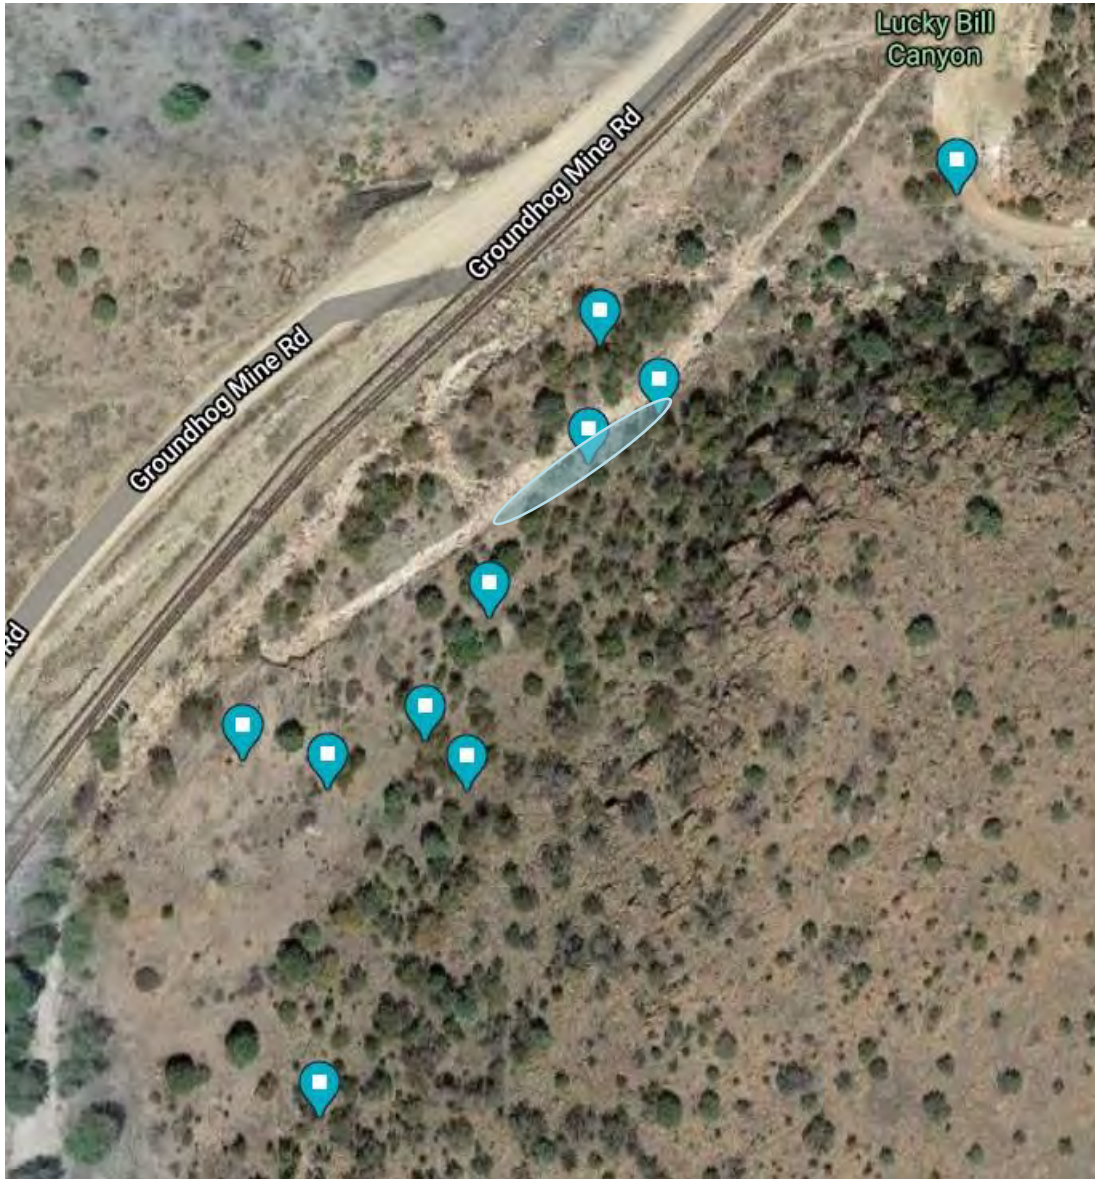
**Figure 1: Central Area Backfill Map:**

- Shared Services returned to areas along the access road below Lucky Bill, placed mounds over former workings, covered bare areas, and regraded spots that were cut to build the road.

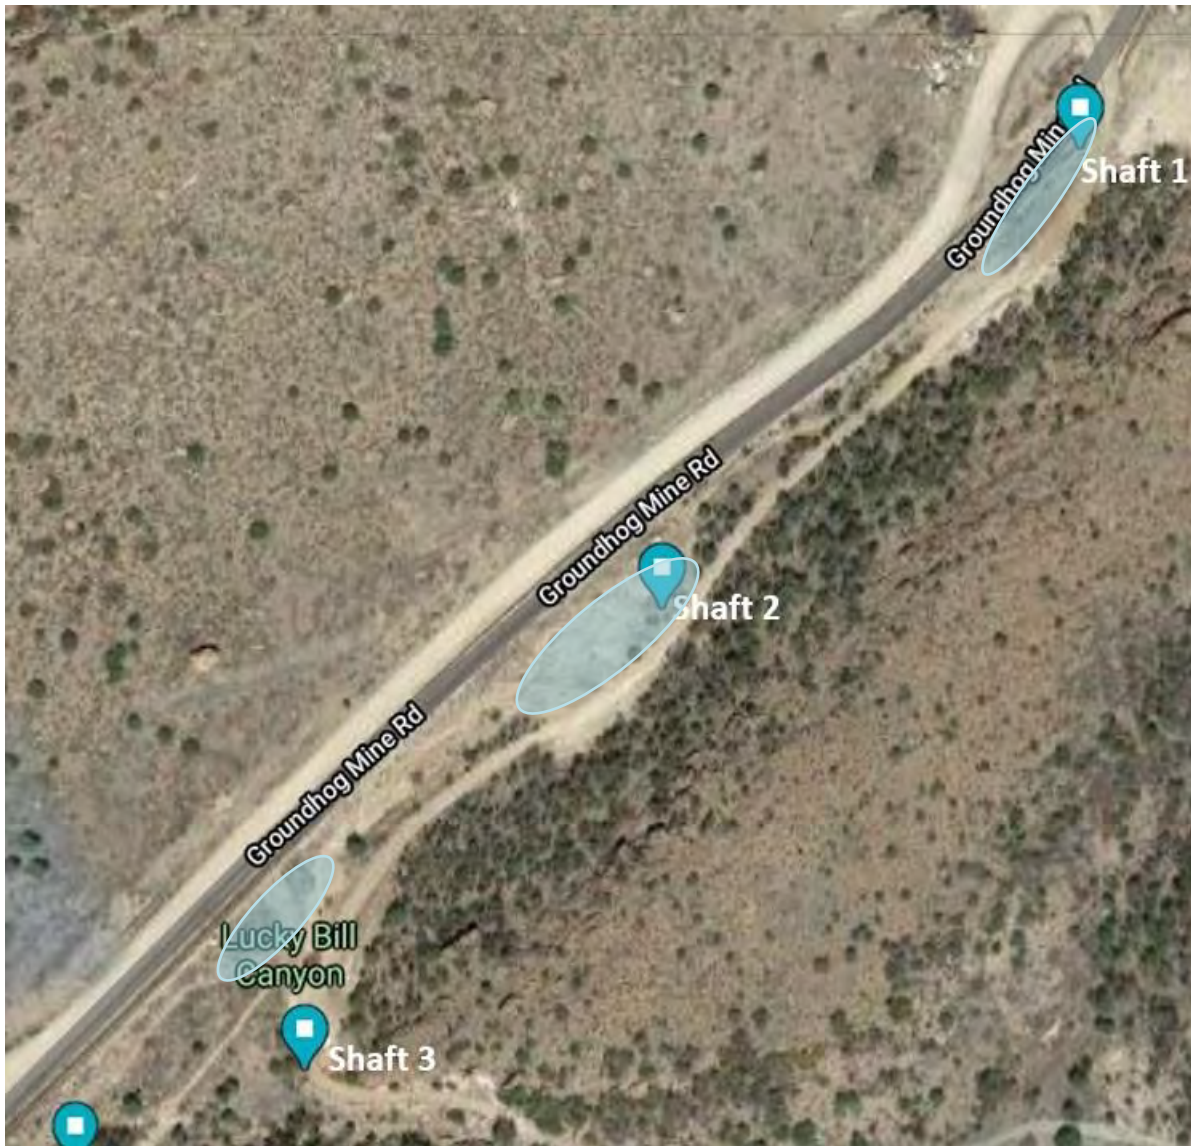
**Figure 2: Northern Area Backfill Map:**

- Shared Services finished filling the low area northwest of the Lucky Bill confluence and then cut a channel through it to control creek flow (lower oval).
- Cover and mounds were placed in broad area around Shaft 2.
- Numerous loads of cover material were placed along the red wall at Shaft 1.

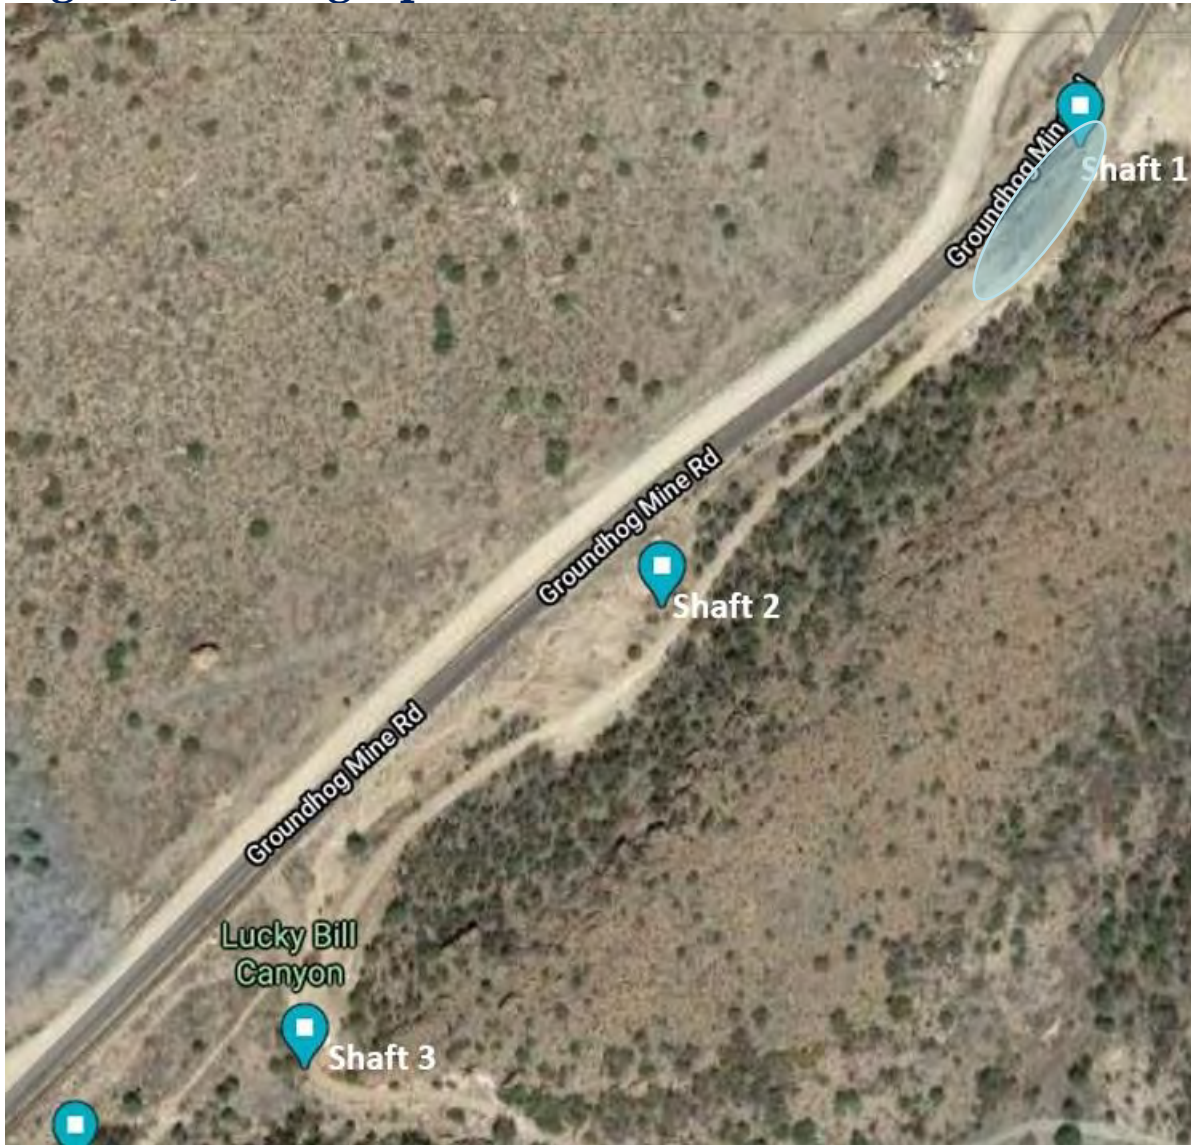
**Figure 1: Northern Area Backfill Map:**

- Shared Services spent most of the day rebuilding the ramp and road going into the north end of Bayard Canyon.

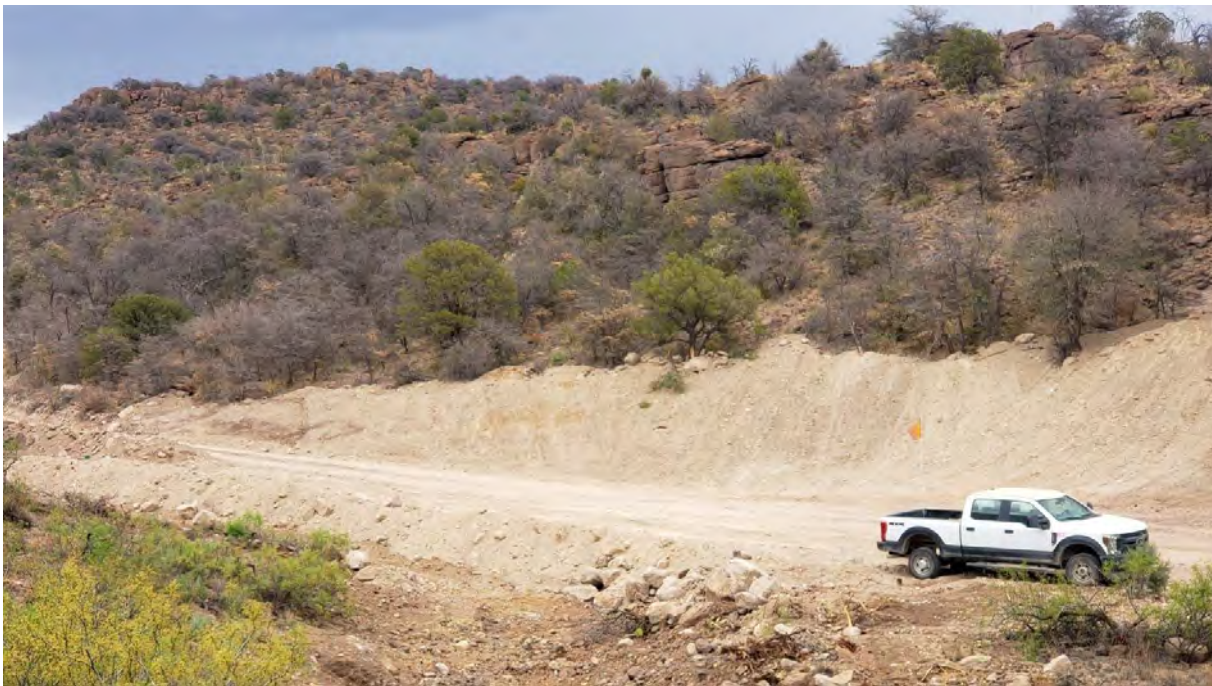
**Photo 4:** Covered area above Lucky Bill confluence.

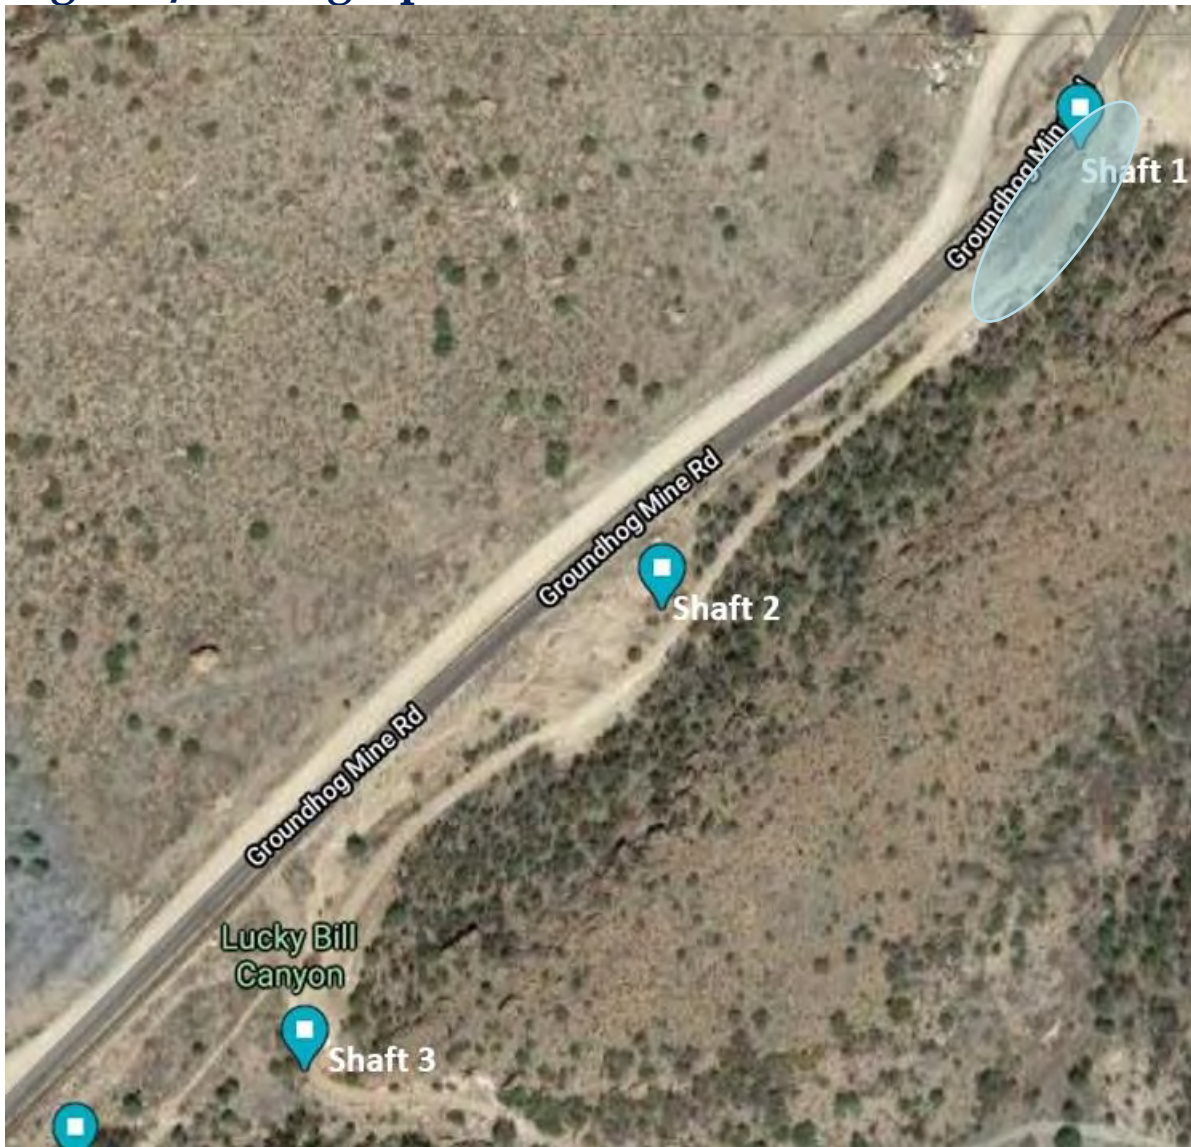
**Figure 1: Northern Area Backfill Map:**

- Shared Services spent most of the day continuing to rebuild the ramp and road going into the north end of Bayard Canyon.
- Crew used rocky material from borrow source near Groundhog for most of base material on ramp and then placed several loads of finer material from the lower borrow area on top to reduce rockiness on the surface.
- Crew began covering eastern slope at north end of work area – adjacent to ramp, where stormwater will be channeled.

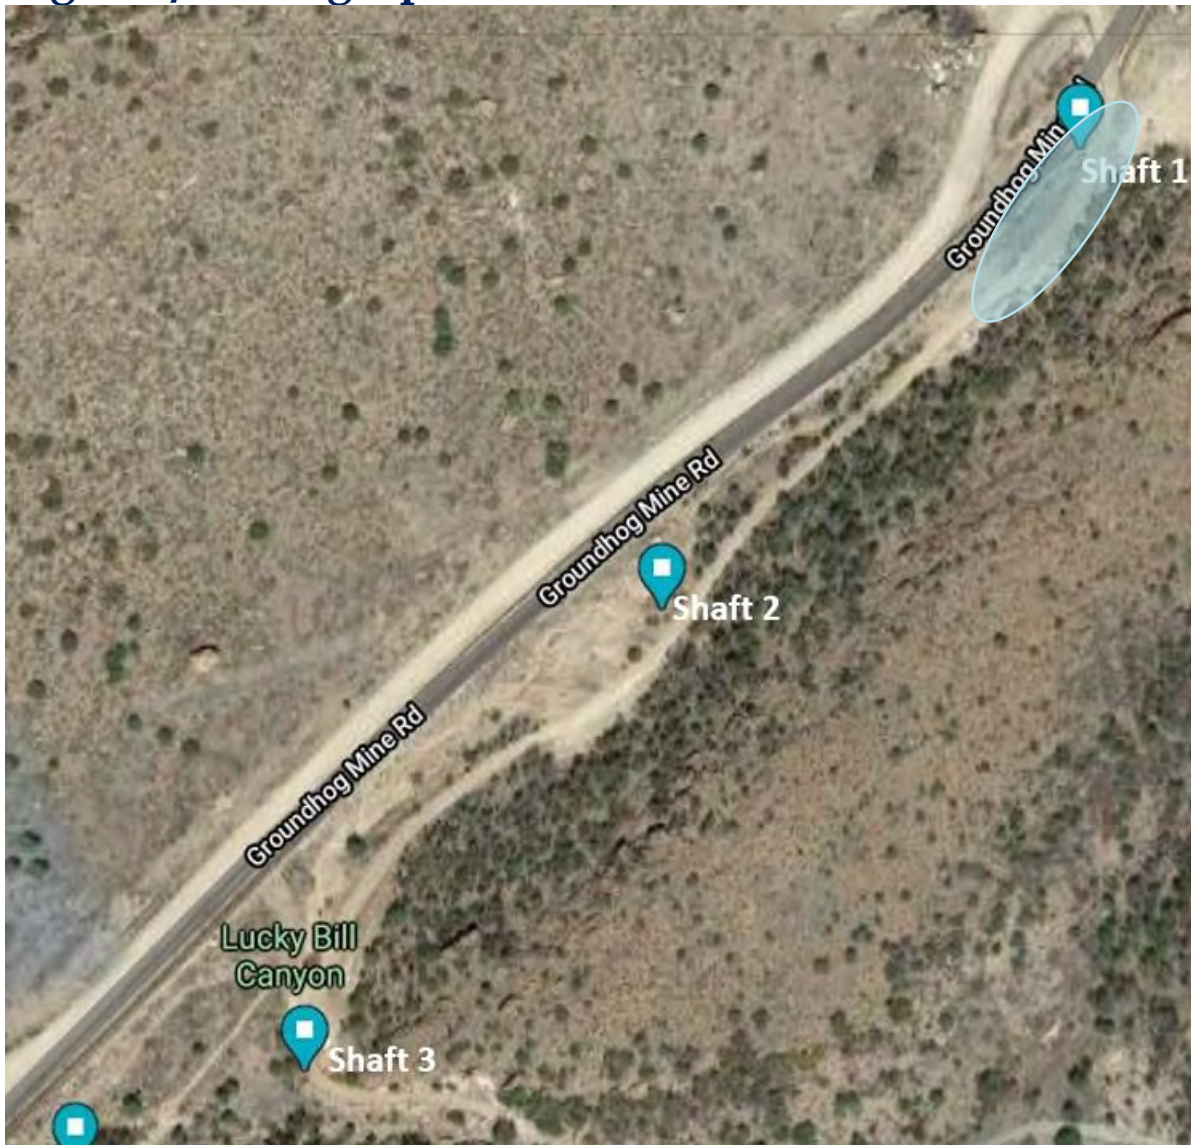
**Figure 1: Northern Area Backfill Map:**

- Shared Services finished reconstruction of the ramp leading into the north end of the jobsite. This work also included covering the east bank with borrow material and constructing features that will keep stormwater flowing in the designated channel.

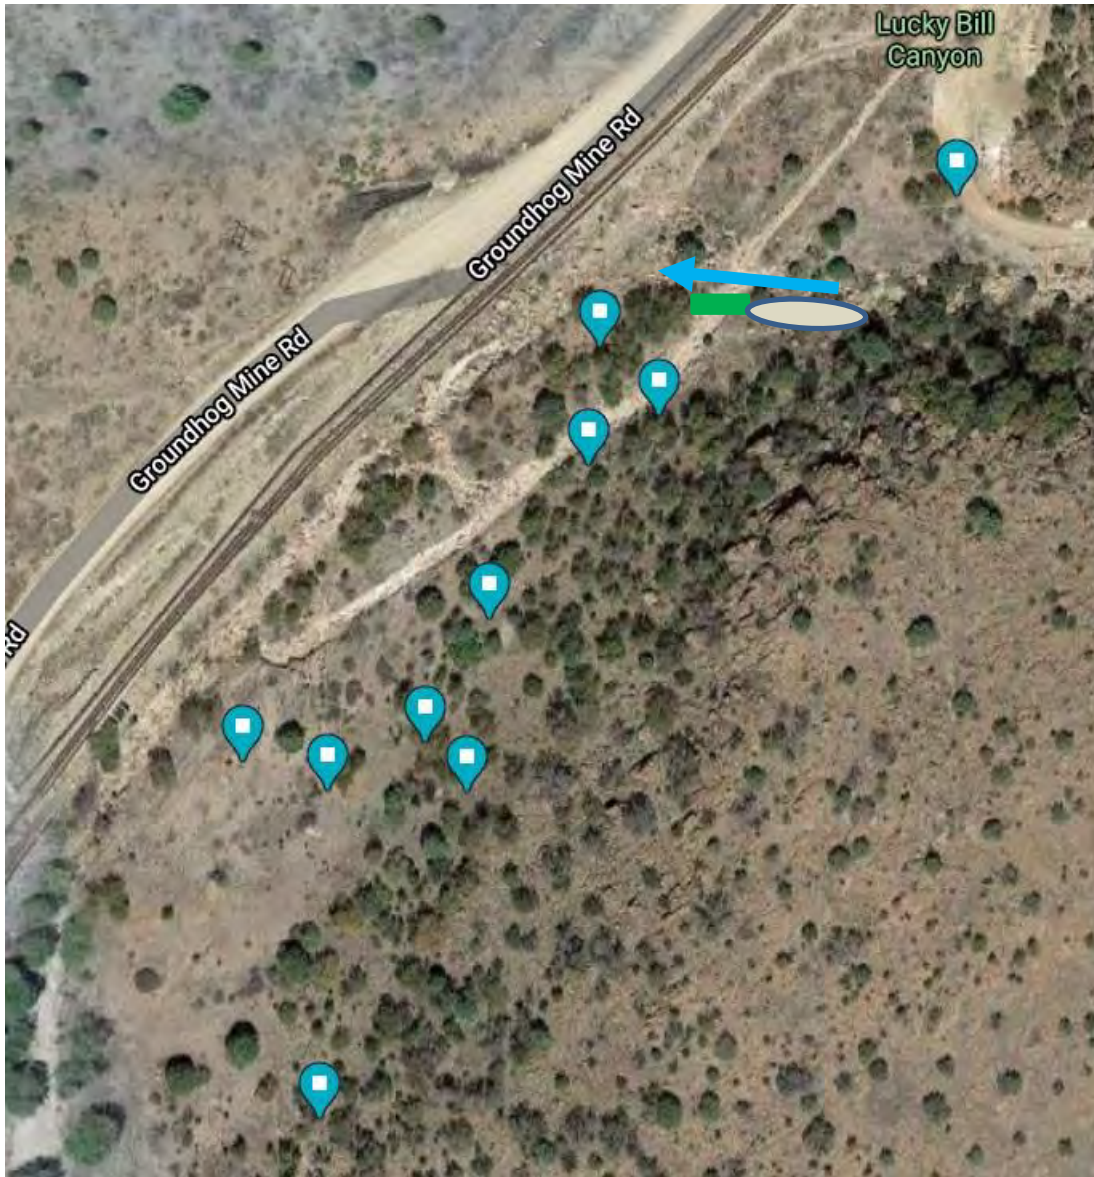
**Figure 2: Central Area Backfill Map:**

- Shared Services removed soil and boulders from creek in an effort to encourage flow from Lucky Bill into its original channel (blue arrow above).
- Crew built a 3'-4'-high berm (green rectangle above) across the access road in line with the creek channel. This should enable the seeding crew to cross the creek while keeping flow within the banks.
- Crew added boulders and a levee of cover material along creek bank (tan oval above) at spot where creek from Lucky Bill previously jumped bank.

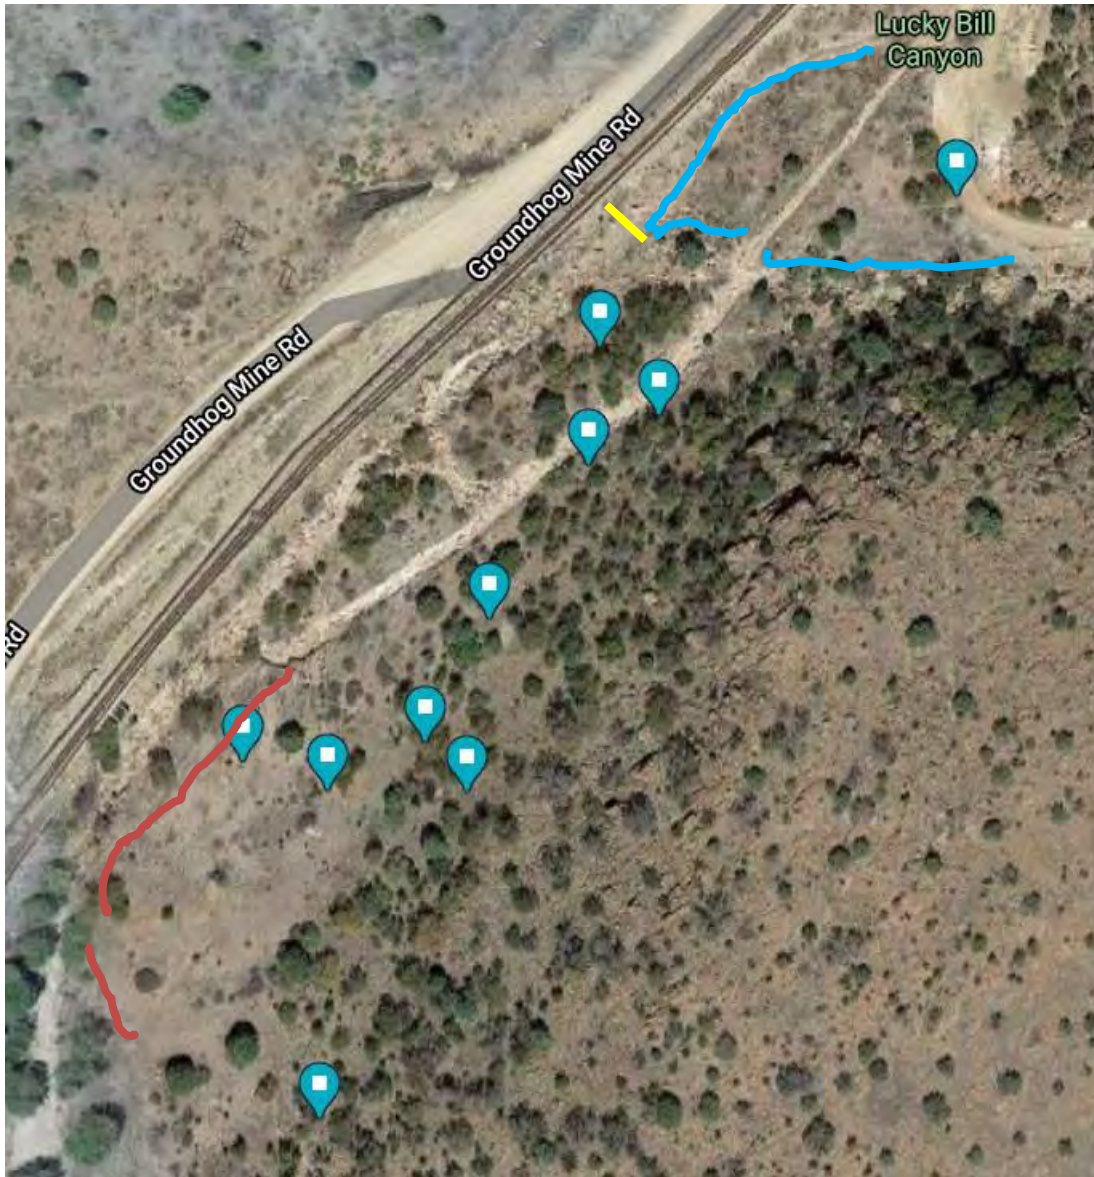
**Figure 2: Central Area Backfill Map:**

- Crew constructed stormwater control berms along creek bank where ground was too rocky for staking wattles – blue lines above.
- Crew installed straw wattles along portions of creek where practicable – red lines above.
- Crew used boulders and cobbles to construct a filter dike (yellow line) across the Bayard Canyon creek slightly upgradient of creek’s confluence with Lucky Bill creek.

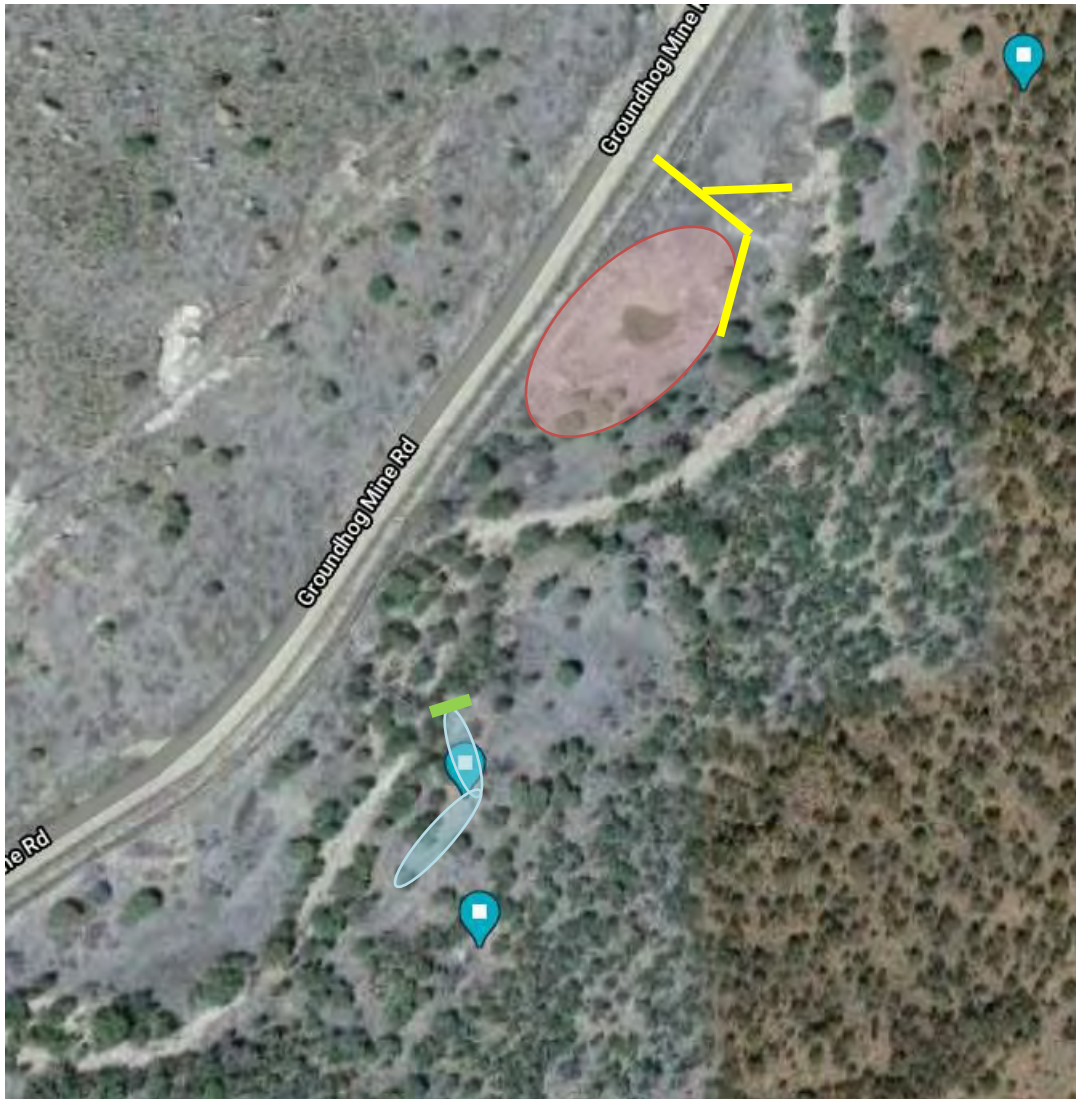
**Figure 3: Southern Area Backfill Map:**

- Crew installed straw wattle (green line) at downgradient edge of removal area (blue oval) adjacent to creek bank.
- Crew constructed substantial berms (yellow lines) at the upgradient edge of the southern borrow area (red oval) to prevent stormwater from entering and filling the low area and also to prevent stormwater from following access road south.

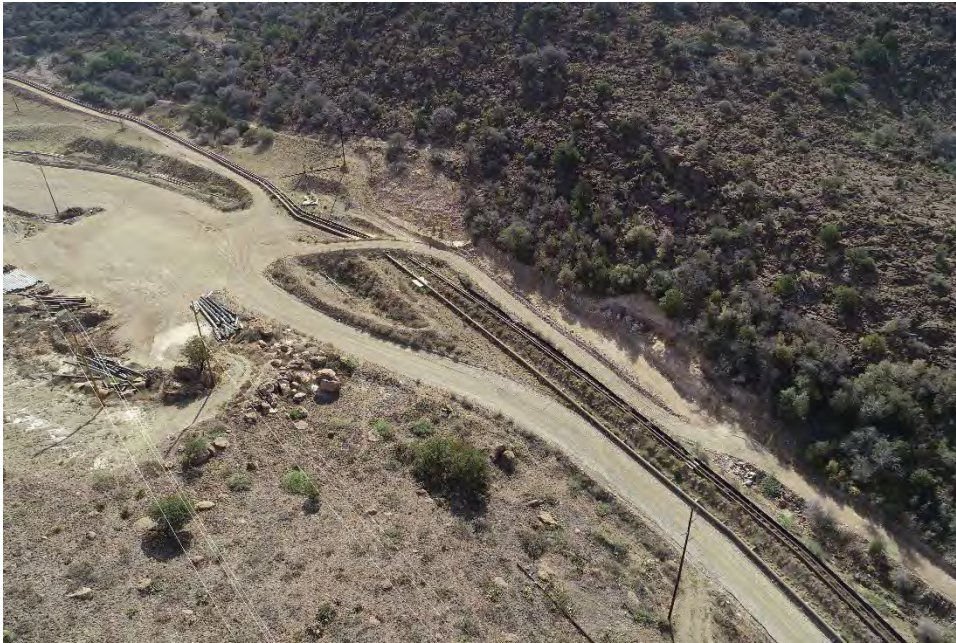
**Photograph: 13**

**Description:**  
BC26; looking northeast
